Current State of Masonry Properties Material on Emerging Zones in Lima City

Luis Lavado, Jenny Taira, and Jorge Gallardo

Japan–Perú Center for Earthquake Engineering Research and Disaster Mitigation (CISMID)

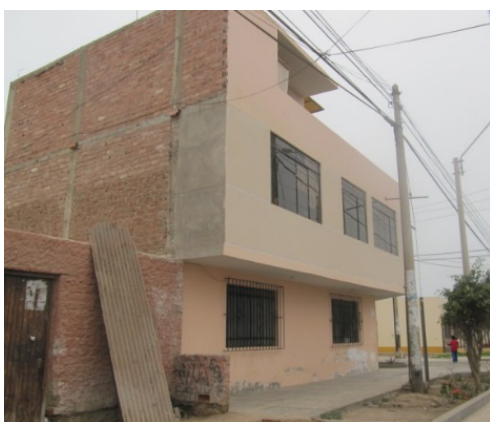
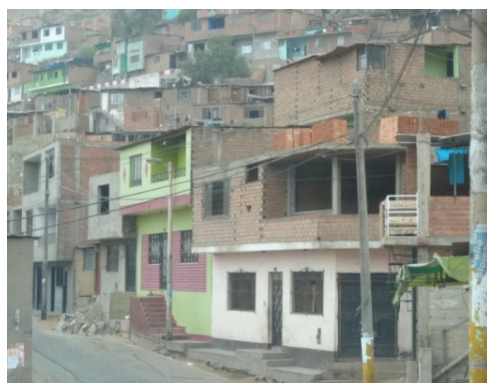
Fig. 1. Masonry houses in Lima.

Several districts in Lima have been assessed for seismic risk since 2010. These studies were conducted by CISMID after being requested by national government entities [2–6], with 25% to 30% of all blocks of district used as representative samples. **Table 1** shows the percentage of blocks built using masonry, beside the types of bricks used in walls and **Fig. 1** shows masonry houses in Lima.

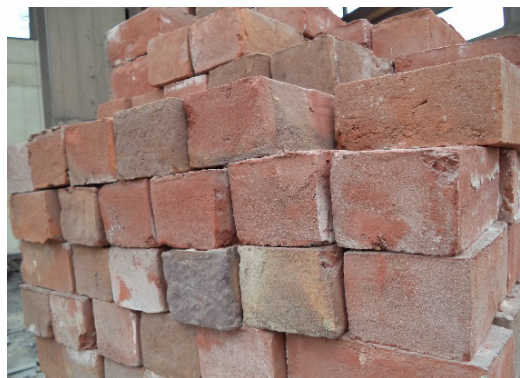
Fig. 2. Hand-made bricks.

Mechanical properties of bricks, mortar, and masonry were tested based on the Peruvian Standard [7]. Eight types of clay bricks from six manufacturers (three hand-made and five industrially produced) and two mortar grade were tested to determine mechanical properties. **Fig. 2** shows hand-made bricks and **Fig. 3** shows industrially produced bricks while **Table 2** shows type and location of clay brick used in this study. Eighty prisms for testing axial compression resistance and thirty six wallettes tested for diagonal tension tests.

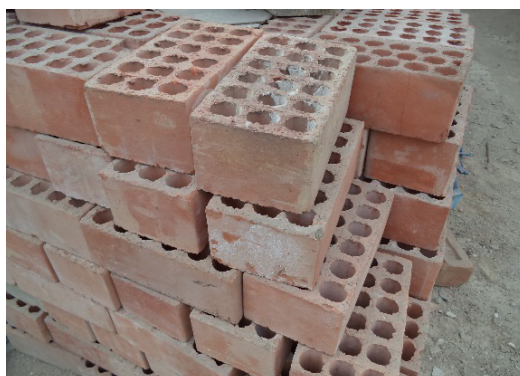
Fig. 3. Industrial bricks.

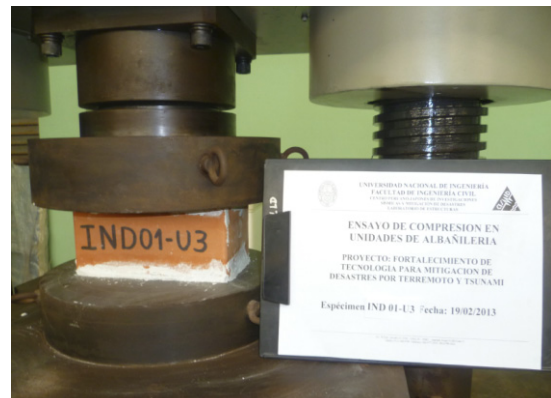
Fig. 4. Compression test of bricks.

For each type of bricks, compression tests were performed on 10 units to determine compression strength $f'b$ and **Fig. 4** shows compression test of bricks. Calculating resistance must consider the gross area of brick. Values between 12.6 and 1.9 MPa were obtained. **Table 5** lists test results for the compression strength of bricks.

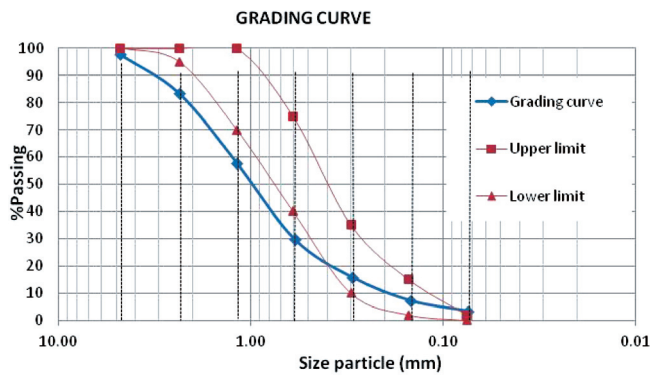
Fig. 5. Grain size of sand.

Two types of mortar were used in this study. The grain size of sand curve does not fit between upper limit curve and lower limit curve given by Peruvian Standard (See

Fig. 5). No corrections were made, however, to represent actual construction conditions.

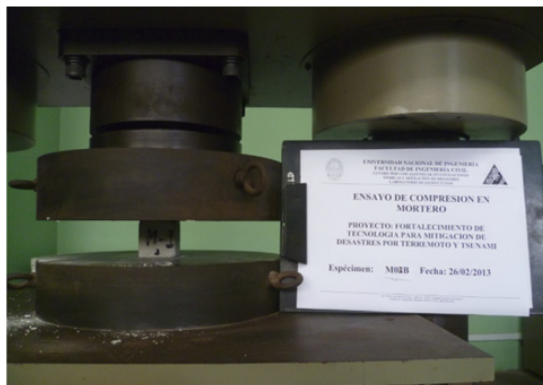
Fig. 6. Compression test of mortar.

Parallel to the construction of prisms and wallettes, samples were obtained for each type of mortar. These samples were cured in water, aged for 28 days, then tested for axial compression. **Table 6** lists compression test results for mortar and **Fig. 6** shows compression test of mortar.

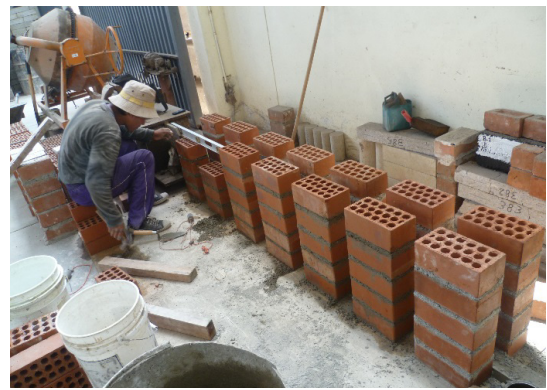
Fig. 7. Prism construction.

Samples for determining the compressive strength of masonry consist of prisms made of 5 bricks. Four prisms were prepared for each of 8 types of bricks using mortar with a ratio of cement to sand of 1 : 3 and 4 prisms using mortar with a ratio of cement to sand of 1 : 5. **Fig. 7** shows construction of prisms.

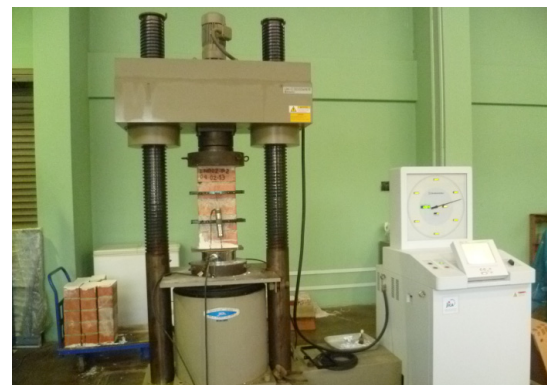
Fig. 8. Compressive strength tests.

Tests started on specimen at the age of 28 days and compression testing was done following NTP 399.605. Test equipment consisted of a 300 ton compression machine and a data acquisition system. LVDT sensors were used to measure deformation. Fig. 8 shows compressive strength tests of specimen.

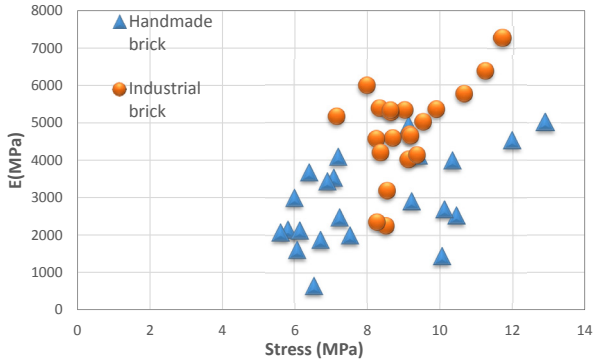
Fig. 11. Variations in modulus of elasticity of masonry with corresponding compressive strengths for all prism sets.

Figure 9 shows this relationship for industrial brick prisms, Fig. 10 that for hand-made brick prisms, and Fig. 11 that for both types of prisms. Fig. 12 shows results for tubular brick prisms. Fig. 13 shows types of failures

The relationship for all sets of prisms, is as follows:

$$E = 439f'm$$

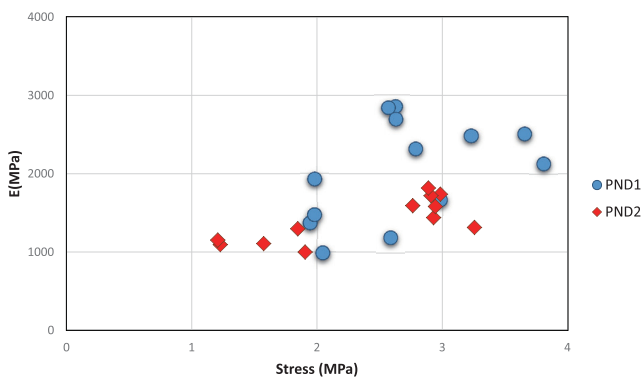
Fig. 12. Variations in modulus of elasticity of masonry with corresponding compressive strengths for tubular brick prism sets.

compressive strength $f'm$ of prisms was developed based on regression analysis of data obtained from an experimental program. The correlation coefficient values fit between 0.6 and 0.75. This correlation has not, however, given good results for pandereta bricks prisms.

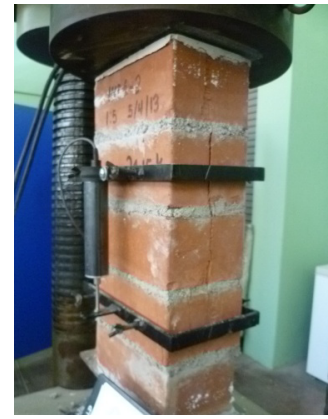
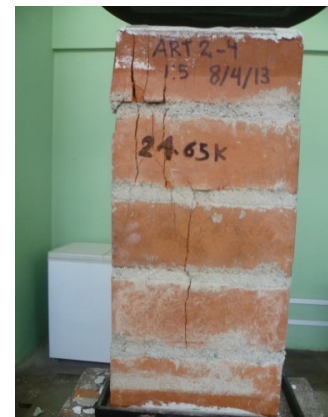
Fig. 13. Types of failures in prisms. (a) Vertical cracking, (b) vertical cracking and crushing.

in prisms due to compressive strength test.

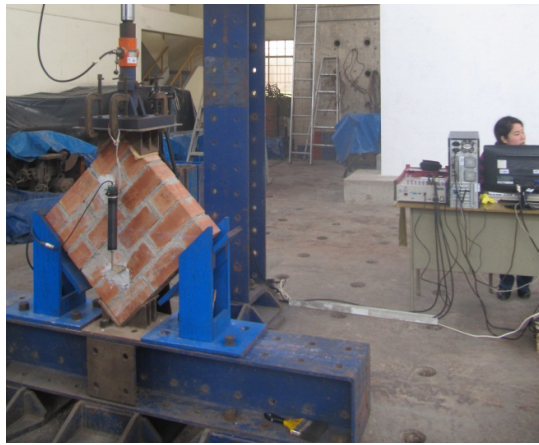
Fig. 14. Diagonal tension tests.

Diagonal tension tests were developed to measure diagonal tension as precisely as possible. Wallettes were loaded in compression along one diagonal causing diagonal tension failure if the specimen split apart parallel to the load direction. **Fig. 14** shows diagonal tension tests. Wallettes consisted of six rows of 2.5 bricks each.
