# Comparison of Behaviors of Non-Engineered Masonry Tubular Block Walls and Solid Engineered Walls

Carlos Zavala, Luis Lavado, Jenny Taira, Lourdes Cardenas, and Miguel Diaz

Japan-Peru Center for Earthquake Engineering Research and Disaster Mitigation (CISMID),  
Faculty of Civil Engineering, National University of Engineering (UNI)  
Av. Tupac Amaru 1150 Puerta 7 Campus UNI, Lima, Peru  
E-mail: czavala@uni.edu.pe

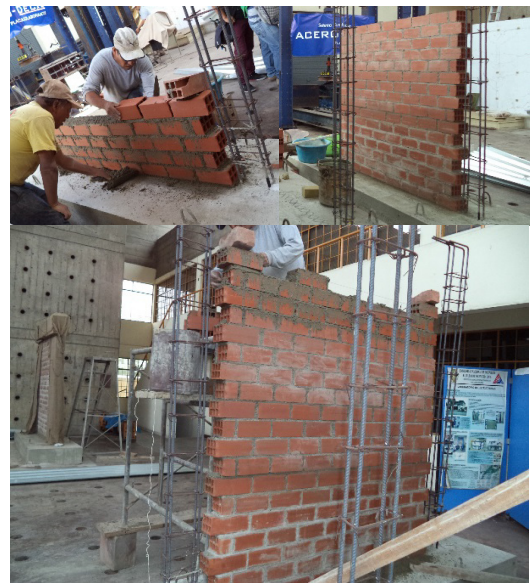
**Fig. 4.** Three stages of specimen construction.

The construction was done in such a way as to replicate, as closely as possible, the actual environment of a construction site. To that end, the wall was built up to half of its full height on one day, with the remainder being completed on the following day. After masonry wall is completed, confined elements reinforce bars are set, to finally put the concrete on site. The three stages of the construction are presented in **Fig. 4**.

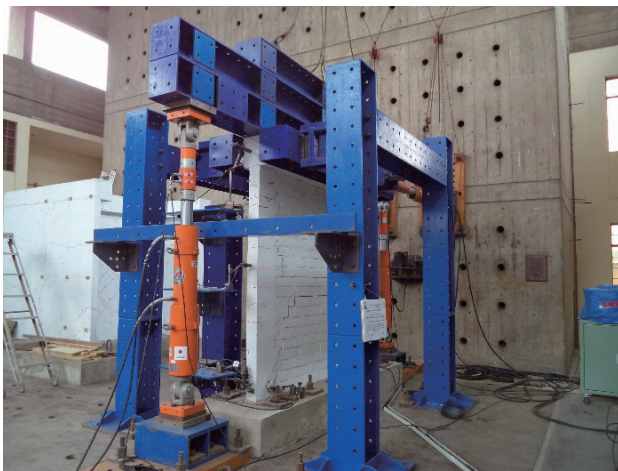
Fig. 7. Test setup for masonry wall test.

The test setup of the specimen is shown in **Fig. 7**. To apply the axial load, two jacks were installed vertically. Another two jacks were used to simultaneously apply a lateral load. Strain gauges were also installed to investigate the yielding of the reinforcing bars at each corner of the confinement elements.

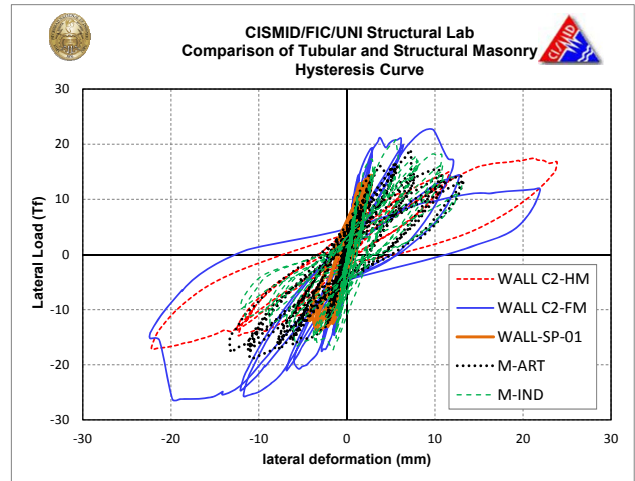
The relationship between the displacement and shear force applied to the walls is shown in Fig. 8, where the displacement of wall WALL-SP-1 reaches a maximum of 13.85 mm, corresponding to a maximum drift of 1/160.

Fig. 8. Hysteresis curves of WALL-SP-1 wall and others.

loads, due to differences in the axial confinement and variations in the quality of the materials. For WALL-SP1 and M-ART, shear cracks appeared at basically the same displacement. Table 2 shows that the maximum load ( $Q_u$ ) is the lowest of all the measured values, and the displacement at the maximum load ( $d_{max}$ ) is the smallest. WALL-SP-1 is subjected to more confinement stress and this has a major influence on the displacement. From the table, it is possible to conclude that the confinement will yield before the other walls, due to the low material strength and high axial load on the wall.

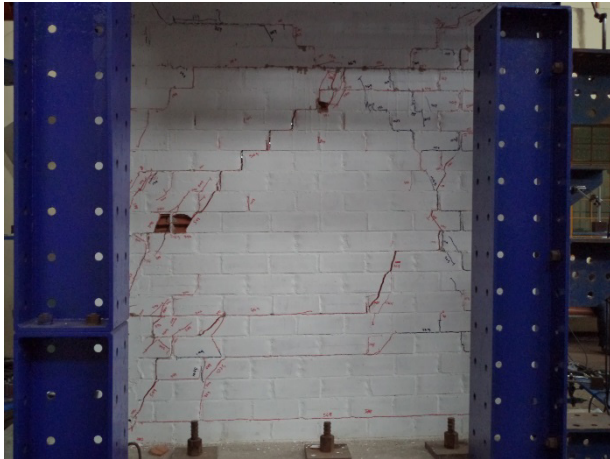
Initial cracks appeared in the masonry at a drift of 1/1500, and diagonal cracks started propagating at a drift of 1/1075. Finally, diagonal crack openings appeared at a drift of 1/200 with shedding of the brick surface. The final state of specimen WALL-SP-1 is shown in Fig. 9.

**Fig. 9.** Final state of wall (1/150) – WALL-SP-1.

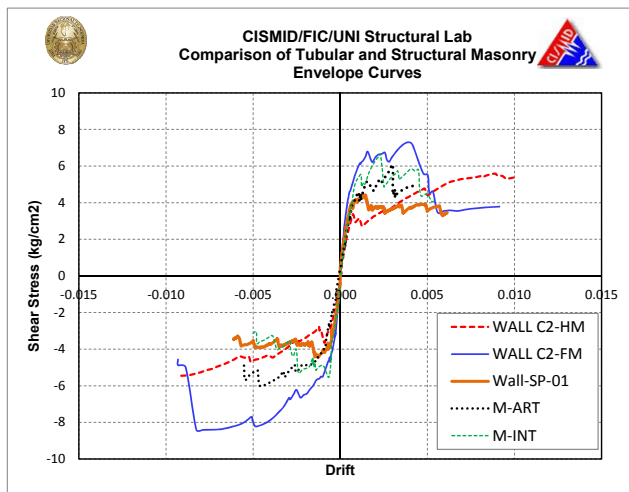
The backbone curves of the relationships between the displacements and shear forces are shown in Fig. 10. Table 3 lists the maximum shear stresses, together with the corresponding drifts. It can be seen that the stress for the SP-01 wall is lower because of the action of the strong axial load and the low strength of the material, producing a shear stress of 4.44 kg/cm<sup>2</sup>. The M-IND and M-ART walls exhibit the second-lowest level of shear stress among the specimens. Since WALL C2-FM is an engineered wall, it exhibits a higher shear stress.

**Fig. 10.** Comparison of behavior curves.

Also evident is the great difference in the maximum capacity of the engineered wall and that of the M-ART and M-IND walls.

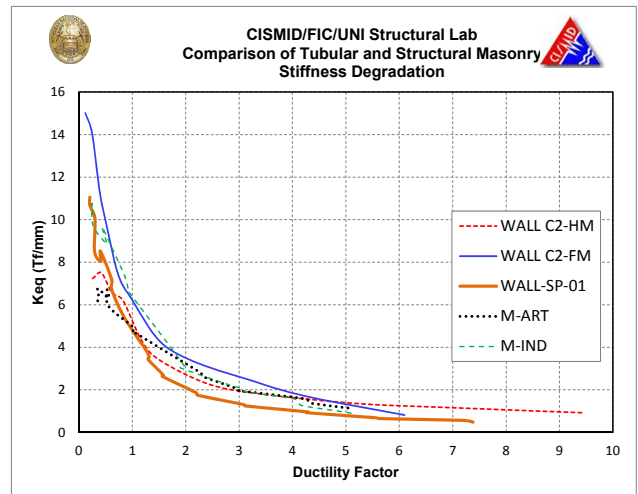
**Fig. 11.** Comparison of equivalent stiffness relative to ductility factor.

**Figure 11** presents a comparison of the equivalent stiffness relative to the ductility factors of the specimens. The engineered walls (WALL C2-FM) exhibit a higher equivalent stiffness while the tubular walls (M-ART, M-IND, WALL-SP-01) have an average stiffness that is around 60% of the initial stiffness of the engineering wall. In all these cases, the tubular brick walls exhibit the lowest levels of stiffness.
