Paper:

# Post-Disaster Urban Recovery Monitoring in Pisco After the 2007 Peru Earthquake Using Satellite Image

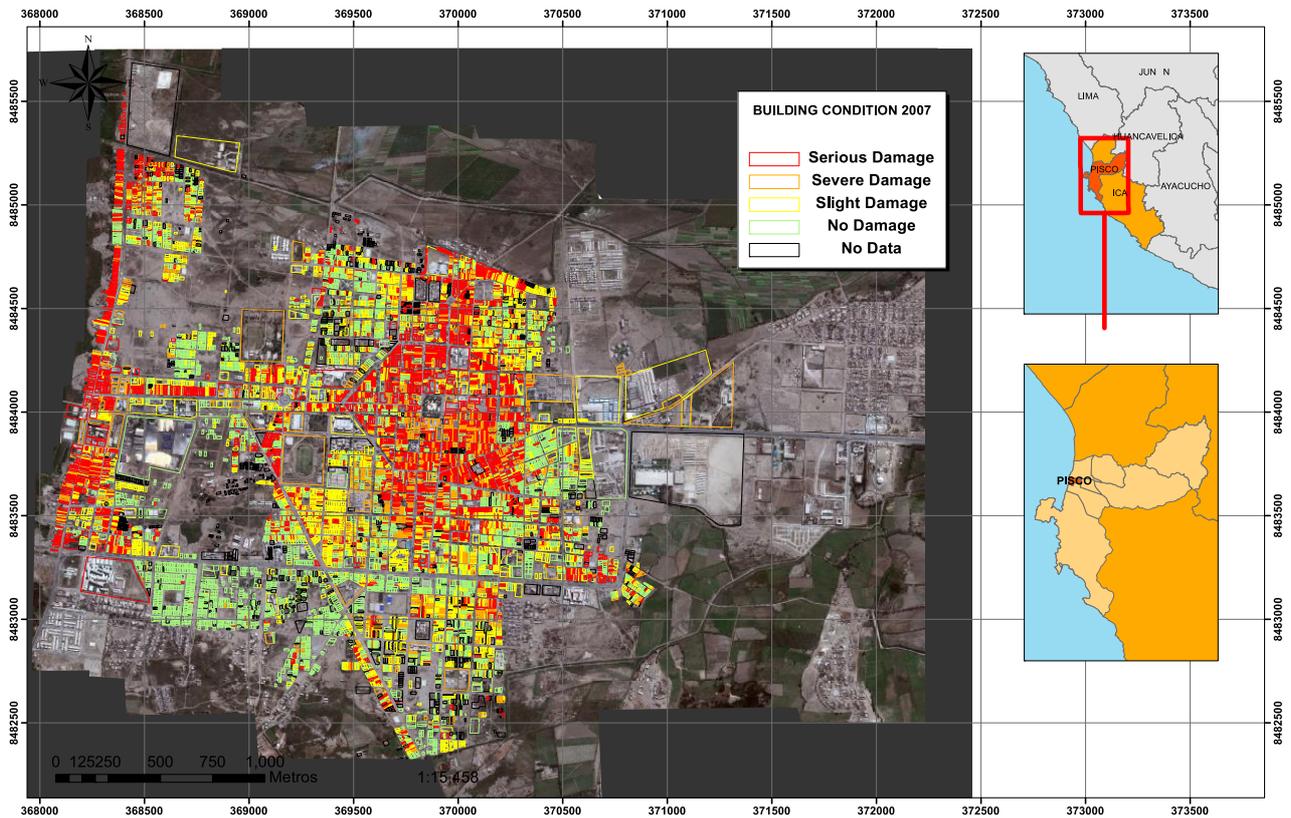
**Fig. 1.** Building damage conditions owing to the 2007 Peru earthquake, as reported by the Japan–Peru Center for Earthquake Engineering Research and Disaster Mitigation.

Just after the earthquake, numerous damage surveys were conducted, and damage conditions were reported by some institutes such as the Earthquake Engineering Research Institute (EERI) [8], and the joint investigation group by the Japan Society of Civil Engineers (JSCE) and Japan Association for Earthquake Engineering (JAEE) [9]. **Fig. 1** shows the building damage

conditions investigated by the Japan–Peru Center for Earthquake Engineering Research and Disaster Mitigation (CISMID).

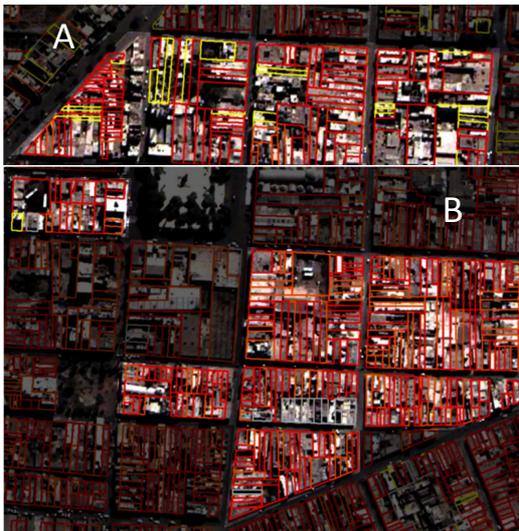
**Fig. 2.** Blocks included in our field survey. Location of Picture A and Picture B are shown in **Fig. 3**.

According to a survey conducted by the Pisco city government, eleven blocks were occupied by mostly adobe-structure buildings [12]. These blocks were characteristic of the central districts of Pisco and were devastated by the earthquake and characteristic of the central districts of Pisco. We assumed that these destroyed buildings had been replaced with new solid-structure buildings such as rain-forced concrete buildings or brick buildings. We then conducted a field survey by visual interpretation to examine the recovery conditions of the town blocks. The eleven blocks that were congested by adobe structures are shown in **Fig. 2**.

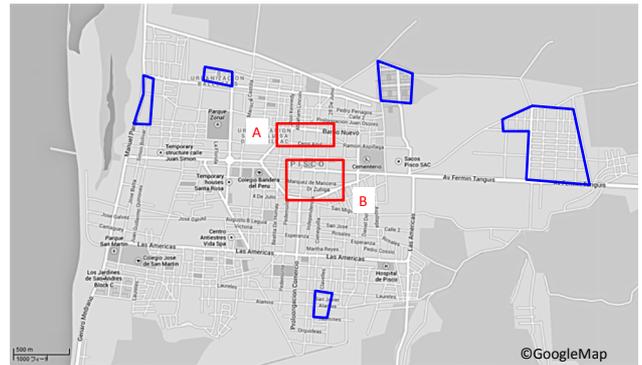
**Fig. 3.** Residential areas selected for hearing survey corresponding to that shown in **Fig. 2**.

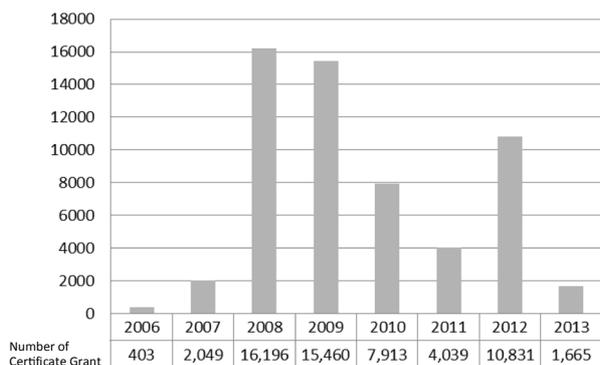
**Fig. 4.** Changes in numbers of residence certificates granted [13].

Residence certificates were examined by Organismo de Formalización de la Propiedad Informal (COFOPRI). **Fig. 4** shows changes in the number of certificates granted from 2007 to 2013 in the Ica region, which includes Pisco province [13]. This chart indicates that illegal residents had gained residence certificates and had been living in

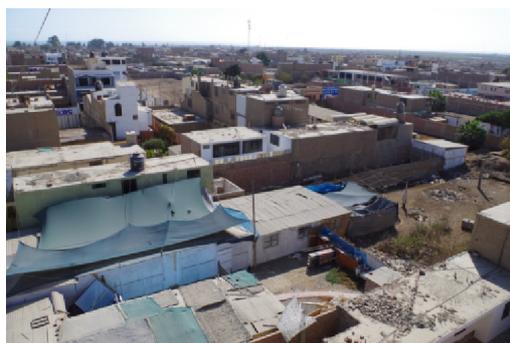
**Fig. 5.** View of Pisco central district.

###### (2) Characteristics recognized by the survey (**Fig. 5**)

- The target area is basically earthy.
- Most buildings are one- or two-story residential.
- Most streets are unpaved except for main roads.

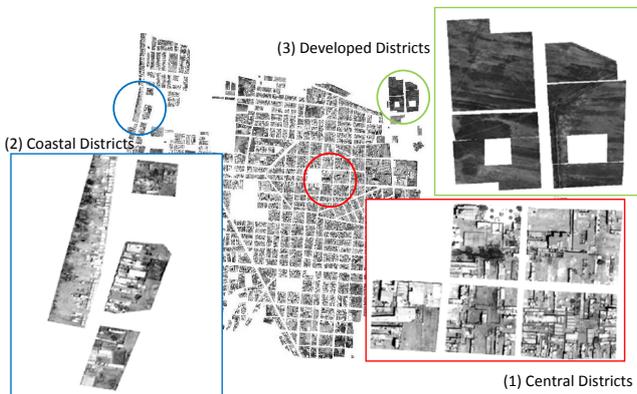
**Fig. 6.** Scope of analysis and selected training districts.

Prior to image analysis, it was necessary to examine the accuracy of using the images. We selected the following three areas according to damage conditions and locations (**Fig. 6**):

- (1) Central districts, commercial with public facilities.
- (2) Coastal districts, residential illegally occupied.
- (3) Developed districts, residential developed after the 2007 earthquake.

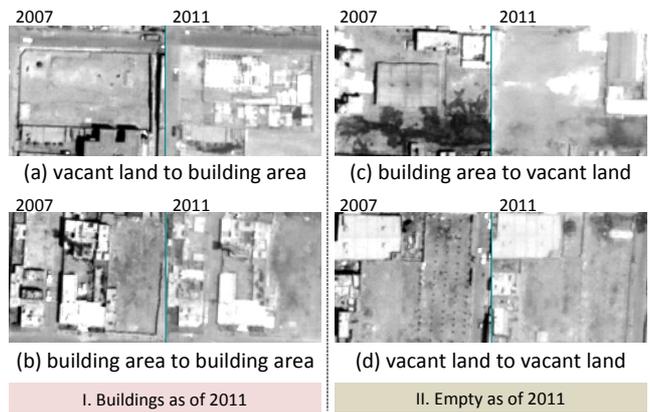
**Fig. 7.** Four types of changing land lot usage patterns.

Regarding changes in land lot usage from 2007 to 2011, four types of changing patterns were identified: (a) vacant land to building area, (b) building area to building area, (c) building area to vacant land, and (d) vacant land to vacant land (**Fig. 7**). An understanding of these four types of building–vacancy patterns is essential for analyzing the chronological recovery transition of individual land lots.

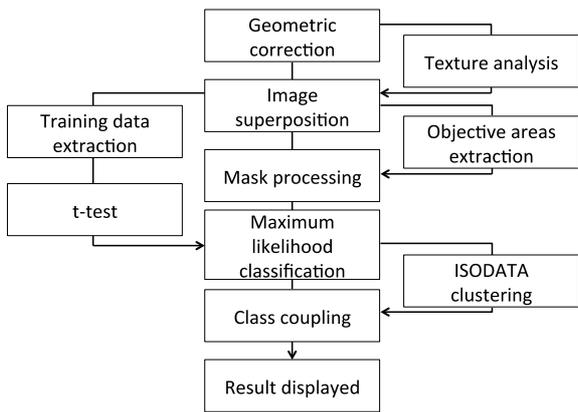
Fig. 8. Analysis flowchart used in this study.

The analysis procedure we applied in this study is illustrated in **Fig. 8**.

As a common treatment, we first superimposed each band of individual images on one layer after geometric correction, indicated as “image superposition” in the figure. By comparing the images, we recognized no difference in the urban fabric or shapes of town blocks. Then

we eliminated most areas except the focus districts by mask processing.

Second, we selected remarkable changing patterns as training data and calculated fundamental statistics to evaluate statistical significance using pixel-based analysis and texture analysis.

Finally, as evaluated by the t-test, we conducted maximum likelihood classification based on the training data and classified changing pattern. Unclassifiable areas with shadows were eliminated by Iterative Self-organizing Data Analysis Technique (ISODATA) clustering.

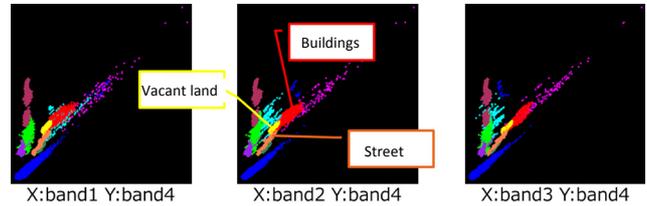
Fig. 9. Spectrum separation conditions.

Checking spectrum separation by calculating fundamental statistics reveals that the scatter plot area for buildings and that for vacant land overlapped (Fig. 9), which indicates that the spectrum separation performance was not very high for this analysis.

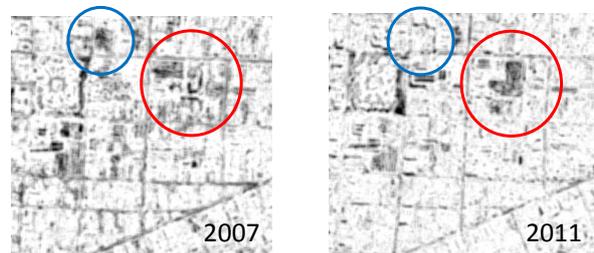
Fig. 10. Comparison on image represented by entropy.

Next, we used fundamental statistics based on entropy, or the texture information of the images, to reduce misclassification caused by using only pixel-based classification. The higher the level of tint, the more entropy increases. Entropy decreased in the area surrounded by the red circle in Fig. 10. As shown in Fig. 11, a building existing in 2007 was removed in 2011. On the contrary, entropy increased in that surrounded by the blue circle in Fig. 10, which indicates new building construction. Therefore, we can classify the patterns in listed in Table 4 by using this method.

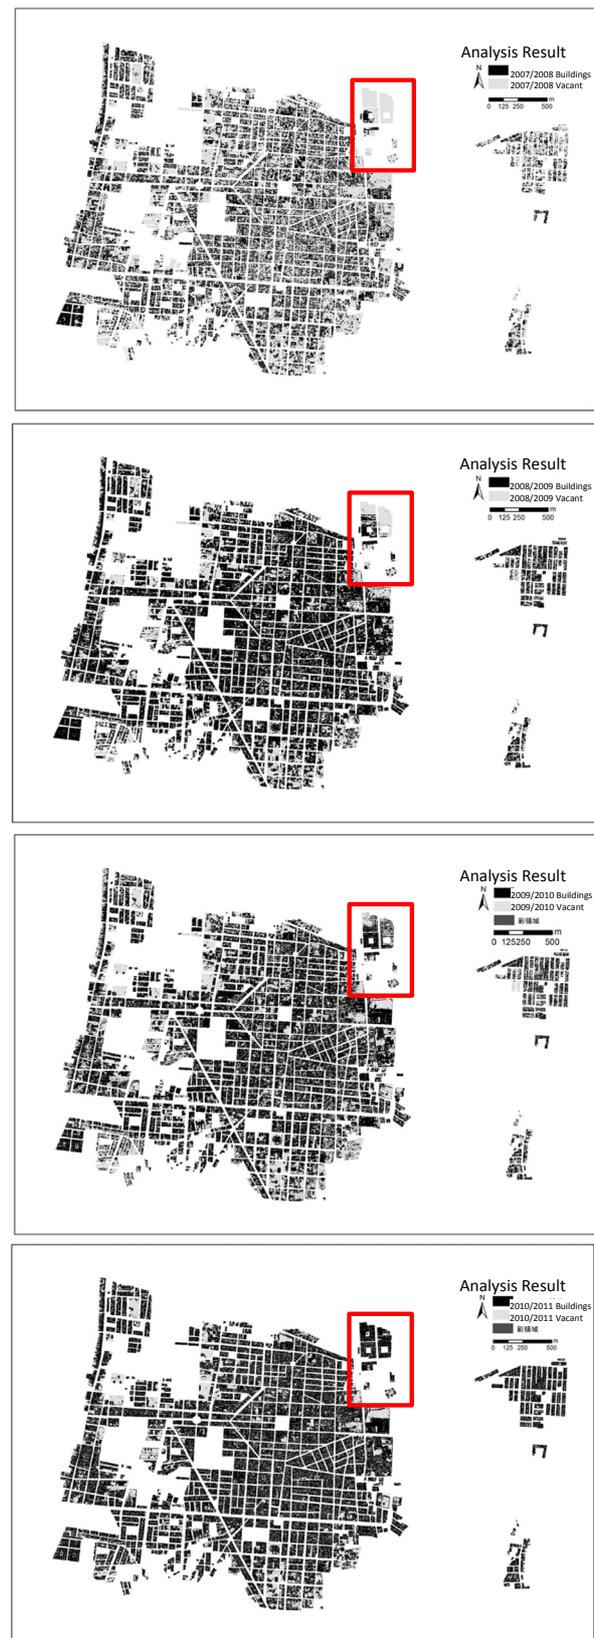
**Fig. 12.** Changes in the entire area of Pisco.

The method described in Section 4 was applied to the objective area. The images in **Fig. 12** show the chronological changes in Pisco from 2007 to 2011 as determined by this analysis.

Each image presents differences detected between spans of one year. Buildings are presented in black, and vacant land is in gray. It is possible to recognize building density conditions and transitions of housing construction in these images. For example, the area surrounded by the red square in each image shows obvious changes in the districts since 2007.

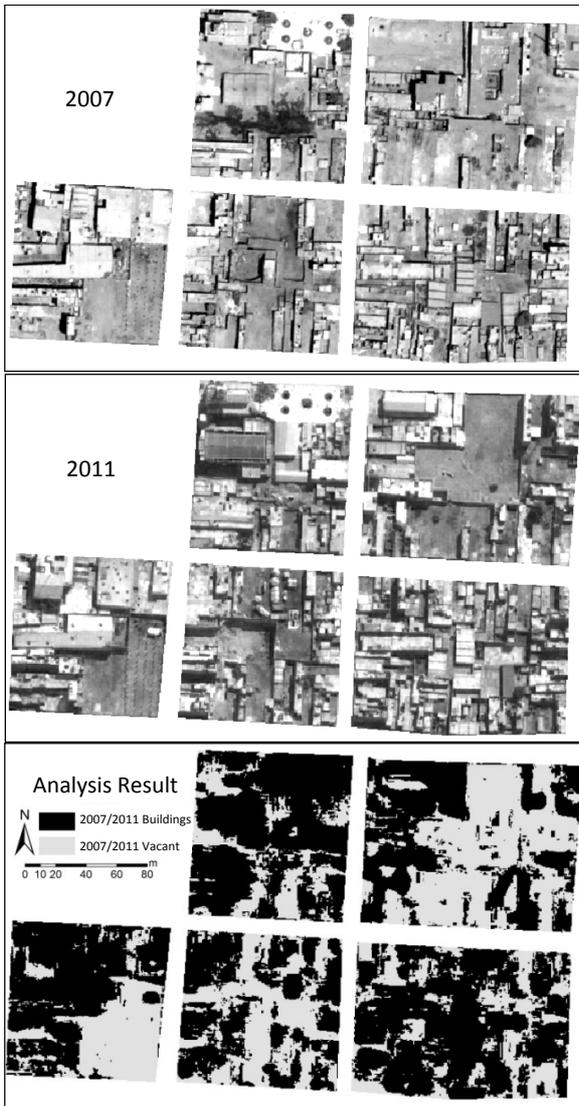
Fig. 13. Changes in central districts in 2007 and 2011.

Changes in the central districts as determined by satellite images captured in 2007 and 2011 in addition to the results of the analysis are shown in **Fig. 13**. It appears that some empty lots remained in the image of 2007 where collapsed buildings had been removed. The analysis results verified relatively large sites with some buildings became vacant lots as of 2011. Large buildings were effectively extracted from the images, though some boundaries between buildings and open space may have been misclassified.

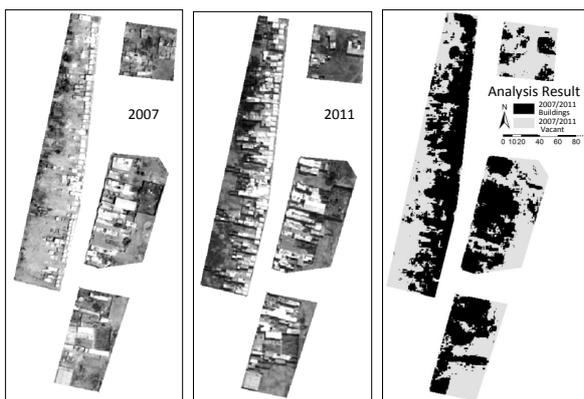
Fig. 14. Change of coastal districts (2007 and 2011).

Changes in coastal districts are shown in **Fig. 14**. These districts were severely damaged by the 2007 Peru earthquake. The government provided temporary housing to the victims in the districts. However, many squatters reconstructed their houses without government aid. As a result of the analysis, the remaining foundations of such damaged buildings were misclassified as sound buildings.

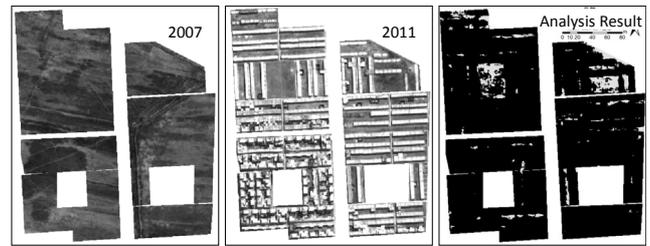
Fig. 15. Changes in developed districts in 2007 and 2011.

Changes in the developed districts are shown in **Fig. 15**. This area, which was a wasteland in 2007, was developed by the government as a permanent housing area following the earthquake. Although this change is obvious through visual observation, misclassification often occurred in the analysis. Such results may be attributed to changes in the components on the ground owing to the development. In particular, concrete that replaced the soil in the new residential area was recognized in the analysis as the same material used for building roofs.

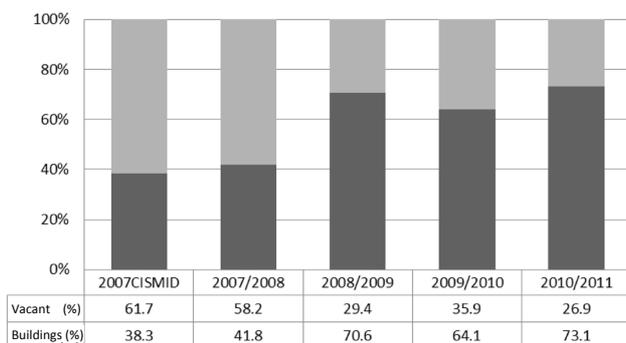
**Fig. 16.** Quantitative recovery process.

Figure 16 shows a quantitative recovery process of Pisco as a result of this effort. Compared with the conditions present four months after the earthquake in 2007, the building ratio increased slightly in 2008. The ratio sharply increased between 2008 and 2009 and rose slightly in 2011. The building ratio in 2010, however, was lower than that in 2009 and in 2011. It is inferred that the high observation angle for the satellite image of 2009 affected to the analysis by increasing the ratio of building shadows.
