## **SEISMIC BEHAVIOR OF TWO STORIES MASONRY BUILDING**

### **SUMMARY**

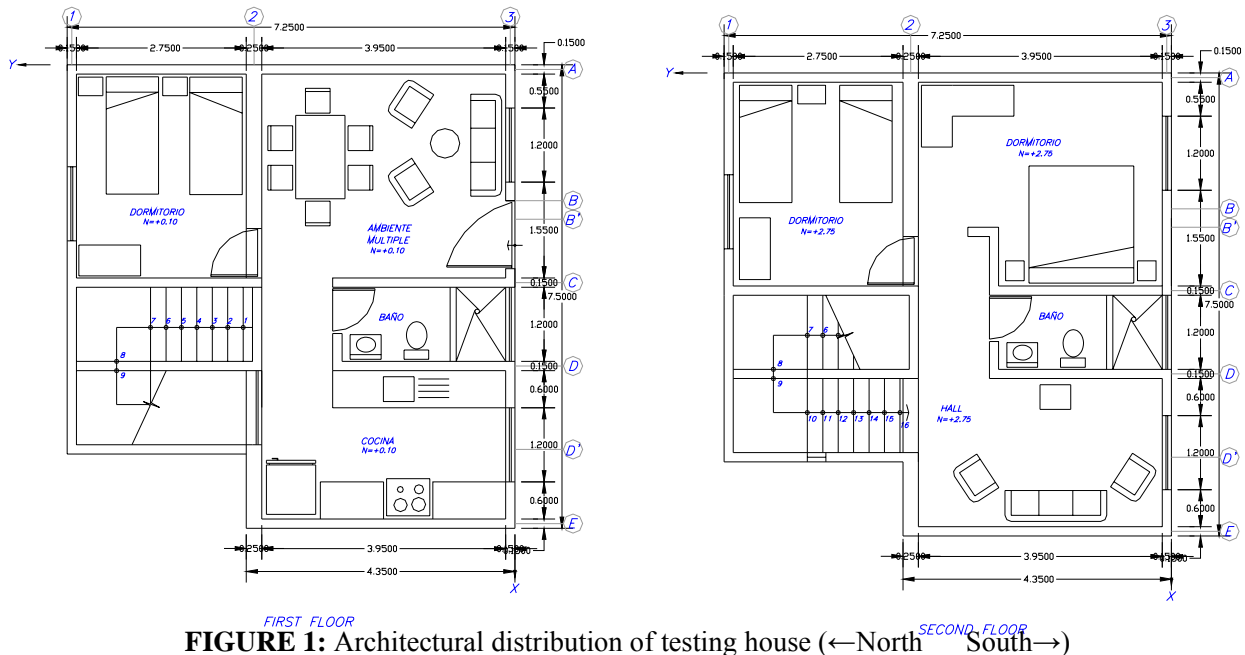
FIGURE 1: Architectural distribution of testing house (←North South→)

Figure 1 presents the architectural drawing of two stories testing building. This house represents a likely used distribution for six family members and have all facilities for living. The house was built using handmade clay bricks taken from a representative sample from common informal sellers in surroundings north Lima’s suburbs. Story height of the house is 2500 mm.. Samples of the material were taken and piles of 4 clay bricks were subjected to compression test for determine the resistance of masonry. Table 2 show the results for the used handmade bricks and also the factory bricks for comparison

The building was designed following the Peruvian earthquake design Standards NT-E030 and the masonry standards NT-E070. Under these standards Table 3 presents the computed design quake demand for the building where design quake acceleration was 267 gals. Table 3 presents the results for the demand of the quake in each of the directions of the building. Test forces application was in direction X-X, which is parallel to the longest length of the building as is presented in Figure 1.

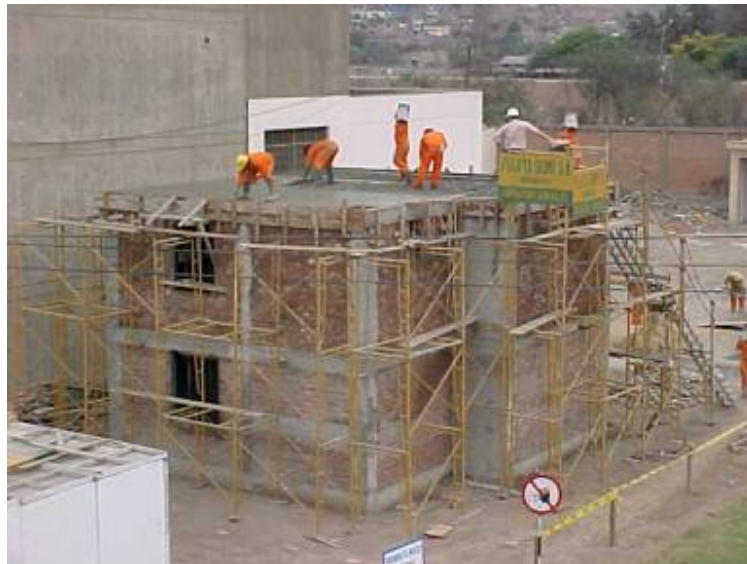
**FIGURE 2:** The building under construction

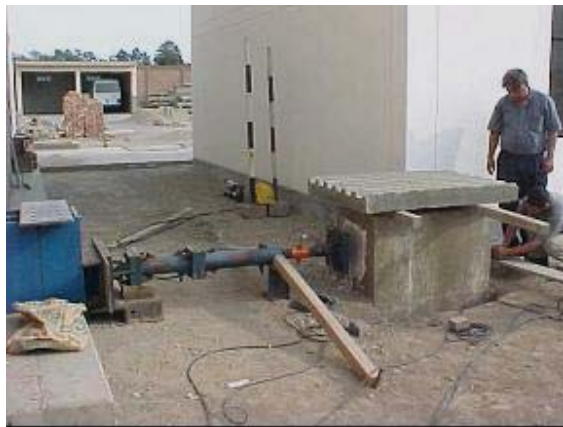
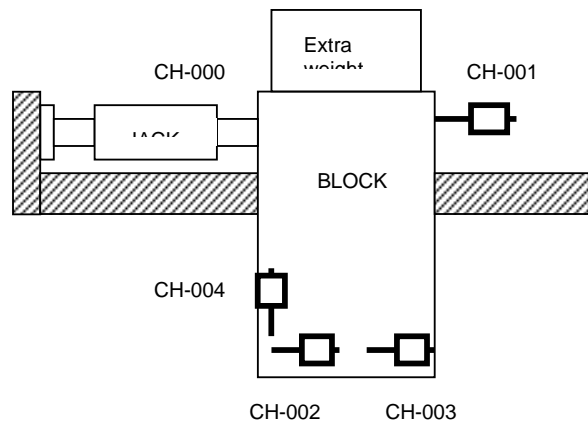
**FIGURE 3:** Block test

To investigate the friction coefficient between foundation and soil, a block of 100 cm length and 60 cm. width was build in a position beside the house as is presented in Figure 3. The block weight is 2500 kg.

The load was applied with a 20 t. Static Jack and 4 displacement transducers were set according with Figure 3. Ch-000 is the load channel and Ch-001 to Ch-004 corresponds to displacement channels.

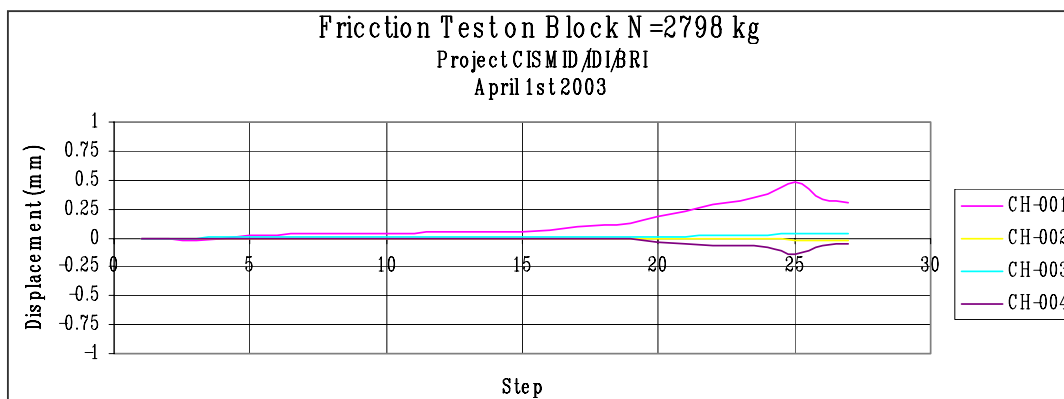
**FIGURE 4:** History of displacements

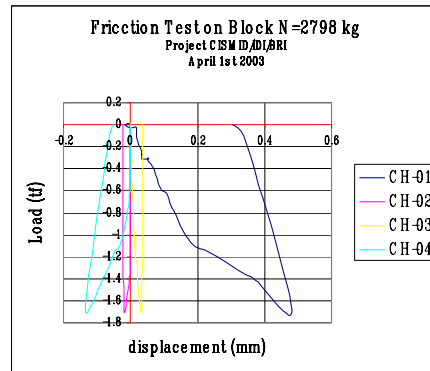
**FIGURE 5:** Load – displacements on block

If the behavior of channel 4 is observed, for a load of 1.073 t. the block started to move vertically as is shown in Figure 5. Therefore the static friction coefficient is computed as the ratio between the start load and the normal load. Then friction coefficient is  $\mu = 1.073/2.798 = 0.3834$ .

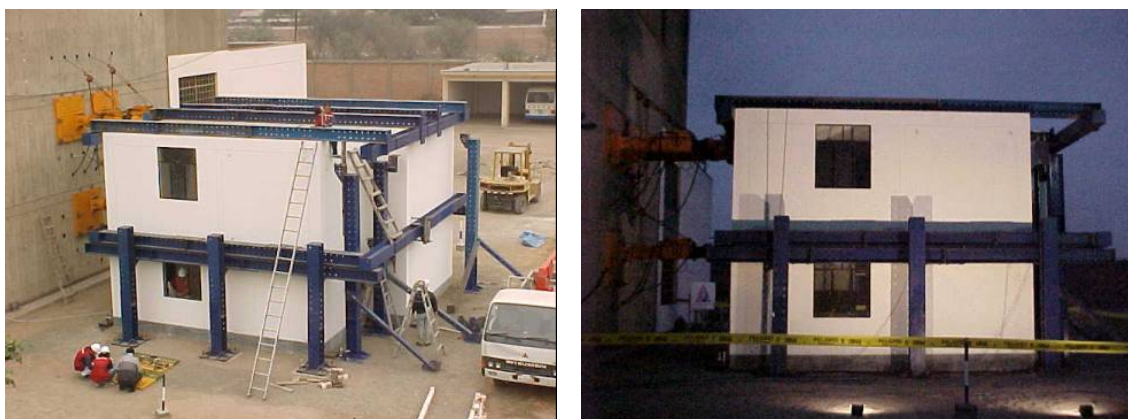
**FIGURE 6:** Test setup of the testing house

In order to develop a cyclic test on the full scale confined masonry house, the procedure proposed by the standard ASTM E564-00e1 Standard Practice for Static Load Test for Shear Resistance of Framed Walls for Buildings have been adapted for this experiment. Considering the possibility of torsion on the house and mitigation the problems for the loading on the experiment using an external support structure as shows in Figure 6.

To develop the test, three actuators of 25 t. of capacity were used. Two actuators on the second floor and one actuator on the first floor were in position to push and pull the full-scale specimen. The actuators were working under a mix control; this is one actuator on the second floor under displacement control (let's name it command actuator) and the others two actuators under load control using the signal from the command actuator. All the actuators work under a stroke range of 200 mm. A computer through a servopulser controlled the actuators. Signal conditioner was used for the acquisition of the signals of each sensor. A set of 45 sensors were set and two measuring systems were used: first a signal conditioner with 16 channels and UCAM 5BT static measuring system using 29 channels.

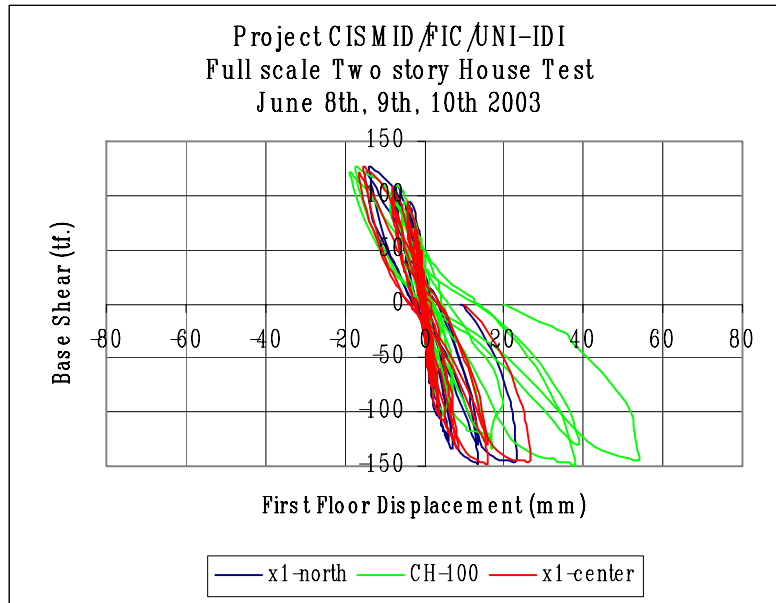
**FIGURE 7:** First Floor displacement versus Base shear

Figure 7 and Figure 8 shows displacement - shear relations on the first and second floors. Here each of the sensors is related with the main axis for walls in the direction of the test. It is possible to read that small torsion is induced because there are difference between each of the sensors on this direction. This is confirmed in Figure 9 where measure rotation is presented. The rotation angle on the top floor has maximum value of 0.0035 radians that was reached for the maximum drift

the lateral displacement will include the displacement of the basement due to resistance of soil is overpassed. Therefore, a correction on the displacement was performed on the curves presented in Figure 7 and 8. The results of the test after this correction are presented in Figure 11 and 12.

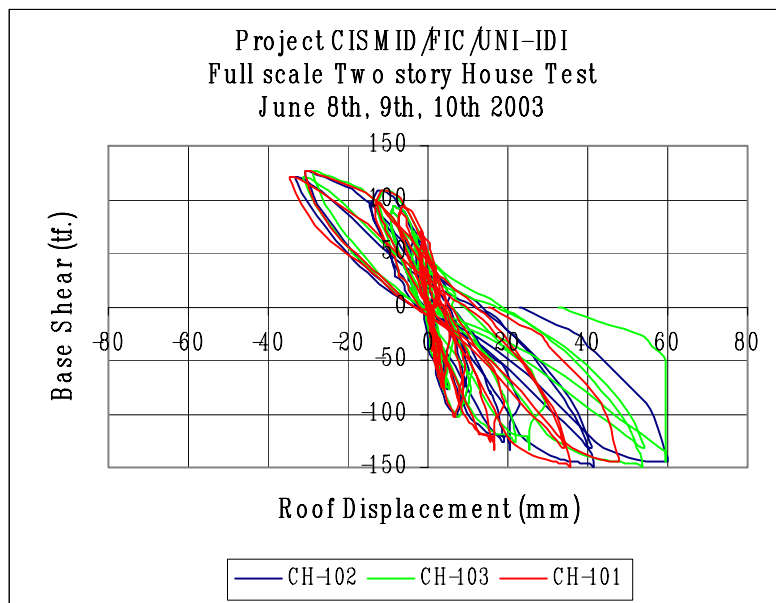
**FIGURE 8:** First floor displacement history

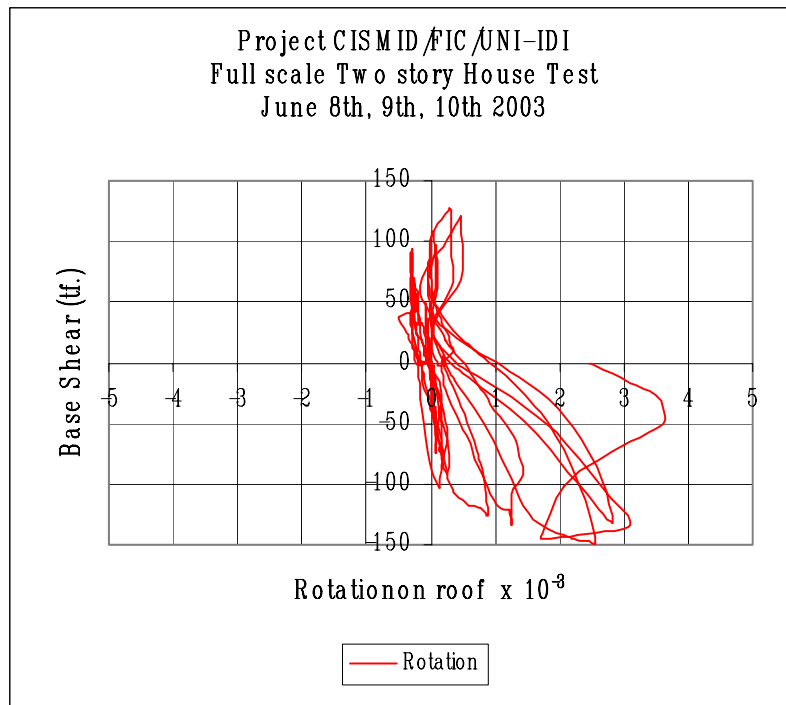
**FIGURE 9:** measured rotation on roof

- Behavior curves are presented in Figure 13 and Figure 14 for first and second floor of the building. Here it is possible to read how the displacement in the south side of the specimen is bigger than the displacement of north side. Is obvious influence of the torsion effect was verified in Figure 9 where rotation on roof was reported. Then specimen rotates to the south side because north side has bigger stiffness than the south side.

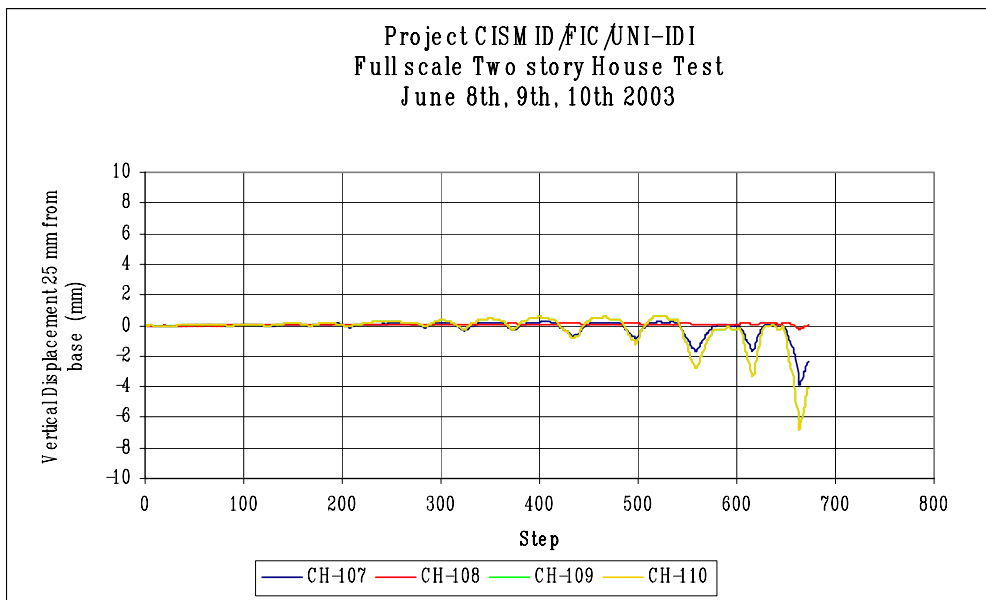
**FIGURE 10:** Vertical displacement at level 25 mm. from basement

Figure 10 presents the vertical displacement at level 25 mm. from basement. By observation of Figure 10 is possible to read that after step 250, the base shear of the house reach the friction resistance value and

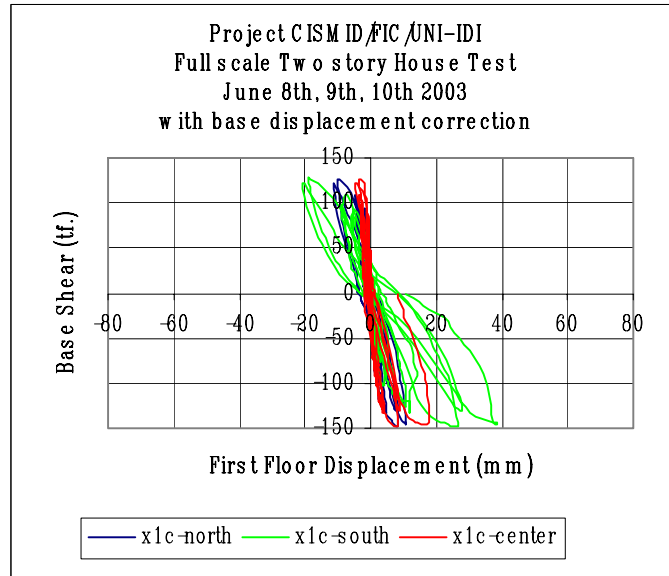
**FIGURE 11:** First Floor displacement versus base shear with base displacement correction

Using the peak values for each of the applied loading cycles of Figure 11 and Figure 12, the behavior curves of each floor is built. Figure 13 and Figure 14 presents the behavior curves for first and second floor respectively. It is possible to read from Figure 13; Then, the displacement of the central part of the structure became smaller than the south and north sides. However the south side have bigger displacement because the torsion effect (irregularity in plan of the structure). Then the building has more displacement

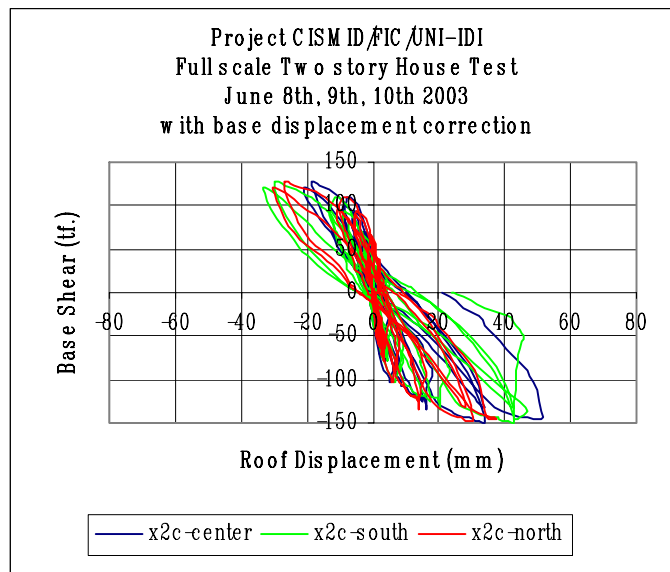
**FIGURE 12:** Second floor load - displacement corrected

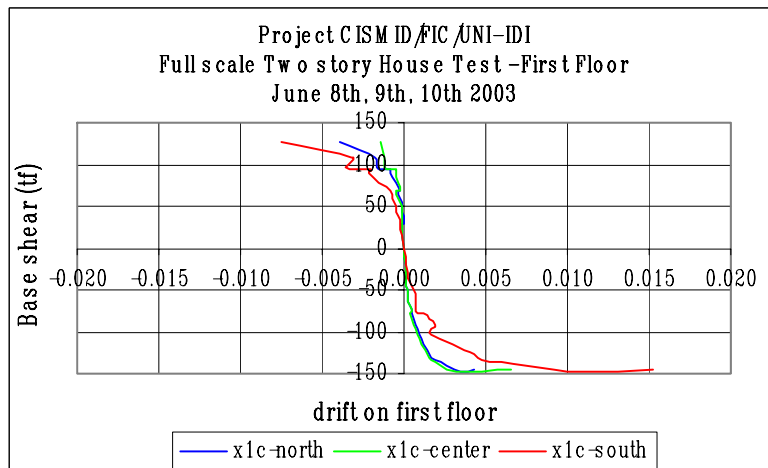
**FIGURE 13:** Behavior curve on first floor

in the south side than in the north one, as is expected. A maximum drift of 1/140 in the south side was reach on the first floor and 1/250 on north side when actuator pulls the specimen. By the other side when actuator push the specimen maximum drift of 1/65 and 1/250 was reach for south and north sides

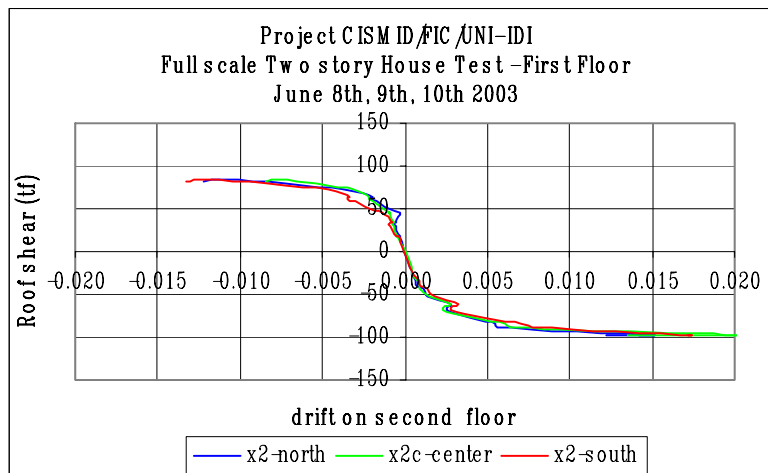
**FIGURE 14:** Behavior curve on second floor

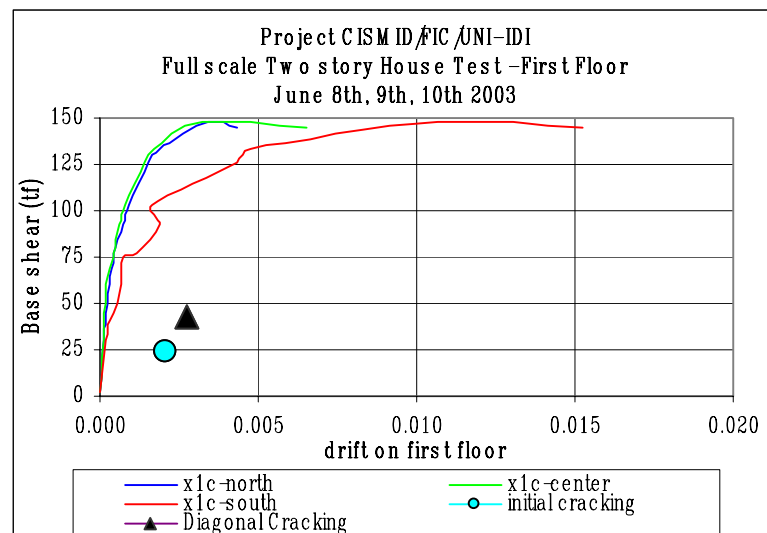
**Figure 15:** Design require demand points and cyclic behavior on full scale house

- Considering that the actuator pushing behavior curve represents the performance of the structural system, the required demand for severe quake and the required demand for moderate quake is presented in Figure 15. Considering the diagnosis by capacity design values from Table 4 and 5 we found the values of the standards are in a safety range.

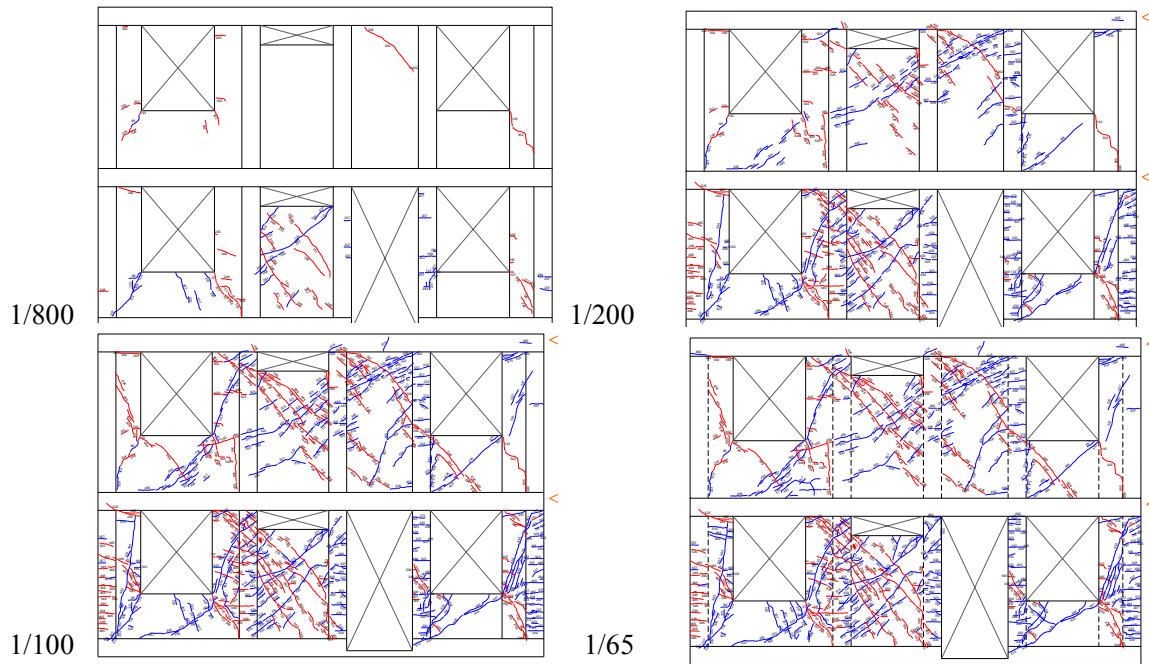
**FIGURE 16:** Crack Pattern during test

- Cracking pattern performed during the test is presented in [5]. Figure 16 shows some cracking patterns in south wing of the building. Here its is possible to understand the meaning of each of the drift values and verify that with 1/200 value the structure could be repair even a considerable cracking appears on walls.

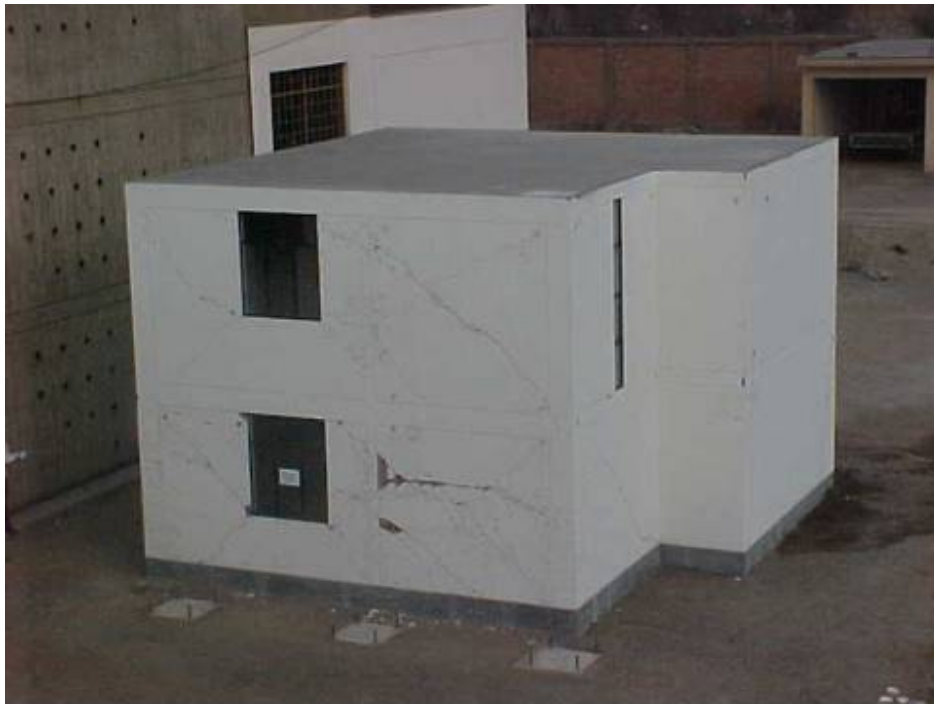
**FIGURE 17:** North wing of the house in final state

- Figure 17 and Figure 18 shows the final state of the house in north and south wings of the house. It can be seen that at final stage some parts of the covering surface fell down and cracks has been open from face to face on the falls.

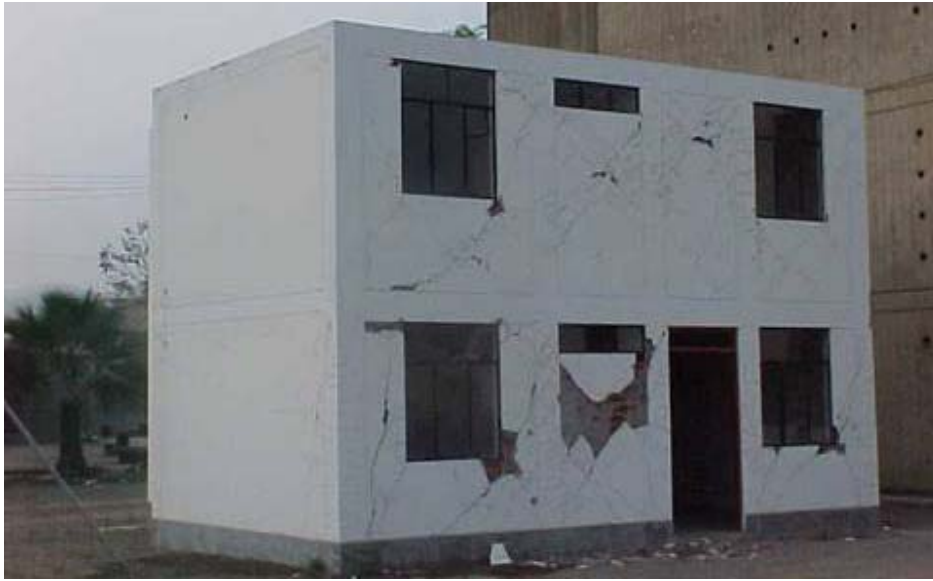
**FIGURE 18:** South wing of the house in final state
