Tsunami Reconnaissance Survey in Thailand Using Satellite Images and GPS

Fumio YAMAZAKI*, Masashi MATSUOKA, Pennung WARNITCHAI,
Supapis POLNGAM, and Shubharoop GHOSH

Abstract

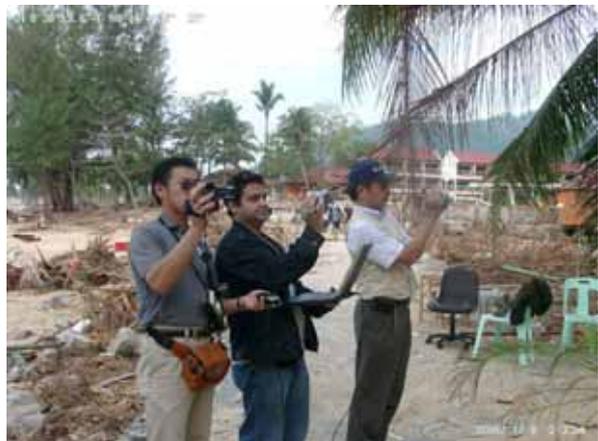
Figure 1(a) shows the members of the international survey team. The team was formed by Chiba University (Japan: F. Yamazaki), EDM (Japan: M. Matsuoka), ImageCat Inc./MCEER (USA: S. Ghosh), Asian Institute of Technology (Thailand: P. Warnitchai), GISTDA (Thailand: S. Polngam and S. Lawawirojwong), and Japan International Cooperation Agency (Japan: M. Honzawa). The primary objective of our survey is to gather geo-referenced tsunami inundation and damage information, and hence we brought several digital video cameras and digital still cameras. Figure 1 (b) shows a scene of geo-referenced video shooting using three video cameras.

(a) (b)
Figure 1: (a) Members of the international survey team and (b) video shooting with three videos synchronized with GPS

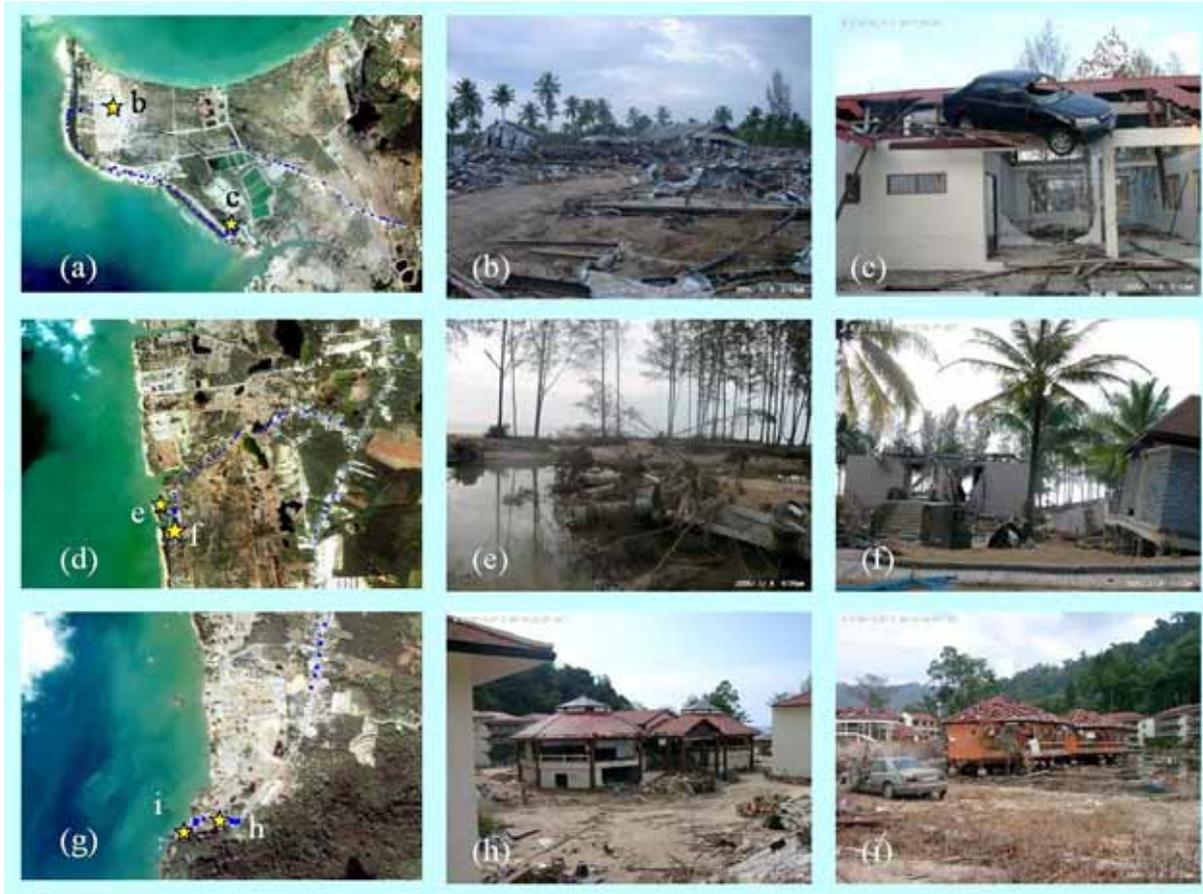
Figure 4 shows the post-tsunami IKONOS image of Khao Lak and photos taken during the field survey. Blue dots in IKONOS images are the location of geo-referenced photo shooting. Figure 4(a) is IKONOS image of Phakarang cape area with 1m resolution, (b) is the photo of devastated Bamboo Orchid Resort on the Phakarang cape, (c) shows a car thrown on the roof by tsunami. If we enlarge the IKONOS image, several black pixels corresponding to this car can be identified. Figure 4(d) is

Figure 4: Post-tsunami IKONOS image of Khao Lak and photos taken during the field survey. Blue dots show the location of geo-reference photo shooting. (a) Phakarang cape area, (b) devastated Bamboo Orchid Resort on the Phakarang cape, (c) a car on the roof, (d) mid Khao Lak area near Weather Station, (e) a collapsed bridge by tsunami, (f) destroyed cottages in a resort, (g) Nang Thong Beach area in lower Khao Lak, (h) & (i) Similana Resort devastated by tsunami

IKONOS image of mid Khao Lak area near a weather station, (e) is a collapsed bridge by tsunami near the weather station, and (f) shows destroyed cottages in a resort. Figure 4(g) shows Nang Thong Beach area in lower Khao Lak, and Figures 4(h) and (i) are photos taken at Similana Resort, which was devastated by tsunami of about 5m high.

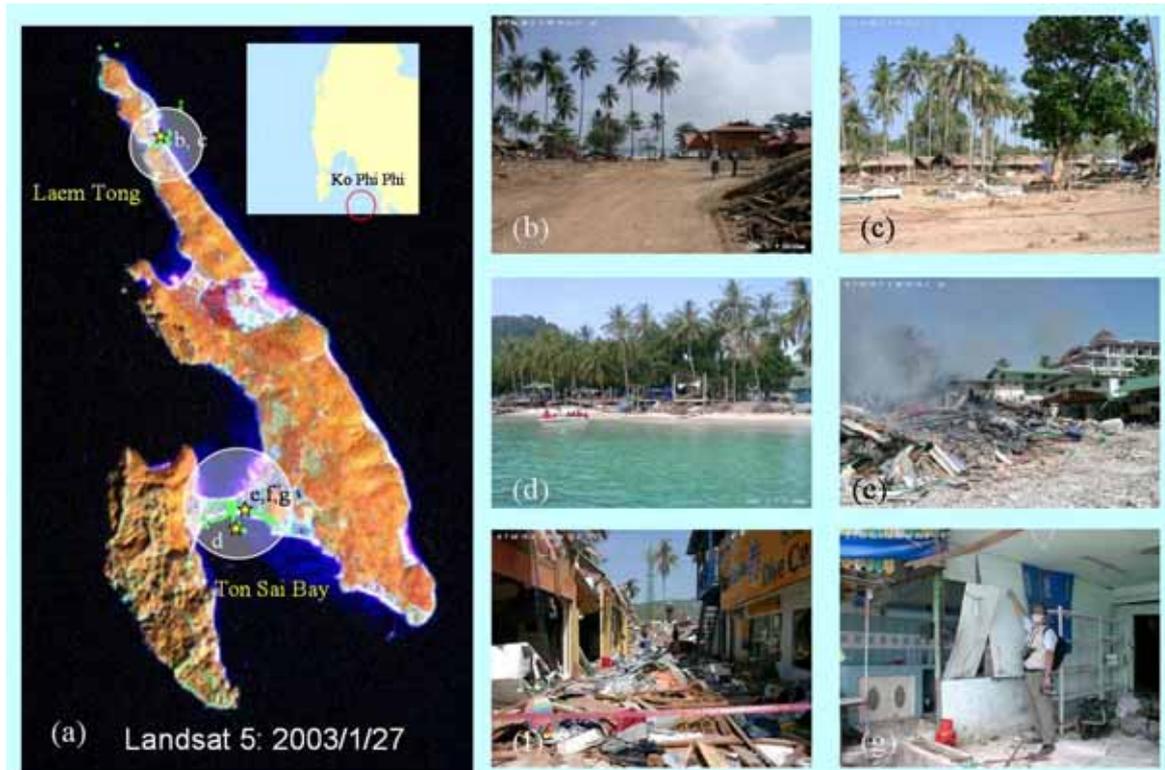
Figure 6: Landsat image of Phi Phi Island and photos taken during the field survey. (a) Ko Phi Phi Don and survey points (green dots), (b) & (c) Laem Tong area and destroyed cottages, (d) Ton Sai Bay from the south, (e) burning of debris, (f) main shopping street filled with debris, (g) water mark remaining inside a completely destroyed shop.

Figure 6 shows Landsat image of Phi Phi Don Island and photos taken during the field survey. As seen in Landsat image (a) on 2003/1/27, Ton Sai area, the center of the island, has been developed on a thin sand belt between two mountainous islands. The elevation of Ton Sai area is only 2-3 m from the sea level. From the topographic condition, there is no place to evacuate in the area, other than higher stories of several reinforced concrete hotel buildings. Tsunami first came from the north bay, and then the higher tsunami attacked the area from the south bay. The scene of tsunami attack was recorded by a foreign tourist from the third story of Phi Phi Cabana Hotel. It is seen that the tsunami came up to the roof of the first story of the hotel.

Photos (b) and (c) show Laem Tong area in the north of the island with several destroyed resort cottages. Although the area was also hit by tsunami, the height and resultant damages were smaller than those in Ton Sai area. Photo (d) is Ton Sai seen from the south bay, photo (e) burning of debris, and photo (f) the main shopping street of Ton Sai filled with debris. The buildings in this area were mostly wood-frame of one or two-storied, and thus the most buildings were collapsed or partly collapsed. Photo (g) shows a water mark remaining inside a completely destroyed shop, showing that the inundated water was sustained at this level.
