# Relationship between Seismic Intensity and Expressway Damages in the 2004 Mid-Niigata Earthquake

Yoshihisa Maruyama  
(Chiba University)

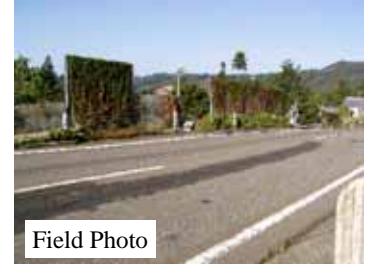
214.9 kp

# Comparison of Damages Detected from the Aerial Photograph and Field Photographs

Aerial Photo

It takes time to conduct visual damage inspection for the entire area<sub>5</sub> where is subjected to severe ground motion.

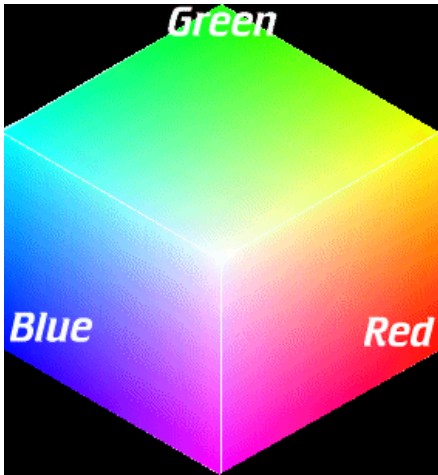
## RGB space

Red  
Green  
Blue

Digital color image is drawn in RGB.

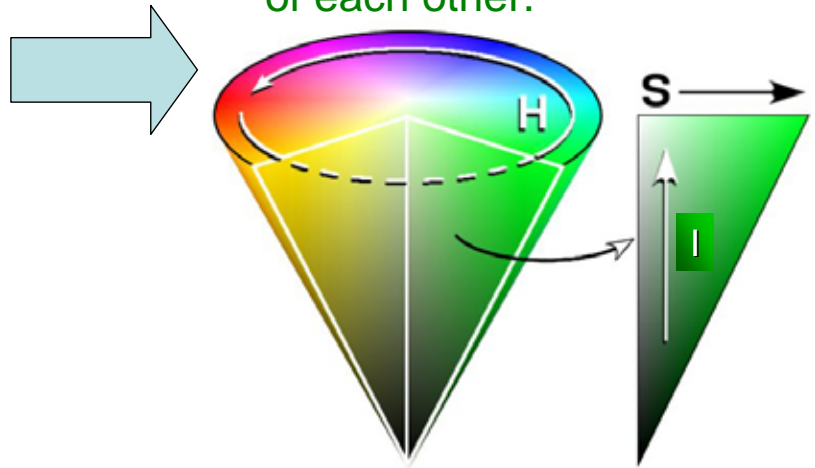
## HIS space

Hue  
Saturation  
Intensity

H, S and I are independent of each other.

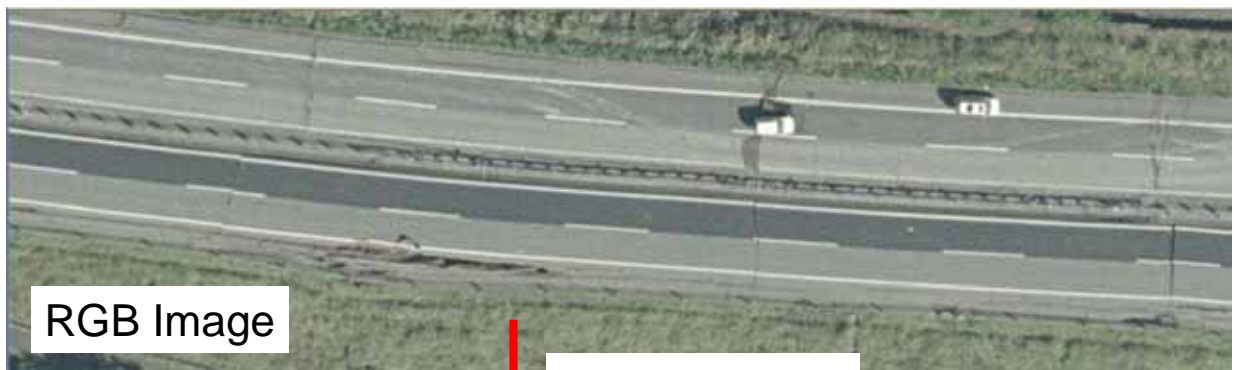
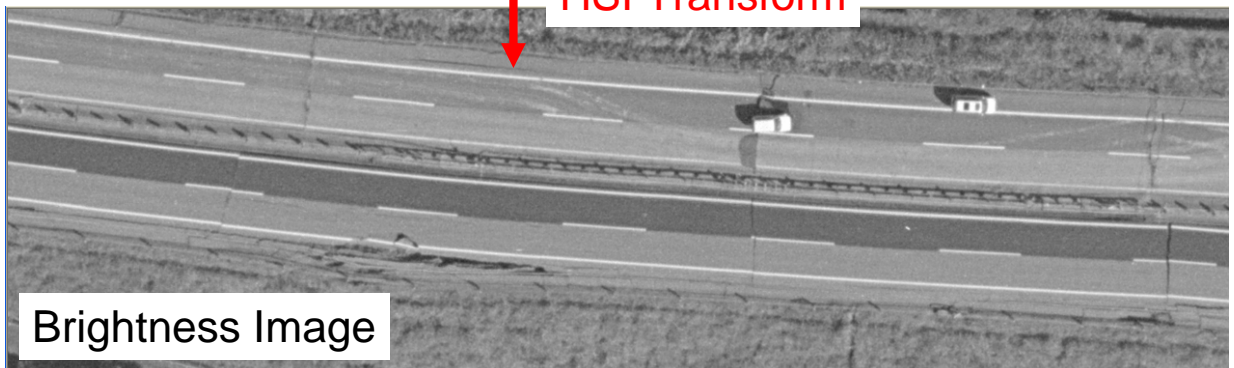
# HIS Transformation

HSI Transform

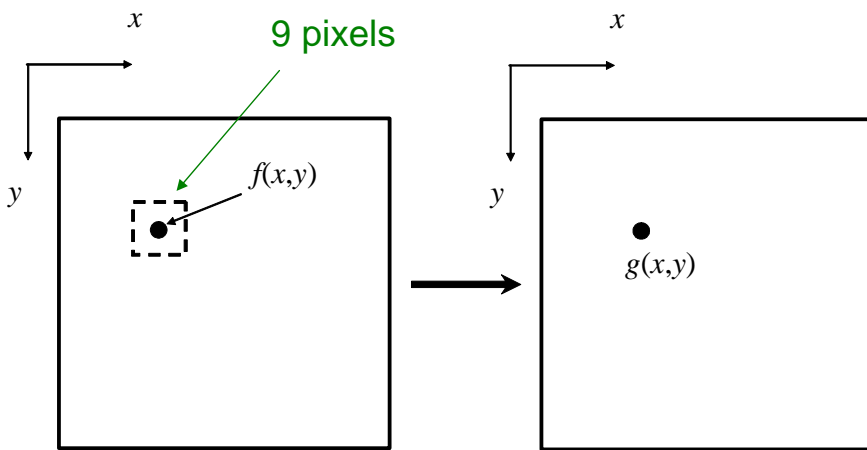
# Differential Operation on Images

$$g(x, y) = K \sum_{i=-1}^1 \sum_{j=-1}^1 C_{ij} f(x+i, y+j)$$

$f(x,y)$ : Brightness of the pixel (0 ~ 255)  
 $g(x,y)$ : Differential value of the pixel

**Sobel Filter**

Horizontal Direction

-1	0	1
-2	0	2
-1	0	1

Vertical Direction

-1	-2	-1
0	0	0
1	2	1

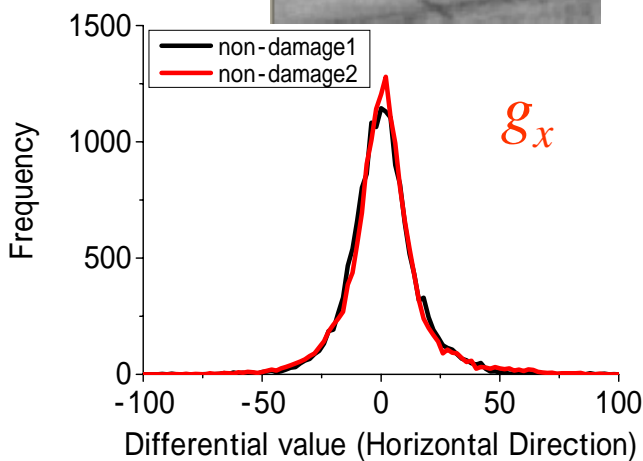
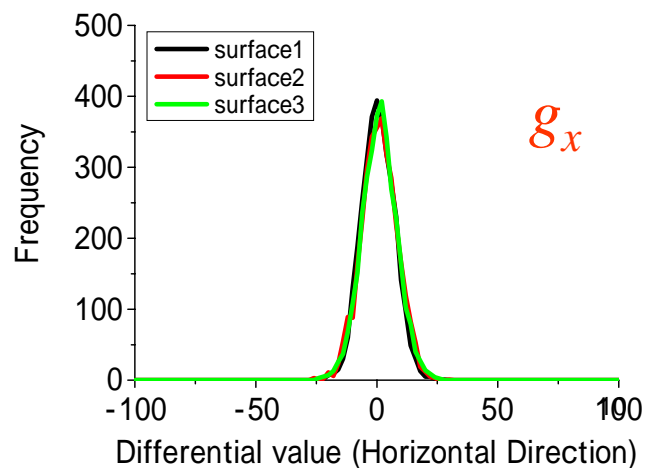
# Differential Operation on Images

## Histogram of differential value

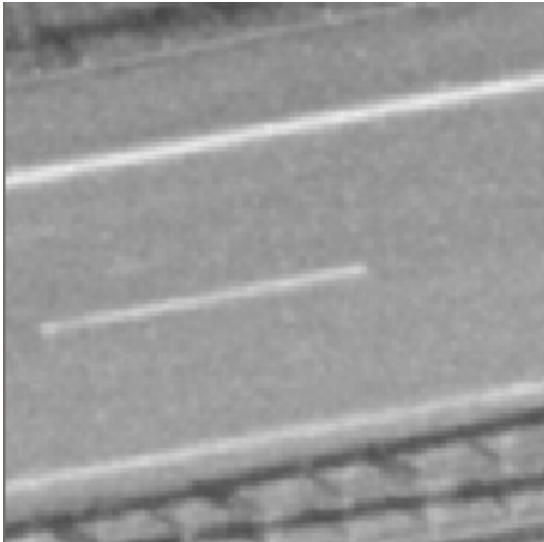
# Removal of road surface from the image

$$(|g_x| < c) \cap (|g_y| < c)$$

$c$ : threshold value to identify the road surface (= 25)

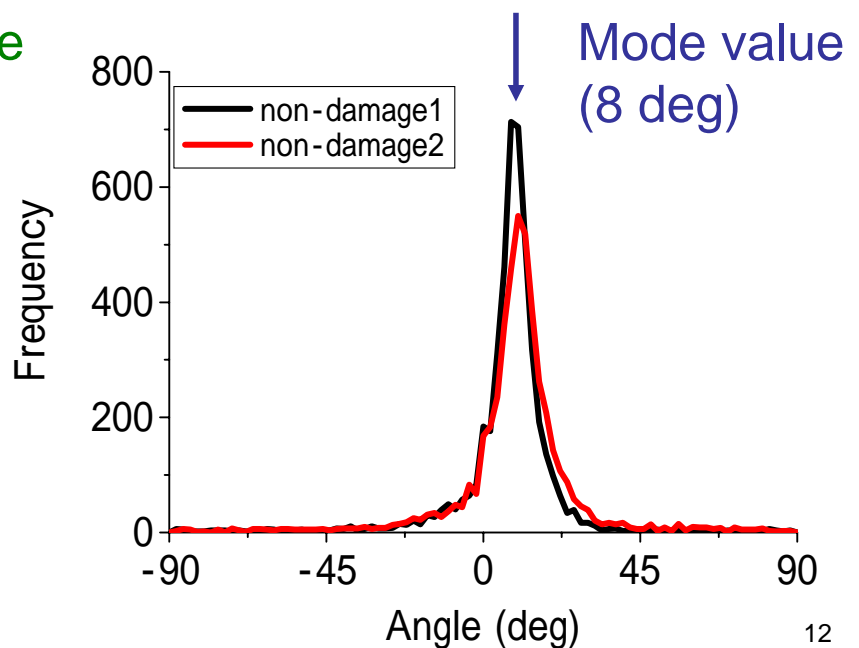
# Estimation of Road Direction through Edge Angle

Edge Angle:  $\theta = \arctan(g_x / g_y)$

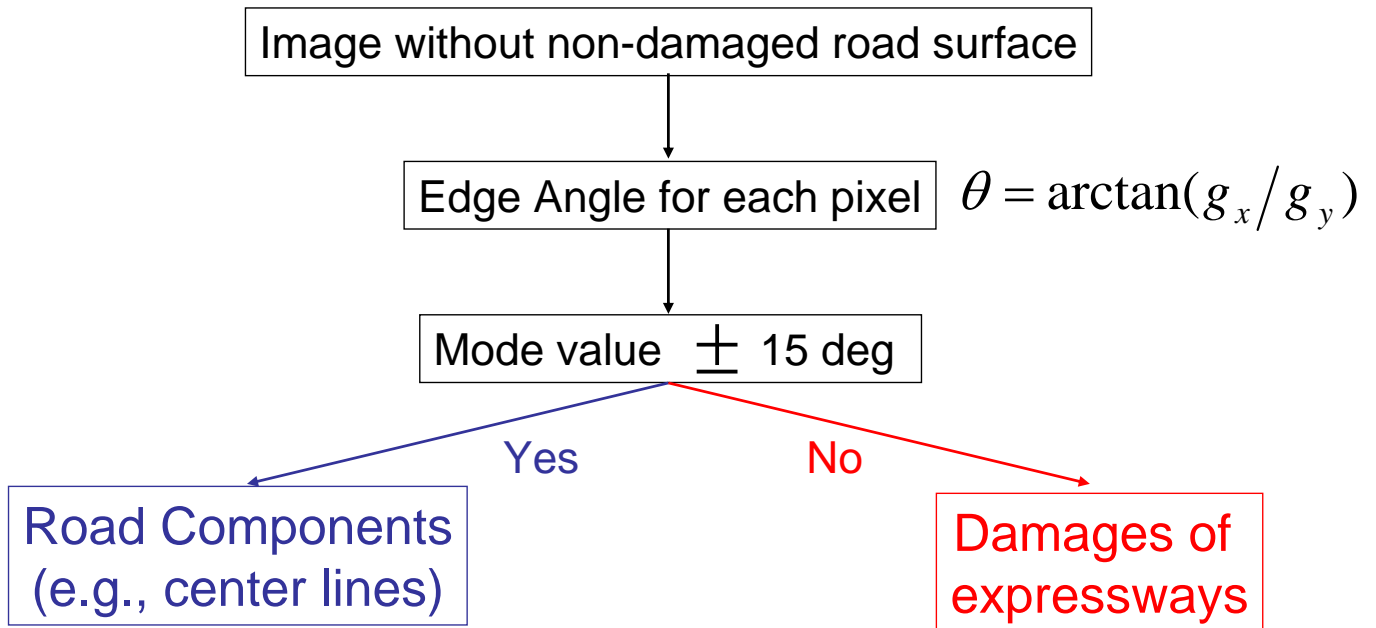
# Distinction between Road Components and Damages

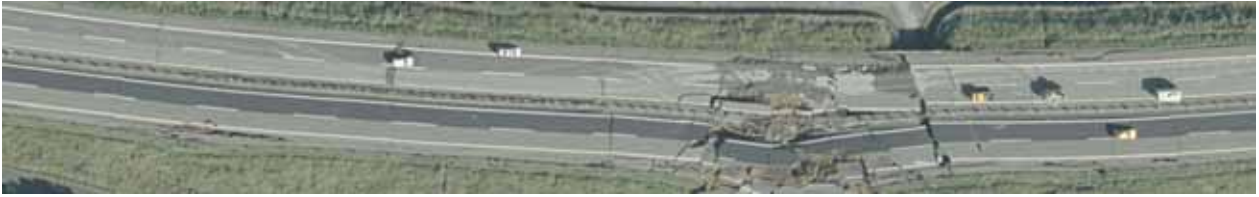
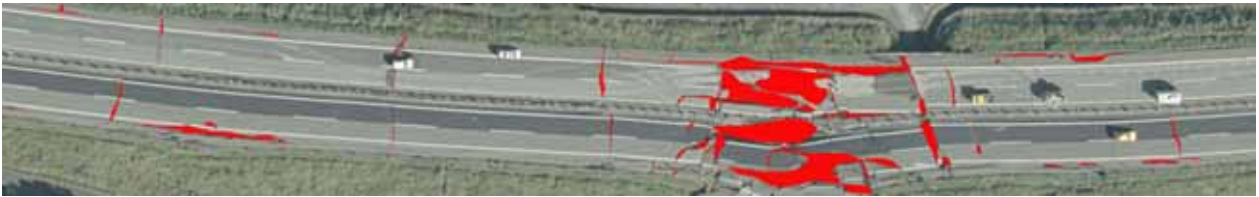
# Comparison between the Result of Image Processing and that of Visual Damage Inspection

Aerial Photo

Visual Inspection

Image Processing

All damaged sections that are recognized visually were classified as damages. However, there remains salt-and-pepper noise in the result of automated damage detection.

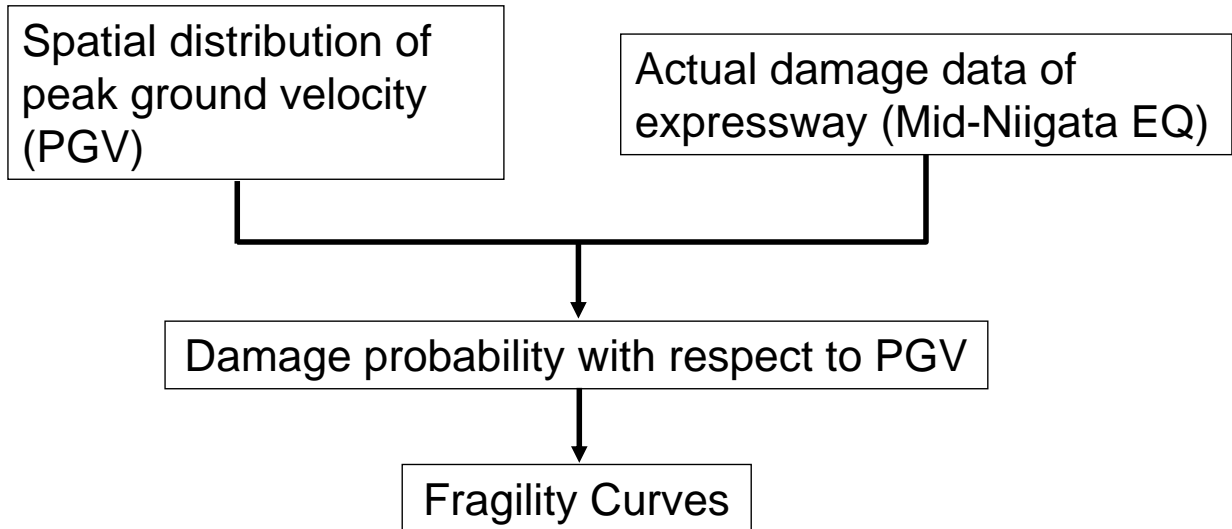
# Analytical flow to construct fragility curve of expressway embankment

In order to predict damage probability of expressway embankment just after the earthquake, fragility curves are constructed by statistical analysis.

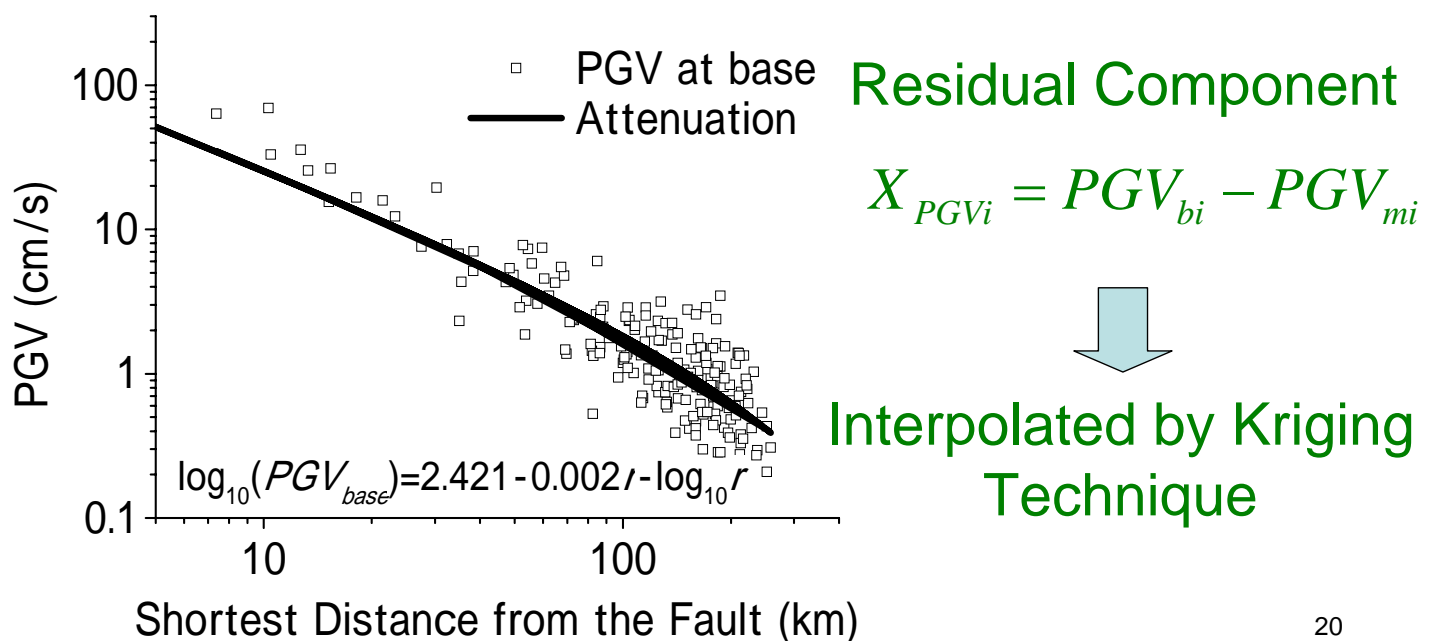
# Estimation of Spatial Distribution of PGV based on Kriging Technique

Kriging interpolation at base rock

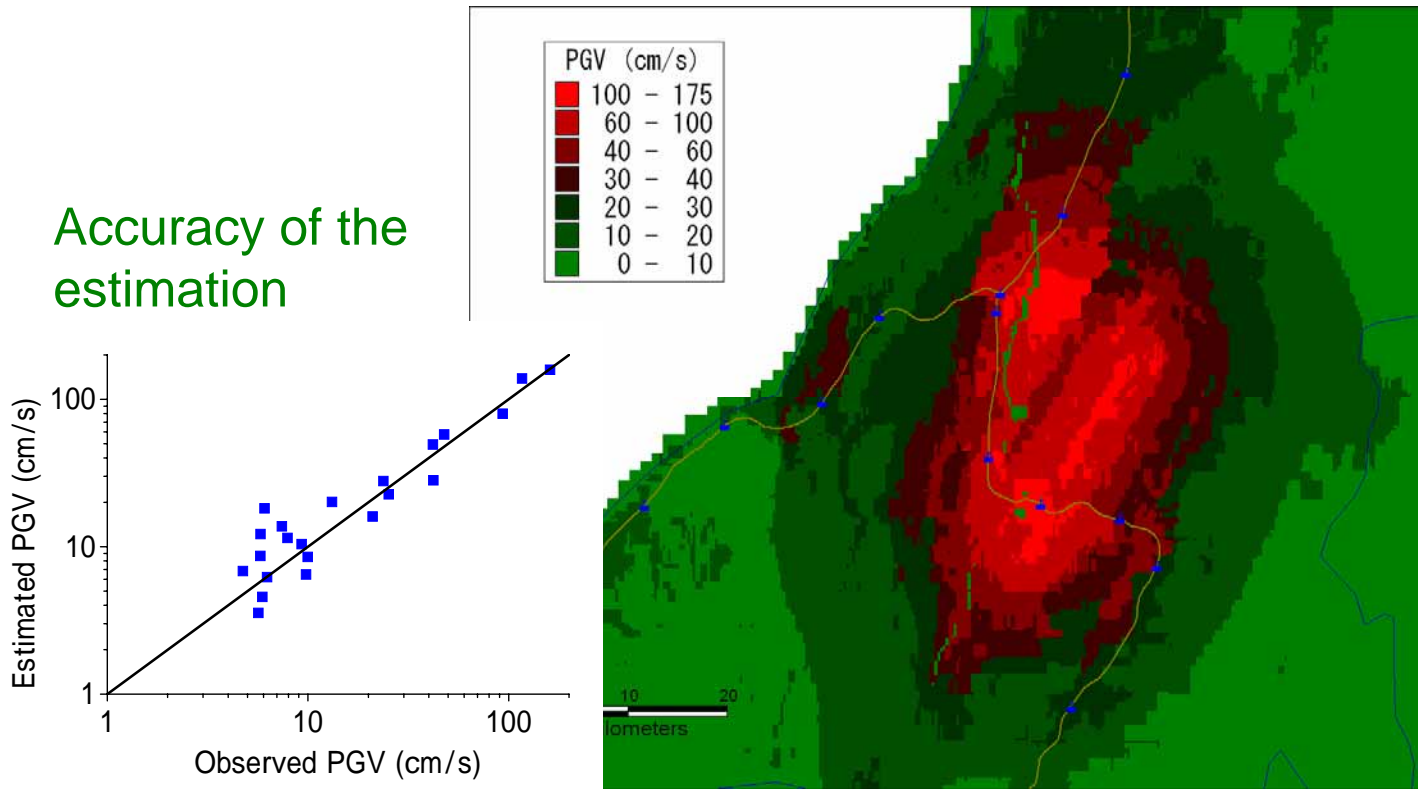
# Estimated Distribution of PGV

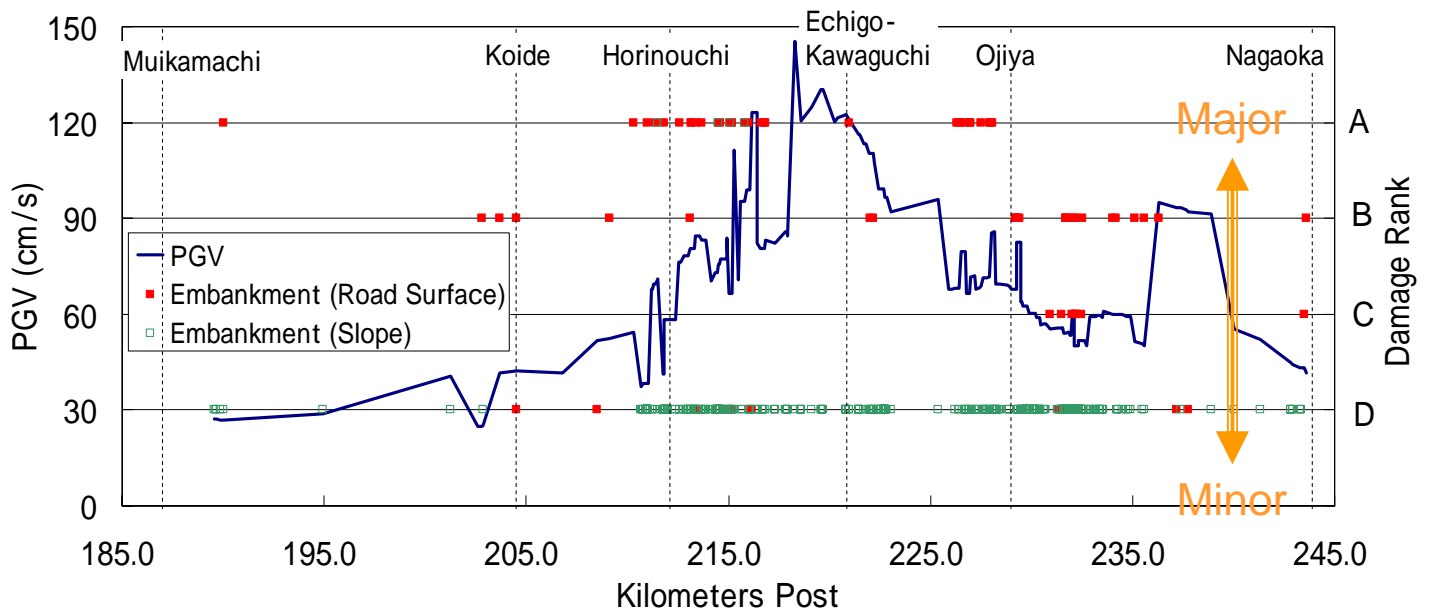
## Relationship between Damage Rank and PGV (Kan'etsu Expressway)

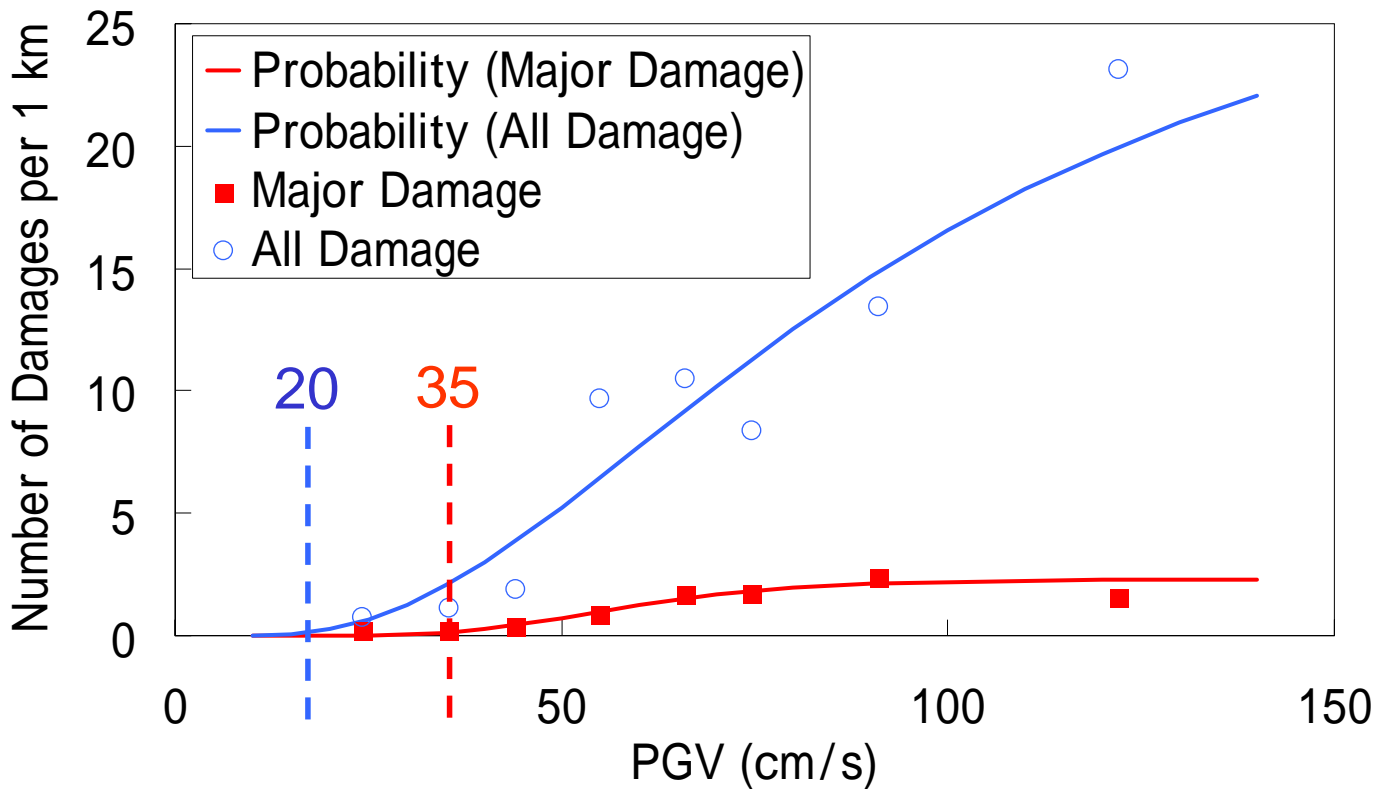
$$P = C \Phi\left(\frac{\ln PGV - \lambda}{\zeta}\right)$$

Damage Rank	C	$\lambda$	$\zeta$
≥B (Major Damage)	2.29	4.06	0.31
≥D (All Damage)	28.99	4.49	0.64

# Fragility Curve of Expressway Embankment

Fragility curves were constructed based on statistical analysis. Major damages that affect the serviceability for traffic are found in the area where the peak ground velocity (PGV) is larger than about 35.0 cm/s.
