Developing Tsunami fragility curves using remote sensing and survey data of the 2010 Chilean Tsunami in Dichato

Abstract. On 27 February 2010, a megathrust earthquake of $M = 8.8$ generated a destructive tsunami in Chile. It struck not only Chilean coast but propagated all the way to Japan. After the event occurred, the post-tsunami survey team was assembled, funded by the Japan Science and Technology Agency (JST), to survey the area severely affected by the tsunami. The tsunami damaged and destroyed numerous houses, especially in the town of Dichato. In order to estimate the structural fragility against tsunami hazard in this area, tsunami fragility curves were developed. Surveyed data of inundation depth and visual inspection of satellite images of Dichato were used to classify the damage to housing. A practical method suitable when there are limitations on available data for numerical simulation or damage evaluation from surveys is presented here. This study is the first application of tsunami fragility curves on the South American Pacific coast and it might be of practical use for communities with similar characteristics along the west Pacific coast. The proposed curve suggest

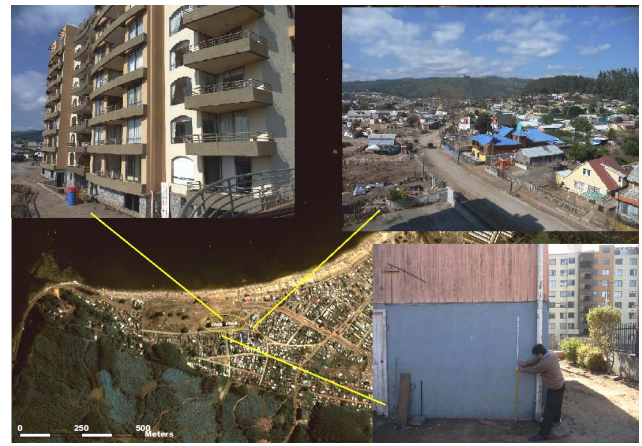
Fig. 2. Location of the ten-story apartment buildings and surrounding houses.

The numbers of fatalities and missing persons were reported as 66 persons. According to the Dichato-Tomé emergency office, 405 families were living in camps still after one month from the earthquake. A total of 1223 families were affected on their properties (Koshimura et al., 2011). The tsunami penetrated as far as 800 m, and in some areas of Coliumo Bay, measures were of approximately 2.2 km inundation and an estimated maximum water depth of 6 m in the town (Bray and Frost, 2010). According to witnesses, the first wave arrived within an hour after the earthquake, followed by a second and third set of waves in the next five hours. The most destructive wave was the second or third wave, depending on the location in the bay. The characteristics of houses in Dichato were mixed, some made of masonry in the first floor and wooden in the second floor, others of lightweight material such as wood and corrugated metal. Only two ten-story buildings on the west side of the town and no more than 150 m from the shoreline are reinforced concrete and engineered apartment buildings (see Fig. 2). There were no structural damages despite that the first floor and the basement were inundated and submerged under waves of around 3 m height. Also behind these buildings several houses starting a short slope to the hill were apparently protected from the wave force by these two buildings and the slope.

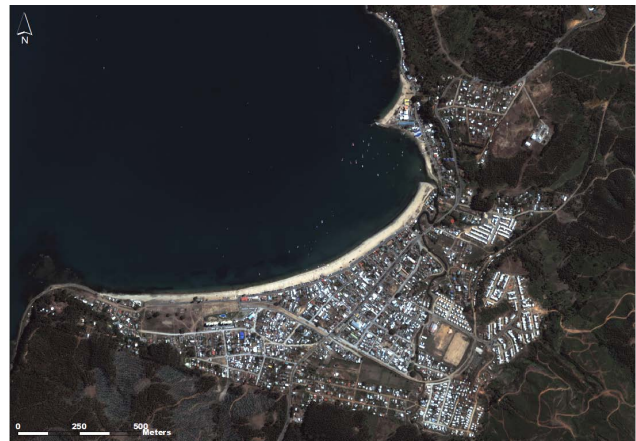
Fig. 3. Satellite image taken before the tsunami event in Dichato (Chile) – 10 February 2010.

is the capability of understanding structural damage visually. Satellite images taken before – QuickBird – and after – WorldView-2 – the tsunami event were used for the visual damage inspection. The pre-event image (see Fig. 3) was acquired on 10 February 2010, while the post-event image (see Fig. 4) corresponds to 10 March 2010. The spatial resolutions of the pre-event image and post-event image are $0.6 \times 0.6 \text{ m}^2$ and $2.0 \times 2.0 \text{ m}^2$, respectively. Higher resolution for a post-event image allows a finer interpretation. For instance, Gokon et al. (2011) used four damage levels, “not collapsed”, “major damage”, “collapsed” and “washed away” and a post-image of $0.6 \times 0.6 \text{ m}^2$ to construct fragility curves. In our case, the resolution of the available image of Dichato is not as fine as the images used by Gokon et al. (2011) in such a visual interpretation. Then we followed the approach taken by Suppasri et al. (2011), who analyzed an IKONOS satellite image of $1.0 \times 1.0 \text{ m}^2$ resolution into two levels of classification. Thus, in this study the damage classification was limited to the structural destruction or failure by the interpretation of roof condition or drifted structures without considering the impact of debris. Classification labels are “washed away” and “survived”. Due to the limitations of the visual inspection from satellite images, some “survived” structures may have some level of damage that was not possible to identify through the remote sensing technique.

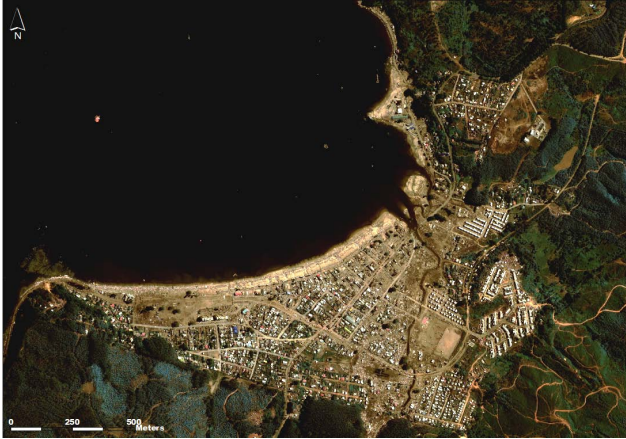
Fig. 4. Satellite image taken after the tsunami event in Dichato (Chile) – 10 March 2010.
