# Estimation of Tsunami-Inundated Areas in Asahi City, Chiba Prefecture, after the 2011 Tohoku-Oki Earthquake

Yoshihisa Maruyama,<sup>a)</sup> M.EERI, Ken Kitamura,<sup>a)</sup> and Fumio Yamazaki<sup>a)</sup> M.EERI

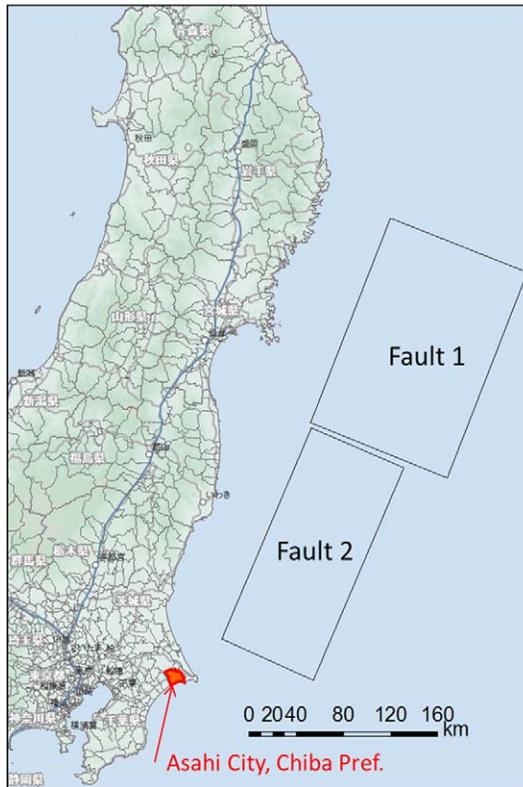
**Figure 1.** Locations of Asahi City, Chiba Prefecture, and the fault model developed by the Geospatial Information Authority of Japan (GSI).

Numerical simulation of tsunami propagation was performed to estimate the tsunami-inundated areas in Asahi City. The seismic fault model developed by the GSI (2011b) was employed to estimate the vertical displacement of the seabed (see Figure 1). The specifications of this fault model are listed in Table 1. Figure 11 shows the vertical displacement estimated by Okada's method (Okada 1985). Assuming the water layer to be incompressible, the estimated vertical displacement of the seabed was regarded as the initial profile of the tsunami.

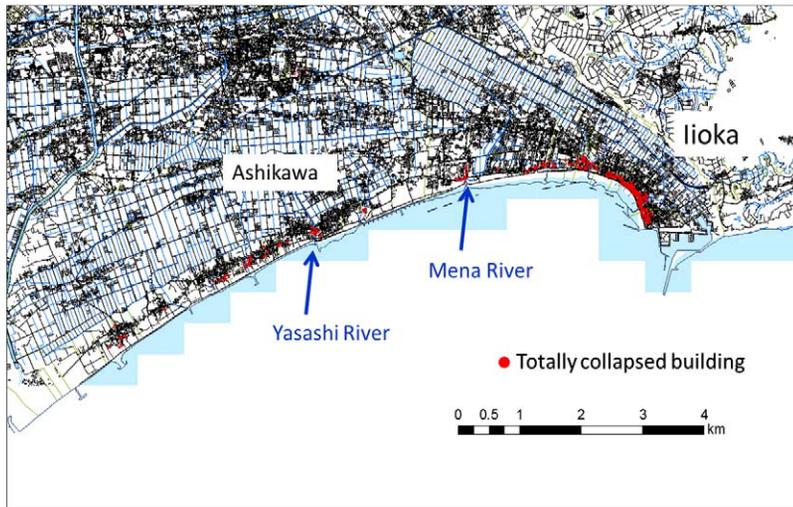
**Figure 2.** Distribution of totally collapsed buildings after the tsunami in Asahi City, Chiba Prefecture.

[Figure 2](#) shows the distribution of totally collapsed buildings by the tsunami in Asahi City. The dataset was compiled by the city and the number of totally collapsed buildings was

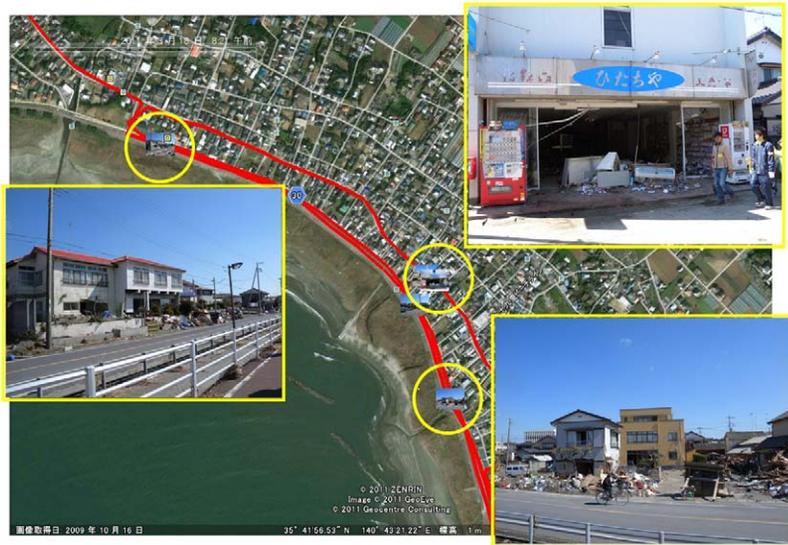
**Figure 3.** Survey route and examples of damaged buildings in Asahi City, Chiba Prefecture.

reported as 229. The damage to buildings was concentrated in the Iioka district in the eastern part of the city. The authors surveyed Asahi City for the first time on March 18, a week following the earthquake. Figure 3 shows the survey route and photographs of damaged buildings. Many damaged buildings were observed along not only the coastline but also a road on the survey route, further away from the coastline.

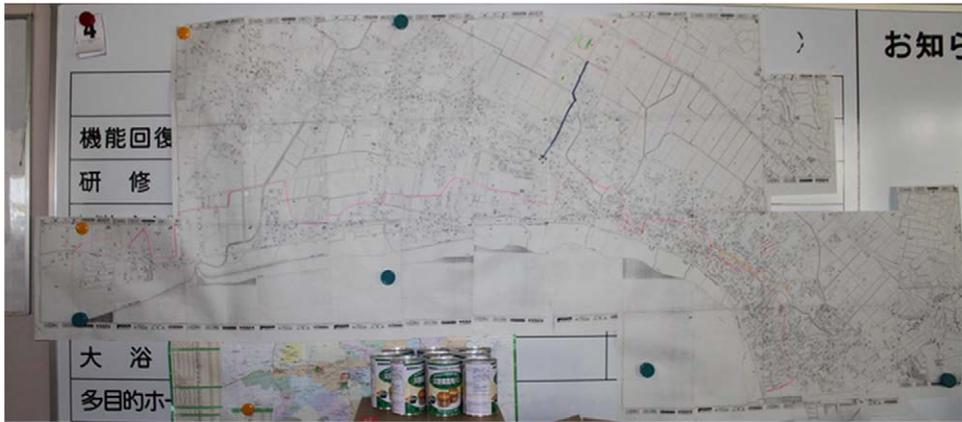
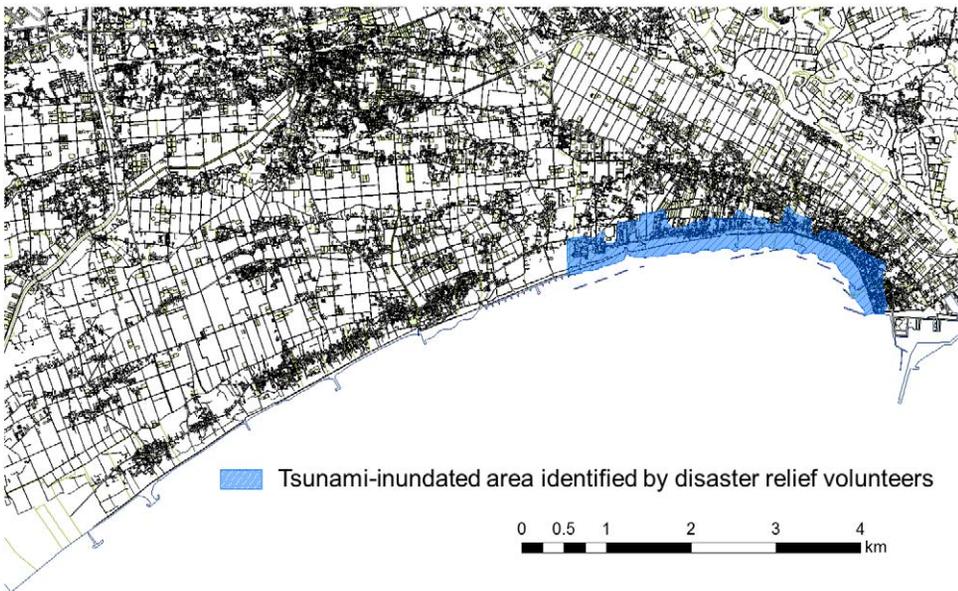
**Figure 4.** (a) Tsunami-inundated areas identified by disaster relief volunteers in Asahi City and (b) the identified areas projected onto a GIS system.

during the second field survey conducted on 12 April 2011. The tsunami-inundated areas identified by the volunteers were highlighted on regional maps for the city area (Figure 4a). The authors obtained photographs of these maps and constructed polygons showing the tsunami-inundated areas. These were then projected onto a geographic information system

(GIS) as shown in Figure 4b. The map of this study covers mainly the Iioka district in the eastern part of Asahi City.

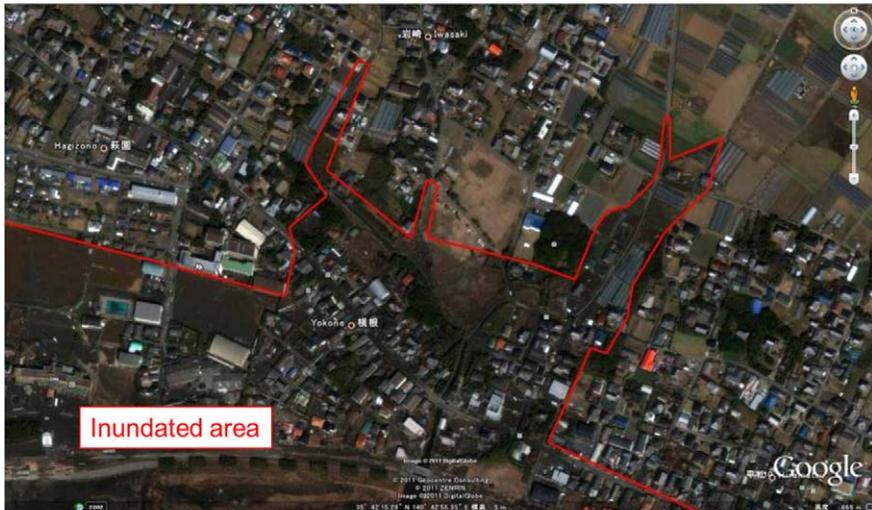
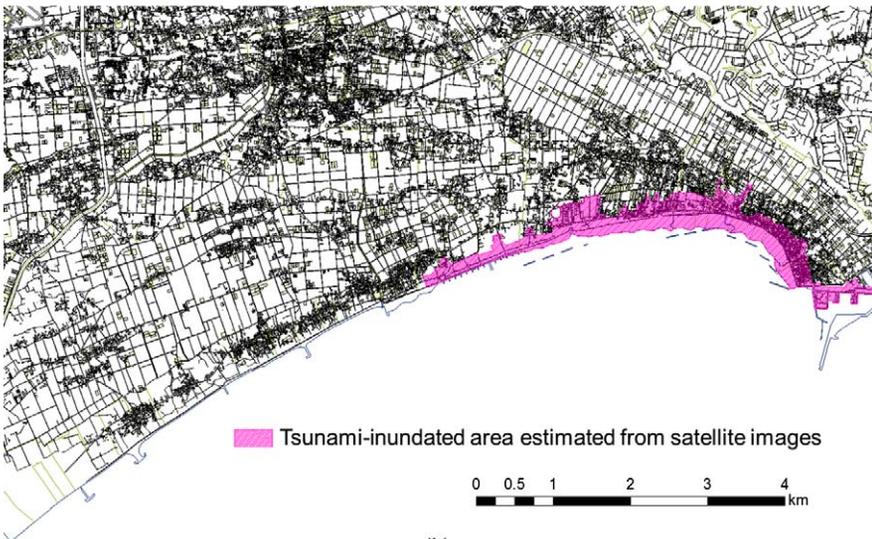
**Figure 5.** (a) Example of visual inspection of satellite images to identify tsunami-inundated areas and (b) results of the visual analysis in GIS system.

identification of the tsunami-inundated areas by visual inspection (Figure 5a). The change in color on the ground was mainly used to identify the tsunami-inundated areas. Figure 5b shows the tsunami-inundated areas identified by visual inspection of the satellite images.

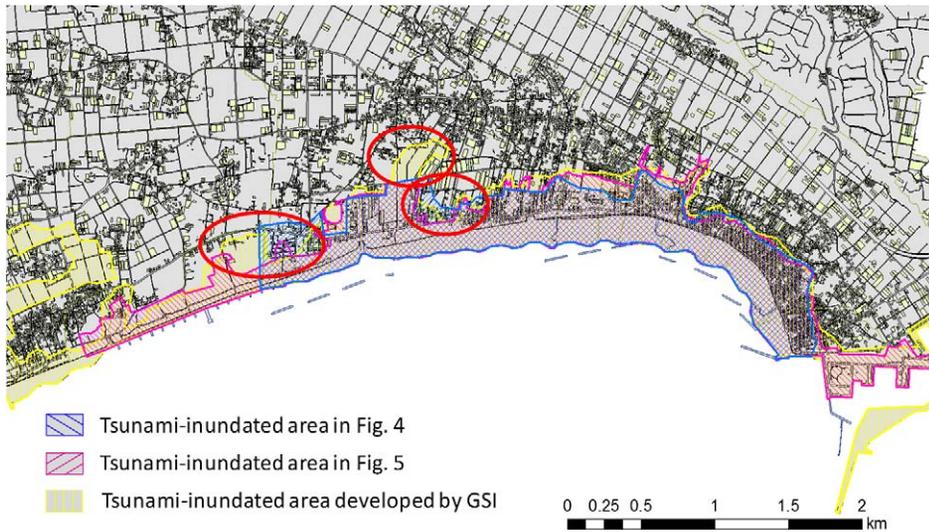
**Figure 6.** Comparison among the tsunami-inundated areas shown in Figures 4 and 5 and those developed by GSI.

The Geospatial Information Authority of Japan (GSI) developed tsunami inundation maps by interpreting satellite and aerial images taken after the earthquake (GSI 2011a). Figure 6 presents a comparison of the tsunami-inundated areas shown in Figures 4 and 5

and the results produced by GSI. Overall, the areas of tsunami inundation on the three maps overlapped with one another in the eastern part of Asahi City. The three areas marked with circles indicate sites where the estimates did not coincide. Hence, the authors revisited these sites on 28 June 2011, and interviewed inhabitants to reassess the tsunami-inundated areas. The final estimates of the tsunami-inundated areas are shown in Figure 7. It should be noted that for the western part of Asahi City, only the map developed by GSI was available. The inundated areas in the eastern part could be validated from three different sources: the map drawn by the volunteers, the result of visual inspection of satellite images, and the tsunami inundation map developed by the GSI.

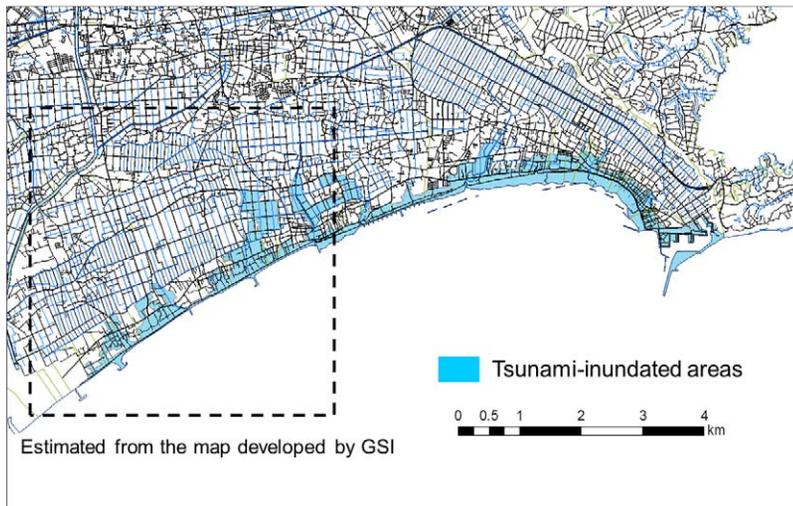
**Figure 7.** Final estimates of tsunami-inundated areas in Asahi City, Chiba Prefecture, after the 2011 Tohoku-oki earthquake.

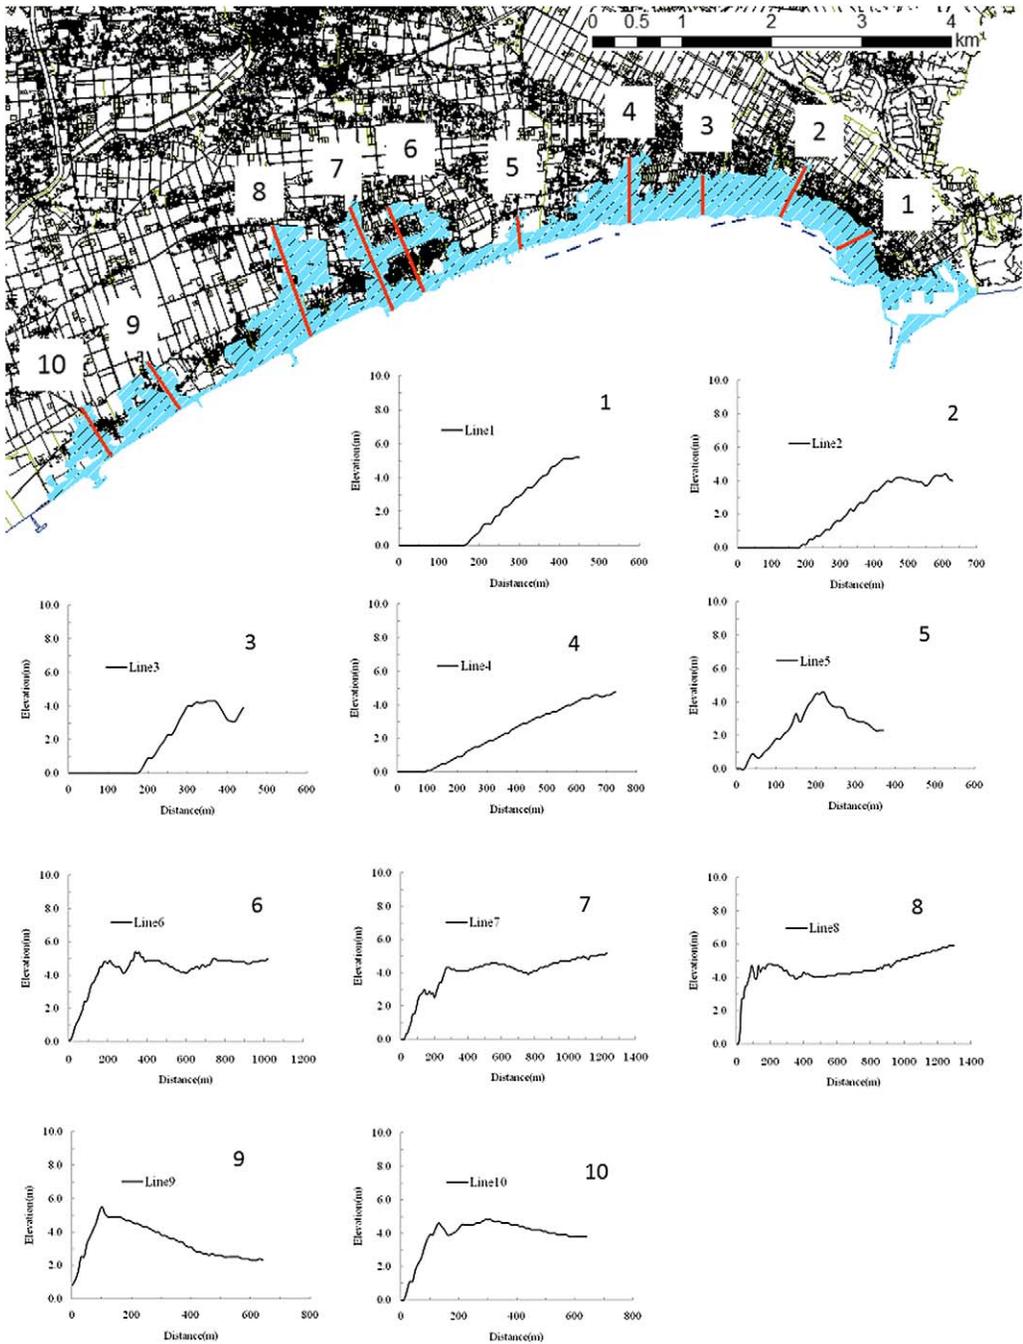
**Figure 8.** Distribution of land elevations along the transverse lines in the identified tsunami-inundates areas in Asahi City.

The authors set ten traverse lines in the inundated area and the land elevations along the lines were determined (Figure 8). The GSI digital elevation model with a grid size of 10 m was employed in this study. The results show that the run-up reached a height of approximately 5 m in Asahi City.

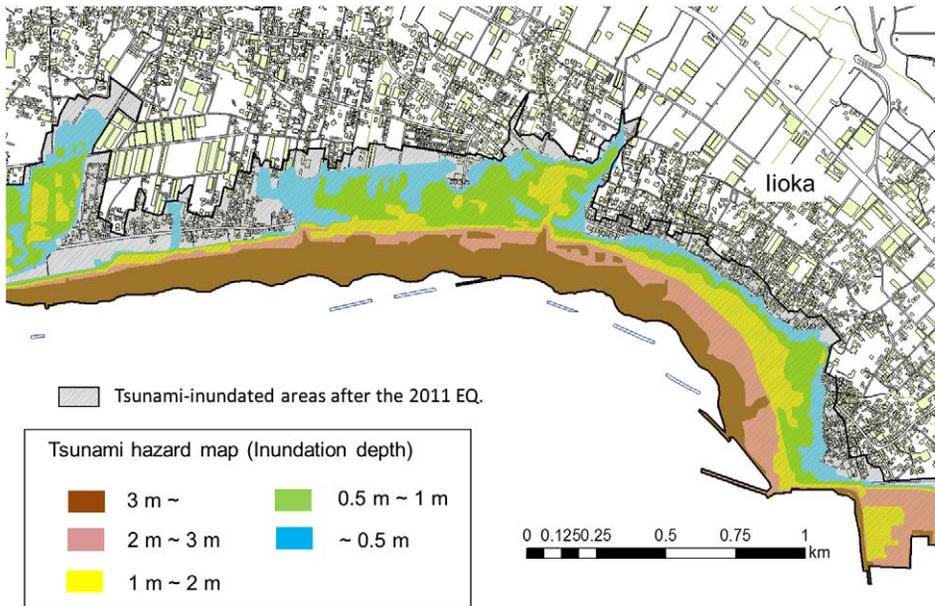
**Figure 9.** Comparison between tsunami hazard map and identified tsunami-inundated areas in Asahi City, Chiba Prefecture, after the 2011 Tohoku-oki earthquake.

Tsunami hazard maps have already been developed for Asahi City (Asahi City 2008) previous to the earthquake. In these maps, the areas of tsunami inundation were estimated on the basis of the past 1677 Empo Boso-oki and the 1703 Genroku Kanto earthquakes (Iwabuchi et al. 2008). Figure 9 shows a comparison of a tsunami hazard map with the identified tsunami-inundated areas of the city after the 2011 Tohoku Earthquake. It can be observed that the eastern parts of the city, such as Iioka, were affected more severely than expected. Seawalls approximately 4 m in height were constructed in Iioka; however, the tsunami waves over topped the walls and flowed into the residential areas.

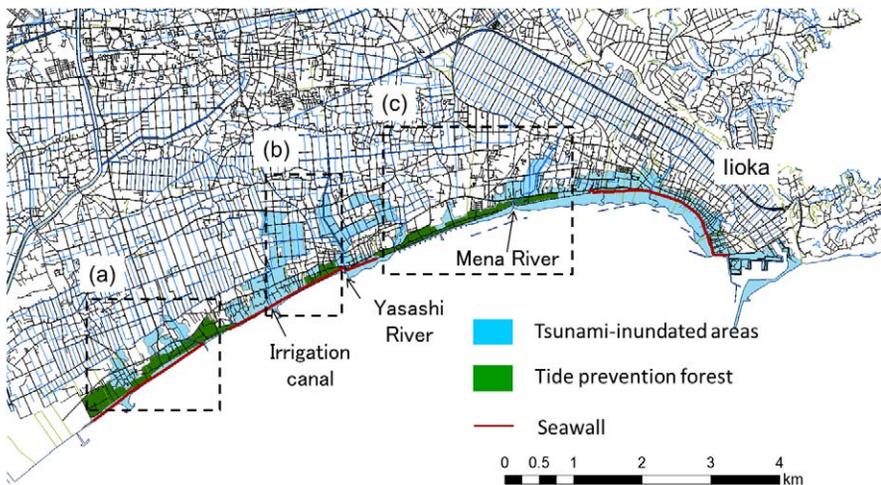
**Figure 10.** Land use classification along the coastal line and the tsunami-inundated areas in Asahi City.

Land use and protection structures along the coast were interpreted from satellite images of Google Earth before the tsunami. The images were projected onto the map coordinate system, and the locations of tide-prevention forests and the seawalls were visually identified (Figure 10). It was observed that the tsunami-inundated areas spread mostly along the rivers. In general, the height of tsunami waves exceeded that of the built seawalls. In the areas labeled (b) and (c), there was comparatively less inundation behind the tide-prevention forests, except for the areas along the rivers. There are both seawalls and tide-prevention forests in the area identified as (a), but this region experienced tsunami inundation. The evaluation of the tsunami mitigation strategies that use both natural and artificial approaches has mixed results. As a whole, the integrity of the trees was able to withstand the forces of the tsunami inundation, and there was a density of trees, so that the effects of the tsunami were significantly reduced in several areas. Overall, the ability of tide-prevention forests to reduce tsunami inundation remains somewhat controversial because in the Tohoku district, large areas of coastal forest failed to provide protection (EERI 2011a). In most cases, this was simply because the tsunami force was too large and the trees were destroyed. For Asahi City, Chiba Prefecture studied in this paper, the tsunami forces might be smaller and the trees survived, providing some measure of protection.

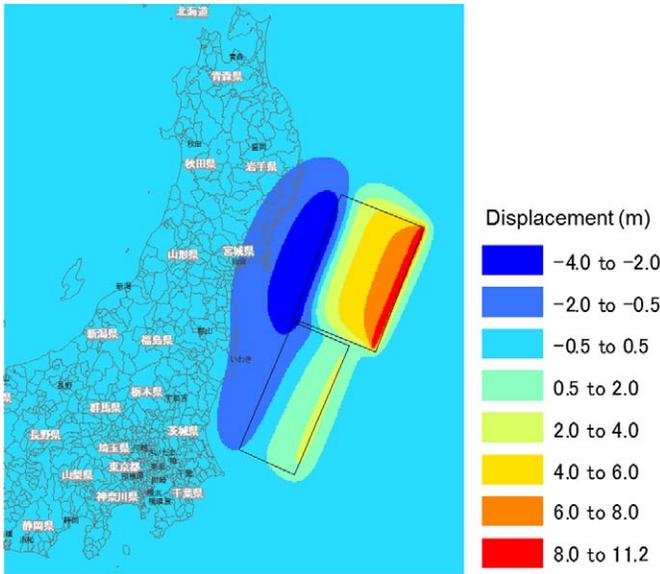
**Figure 11.** Vertical displacement of seabed as estimated by Okada's method (1985).

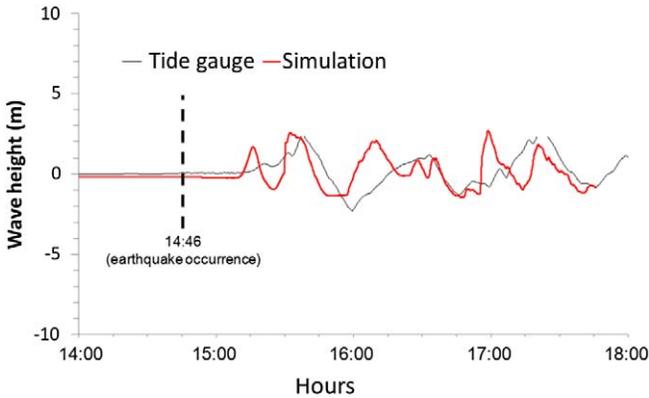
**Figure 12.** Comparison between the heights of tsunami waves estimated by a numerical simulation and those recorded at Choshi fishery port, Chiba Prefecture.

The simulation result was compared with the tidal gauge records. In Chiba Prefecture, a tide station is operated at Choshi fishery port by the Japan Meteorological Agency (JMA). The tide station is located at approximately 13 km east of Iioka port. Figure 12 shows a comparison of the heights of tsunami waves estimated by the numerical simulation with those recorded at the tide station. According to the figure, the estimated maximum height of waves from the model shows good agreement with the recorded data. Moreover, the arrival time of the first tsunami wave calculated in the simulation almost coincides with that observed in the tidal record. However, the total calculated time series does not seem to match the data very accurately. To improve the accuracy, the distribution of vertical displacements of the seabed needs to be obtained for a more detailed fault model, such as determined by the inversion of tsunami wave form (Fujii and Satake 2012).

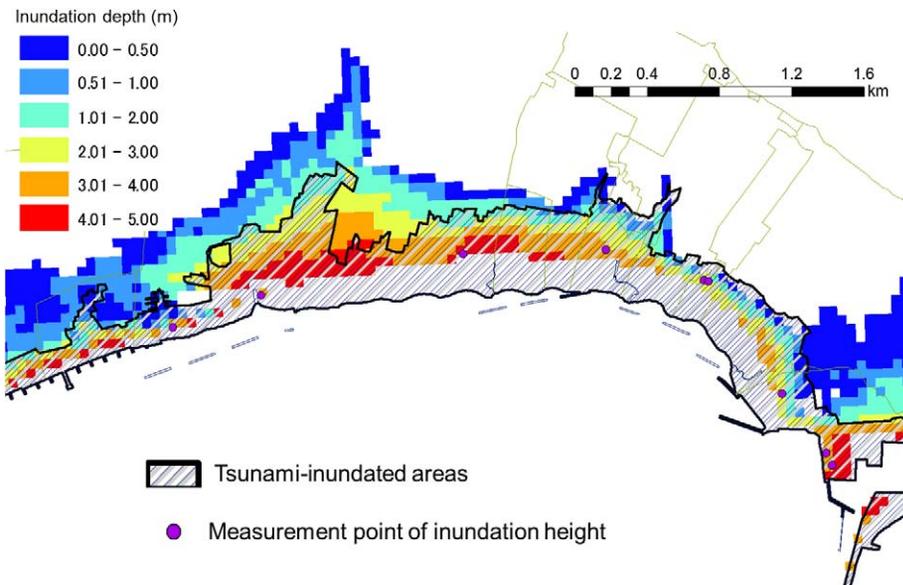
**Figure 13.** Comparison between inundation depths estimated by a numerical simulation and the actual tsunami-inundated areas identified in this study.

Figure 13 shows a comparison of the tsunami-inundation depths obtained by the numerical simulation with the tsunami-inundated areas identified in this study. We focus on the eastern part of Asahi City, where the inundated areas were verified through different sources. The simulated distribution of the tsunami-inundated areas and the distribution identified through the surveys show similar trends. The observed tsunami-inundated areas include almost all the surveyed areas with a simulated inundation depth greater than 1 m, but not some of the areas of shallower depth. The observed tsunami-inundated areas were

identified primarily through the satellite and aerial images captured a few days after the earthquake. Hence, the areas inundated by shallow waters might have been identified with limited accuracy. This may explain the difference between the inundated areas determined by the simulation and those identified in this study.

illustrated in Figure 13. The inundation height collected by the survey group is defined as the elevation of water level with reference to the sea level (Tokyo Peil: T.P.) while the tsunami inundation depth shown in Figure 13 is the elevation of water level with respect to the ground level. Figure 14 compares the measured tsunami inundation heights (from the sea level) and those estimated by the numerical simulation. Although the results of the numerical simulation show a reasonable level of agreement with the observations, the estimations of inundation heights tend to be smaller than measured heights at several points. A finer elevation model should be considered in the numerical simulation to improve the accuracy.

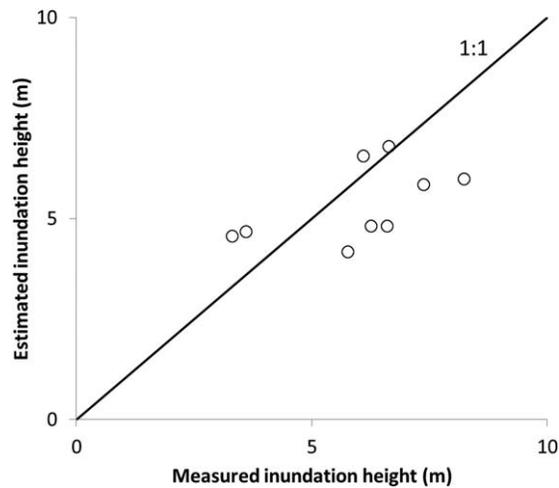
**Figure 14.** Comparison between the measured tsunami inundation heights and those estimated by a numerical simulation in Asahi City, Chiba Prefecture.

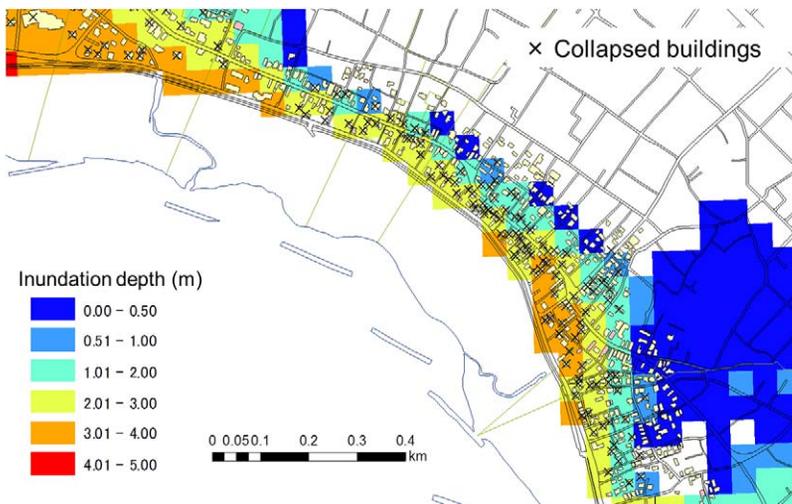
**Figure 15.** Distribution of totally collapsed buildings according to estimated tsunami-inundation depths.

The structural performance due to tsunami loading has been investigated by various research teams (Bertero et al. 1985, Saatcioglu 2006, Ruangrassamee et al. 2006). This study tries to obtain the statistics related to structural damage. Because the exact locations of the totally collapsed buildings were available (see Figure 2), a dataset of the actual damage could be established. Then the damage ratio of the buildings—the ratio of totally collapsed buildings to the total number of buildings—in terms of the inundation depth, was evaluated by combining this dataset with the results of the numerical simulation; the resulting data are listed in Table 3. The total number of buildings listed in this table is for tsunami-inundated areas shown in Figure 9. Figure 15 shows the distribution of totally collapsed buildings in the tsunami affected area according to the estimated inundation depths. Building inventories compiled in 2009 by Zenrin, a Japanese map publisher, were used in this study (Zenrin 2012). In this study, we focus on one- and two-story buildings, which are mainly considered to be wooden houses. Figure 16 shows the relationship between the damage ratio of one- and two-story buildings and the estimated tsunami-inundation depths. The figure also shows a fragility curve constructed after the 2004 Sumatra–Andaman earthquake (Koshimura et al. 2009). In the study, pre- and post-event satellite images were employed to perform visual damage inspection. The buildings were interpreted as “survived” or “destroyed” by detecting

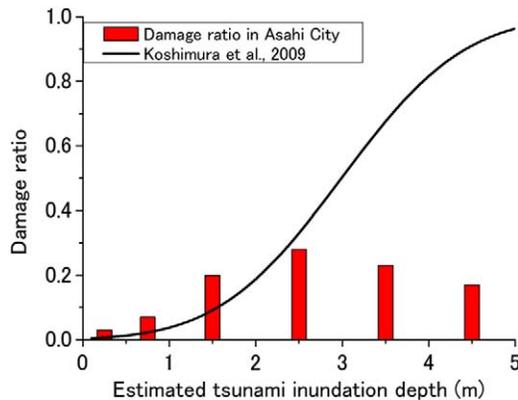
**Figure 16.** Relationship between the damage ratio of one- and two-story buildings and the estimated tsunami-inundation depth.

if the roofs were remained or not, and the fraction of “destroyed” buildings was used as the damage ratio. The damage ratios in Asahi City were similar in level with those in Banda Aceh, Indonesia, for an estimated inundation depth of around 3 m. However, the observed damage ratios in Asahi City associated with the inundation depth of more than 3 m were smaller than the estimations of the fragility function from Indonesia.
