Paper:

Urban Recovery Process in Pisco After the 2007 Peru Earthquake

Keywords: 2007 Peru Earthquake, Pisco, urban recovery process, building examination, satellite image

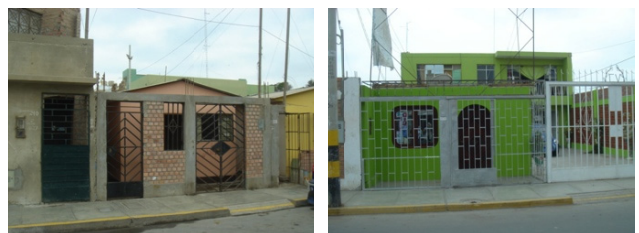
Fig. 5. New front gate instead of solid new house.

some of those receiving subsidies used the money for installing new front gates as symbols of their houses (Fig. 5).

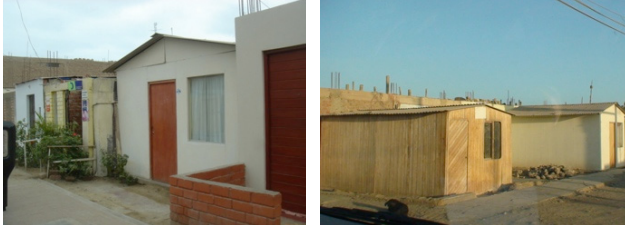
Fig. 7. Remaining temporary housing.

In order to coordinate reconstruction efforts, the Fund for the Reconstruction of the South (FORSUR) was established just after the earthquake. Fig. 6 illustrates the reconstruction stage indicated by FORSUR [5]. Temporary housing were supposed to be in a stage of transition according to FORSUR recovery strategy. There remained many temporary housing around the district, however, when the authors investigated. There were also blocks that were occupied by temporary housing as new settlements into which affected people moved after the event (Fig. 7).

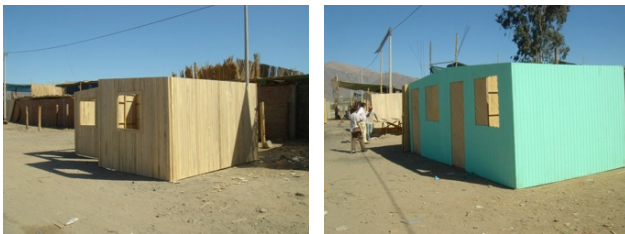
Fig. 8. Temporary house construction.

The authors then visited a few building-materials stores to get some information on temporary housing construction (Fig. 8). Salesclerks gave us information useful for understanding the temporary house construction situation as follows:

- (1) Although house units for sale are not for temporary housing but for huts, affected people often buy them themselves, and they are not provided by the government for temporary use.
- (2) If the user daubs house parts with waterproof paint once a year and changes the roof often, the house can be used for about ten years. It does not last long without maintenance.
- (3) The total price of the material, not including handling, and time necessary for construction is

[3 × 3 m]	S/.1,350 (\$519),	one day
[3 × 4 m]	S/.1,600 (\$615),	two days
[3 × 6 m]	S/.2,400 (\$922),	two days.
