Damage detection in earthquake disasters using high-resolution satellite images

F. Yamazaki & Y. Yano

Keywords: high-resolution satellite, damage detection, earthquake, QuickBird, IKONOS

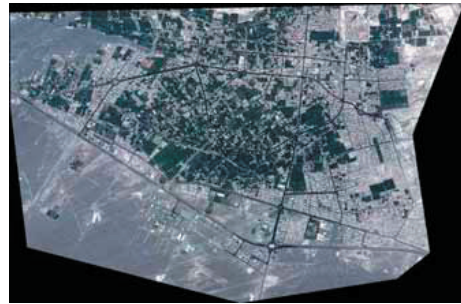
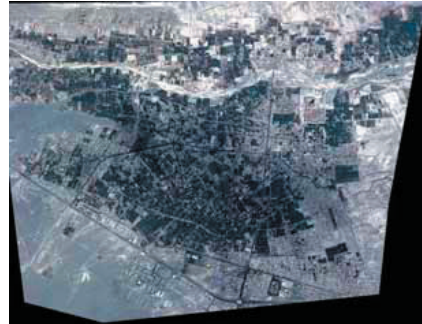
(a) QB on September 30, 2003

(b) QB on January 3, 2004

Figure 2. Pan-sharpened natural color QuickBird images of Bam City.

Pan-sharpened images with 0.6m resolution were produced by combining panchromatic images of 0.6m resolution and multi-spectral images of 2.4m resolution as shown in Figure 2. By this image enhancement, buildings, cars and debris can clearly be seen and the image pair were used in visual inspection of building damage.

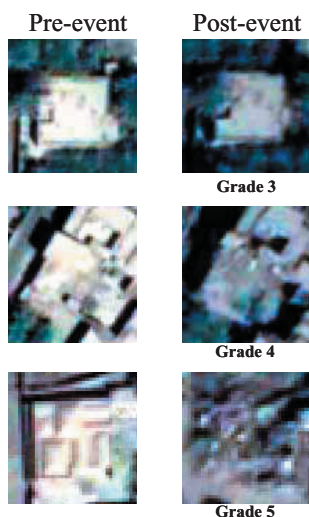
Figure 4. Typical pre- and post-event QuickBird images for Grades 3, 4 and 5 houses.

In Figure 4, typical pre- and post-event QB images for houses classified as Grades 3, 4 and 5 by visual inspection are shown. Because the spatial resolution of the image is around 0.6m, it is almost impossible to detect damage equal to or less than Grade 2. It is rather easy to detect Grade 5 and in our experience, and agreement among different interpreters is good in case of Grade 5 (Yamazaki et al. 2004). The effects of shadow and vegetation in damage classification become more serious for Grade 4

and damage detection becomes more difficult than that for Grade 5. Damage becomes further more difficult to detect for Grade 3, especially from near-vertical images. If some deformation is located on a roof or some debris spreads around a building, Grade 3 damage can still be identified.

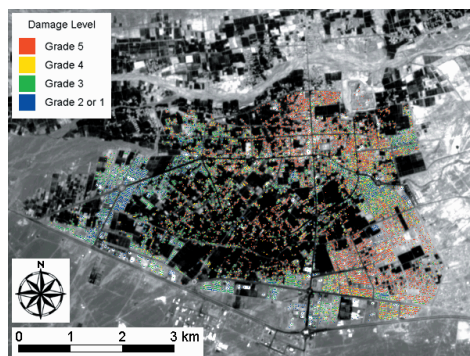
Figure 5. Result of visual damage interpretation using QB images acquired on 30 September, 2003 and 3 January, 2004. Damage levels are based on EMS-98.

By this visual interpretation using the pre- and post-event images, a total 12,063 buildings were classified based on their damage grades as shown in Fig. 5. The numbers of identified damaged buildings are 1,597 (Grades 1 or 2), 3,815 (Grade 3), 1,700 (Grade 4), and 4,951 (Grade 5). In the present case, we did not carry out damage interpretation using only the post-event image because the accuracy of single image interpretation was not so high in our previous experiences for Bourmerdes and Zemmouri in the 2003 Algeria earthquake (Yamazaki et al. 2004). Especially in Bam, houses are generally small and brightness of the two images looks different due to different sunlight condition, thus damage detection was rather difficult even in the case using both the pre- and post-event QB images.

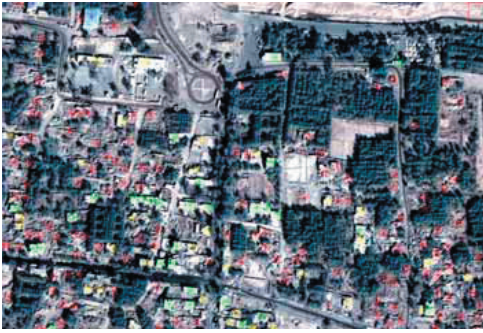
Field survey \ QuickBird	G 1	G 2	G 3	G 4	G 5	sum
G 1 & G 2	0	0	0	0	0	0
G 3	0	2	2	1	4	9
G 4	0	1	2	1	5	9
G 5	0	0	3	2	27	32
sum	0	3	7	4	36	50

Figure 6. Result of visual interpretation compared with field survey data by Hisada et al. (2004) around aftershock recording station No. 1, located in the south of Arg-e-Bam.

To examine the accuracy of our damage detection in Bam, the field survey data by Hisada et al. (2004) was employed. They used the same EMS-98 scale to describe the damage grade of each building near eight aftershock recording stations, which were established by International Institute of Earthquake Engineering and Seismology (IIEES). Figure 6 shows the satellite image and our visual inspection result around the aftershock recording station No.1 together with the cross table between Hisada's survey and our result. This area is located in the south of Arg-e-Bam and 16 houses were made of mud brick (adobe) and 30 houses simple masonry construction. The damage ratio for Grade 5 is 72% by Hisada's survey while 64 % in our visual inspection. The coincidence of damage grade between the two data sets is quite high in this area.

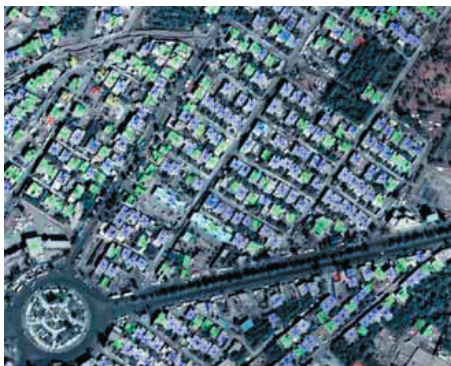
Field survey \ QuickBird	G 1	G 2	G 3	G 4	G 5	sum
G 1 & G 2	6	23	11	7	0	47
G 3	4	12	16	5	0	37
G 4	0	0	0	1	0	1
G 5	0	0	0	0	3	3
sum	10	35	27	13	3	88

Figure 7. Result of visual interpretation compared with field survey data by Hisada et al. (2004) around aftershock recording station No. 3, located in the western part of Bam

Figure 7 shows another comparison for a lower damage area, around aftershock seismic station No.3. In the field survey, a total 45 buildings were classified either Grade 1 or 2 while in our visual interpre-

tation, 47 buildings were judged as Grades 1 and 2. It is seen that omission errors become significant for Grade 4 damage; out of 13 buildings identified by the field survey, only one building was judged as Grade 4. This may be due to the reason that the houses in this area are rather new (mostly masonry, no adobe construction) and thus the damages difficult to observe from the near-vertical image are dominant. However, the coincidence was very good for Grade 5; three buildings out of three were interpreted correctly.

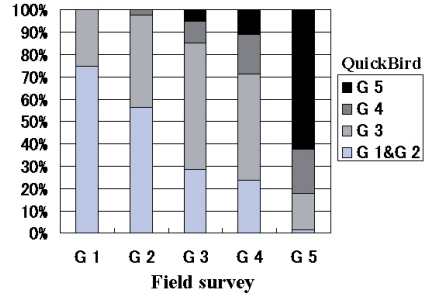
Field survey \ QuickBird	G 1	G 2	G 3	G 4	G 5	sum
G 1 & G 2	12	50	29	15	2	108
G 3	4	37	57	30	25	153
G 4	0	2	10	11	30	53
G 5	0	0	10	7	95	107
sum	16	89	101	63	152	421

Figure 8. Comparison of the result of the field survey by Hisada et al. (2004) around 6 aftershock observation sites in Bam City and that of our visual damage interpretation.

Figure 8 summarizes the comparison of the result of the field survey around six aftershock observation sites (421 buildings in total) in Bam City and that of our visual damage interpretation. Commission errors: judging Grade 1 or 2 damage as Grade 3, and judging Grade 3 damage as Grade 4 or 5, are seen in the cross table. But only 16 buildings were interpreted as more than one grade higher. Thus commission error can be judged as not so significant as for quick-look damage detection.

Omission errors: judging Grade 4 damage as Grade 1-3, and judging Grade 5 damage as Grade 1-4, are also seen in the cross table. Forty-two (42) buildings were interpreted as less than one grade lower. It may be concluded that we should expect some amount of omission errors in damage detection from optical high-resolution satellite images, and thus we should consider this fact in estimating damage aggregate statistics at an early stage.

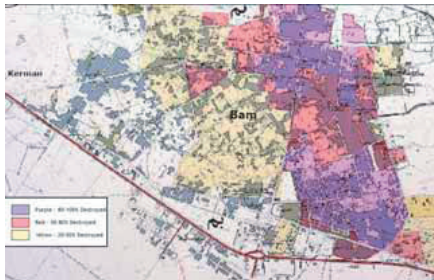
(a) Visual interpretation from QuickBird image

(b) Aerial photo interpretation (USAID 2004)

Figure 9. Result of our visual interpretation from QB images compared with the result of aerial photo interpretation. Colors correspond to 80-100% destruction (purple), 50-80% destruction (red), and 20-50% destruction (yellow).

Figure 9 compares the result of our visual interpretation (the ratio of Grade 5 in each city block) from QB image and the result of aerial photo interpretation (USAID 2004). Some difference is observed between the two maps due to the difference of blocks to calculate the damage ratio although overall agreement is seen to be reasonably well. In obtaining the damage ratio, we counted the number of Grade 5 buildings out of all the buildings in each block although this is very time consuming. On the contrary, the aerial photo interpretation might be conducted rather in a macroscopic manner because the map was created in a rather early period, within a week or so after the earthquake.

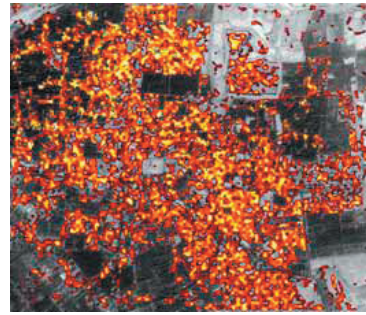
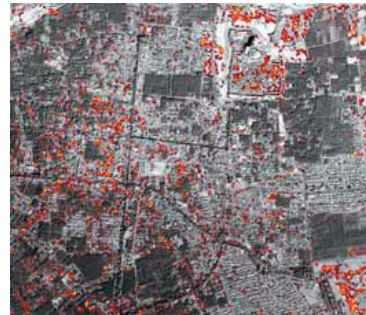
(a) IKONOS image taken on 12/27/2003

(b) QuickBird image taken on 1/3/2004

Figure 10. Results of detected areas with damaged buildings for original pan-sharpened images.

Figure 10 shows the results of the damage detection method applied to the IKONOS and QB images of central Bam. Vegetated areas were removed by thresholding the NDVI (Normalized Difference Vegetation Index). According to the visual damage inspection from QB images in the previous section and the reconnaissance field survey by Hisada et al.

(2004), more than 80% of buildings in the south of Arg-e-Bam were classified as Grade 4 or 5 in EMS-98 scale. The distribution of detected damage from IKONOS is consistent with these results. However, less damage area was detected from the QB image. Spatial resolution and color distribution might be main factors that affect the results.

A re-sampled, one-meter resolution QB image provided a similar result as the original QB image. Hence, spatial resolution is not the reason of the difference. We also calculated the ratios of digital numbers (DNs) of green and blue to that of red in the pan-sharpened images to examine the effects of color. The average rates of green and blue to red values were 0.97 and 0.95 for IKONOS while 1.03 and 1.14 for QB, which implies that the QB image is predominantly cyan. In fact, the original QB image does not look natural, but has a blue tint. Therefore, the color of the QB image was modified by histogram matching with the IKONOS image.

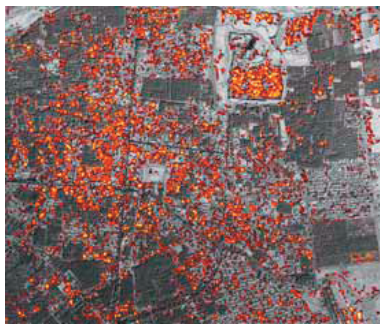
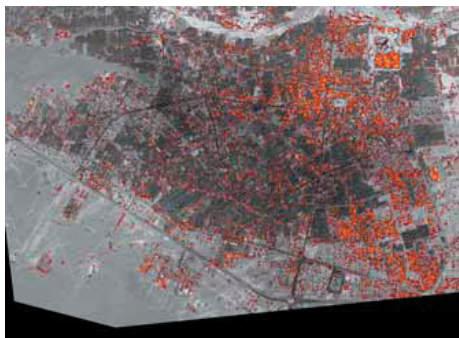
(a) Extracted area corresponding to IKONOS image

(b) Whole QuickBird image

Figure 11. Distribution of detected damage areas using the color-modified post-event QB image.

Figure 11 shows the results of damage detection using the color-modified QB image and the detected result from the color-modified QB image is similar to that from the IKONOS image. Thus, the detection is mainly influenced by the color distribution among red, green, and blue channels. Comparing the automated damage detection results from the post-event

QB and IKONOS images with that from visual inspection and the field survey data, the damage distributions seem to agree reasonably well among them.

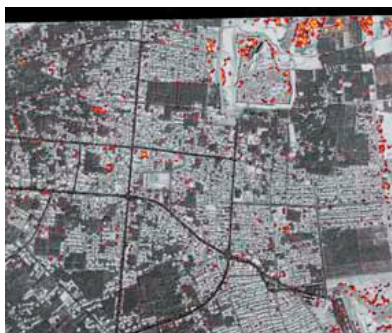
Figure 12. Distribution of detected damage areas using the pre-event QB image. Commission errors are rather limited.

The automated damage detection method was further applied to the pre-event QB image. As seen in Fig. 12, the detected building damage areas (noise) are limited to only small portions on the image.

Hence, the commission error by the present automated damage detection method can be judged to be small.
