Multi-level detection of damaged buildings from high-resolution optical satellite images

T. Thuy Vu^{*a}, Masashi Matsuoka^b, Fumio Yamazaki^a

^aChiba University, 1-33 Yayoi-cho, Inage-ku, Chiba, 263-8522, Japan;

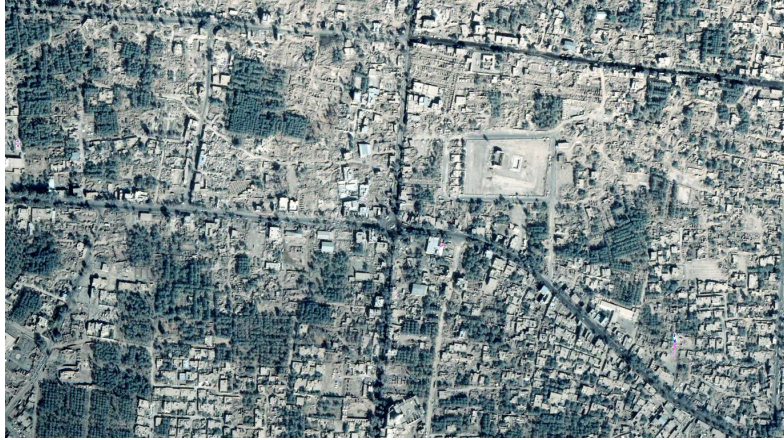
Fig. 1. True-color-composite QuickBird image of Bam, Iran acquired on January 03, 2004.

Post-disaster QuickBird image acquired on January 03, 2004 over the hard-hit areas of Bam city, Iran is shown in Fig.1. The result of texture-based detection is represented as black spots overlain on this true-color-composite QuickBird image (Fig. 2). Visual inspection showed that most of areas of damage buildings were successfully detected.

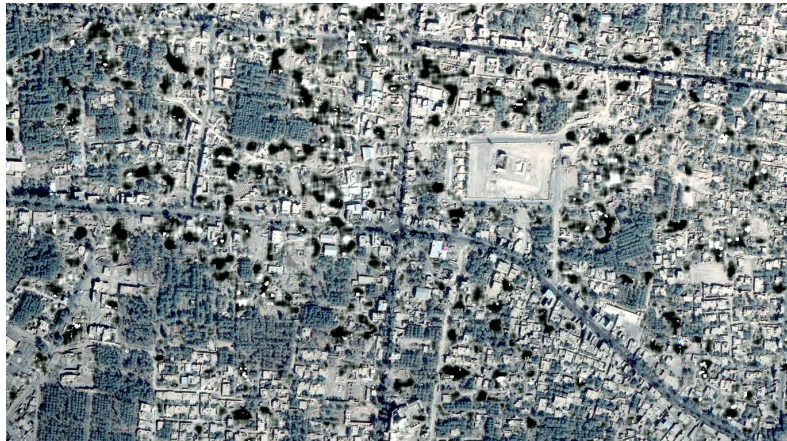
Fig. 2. Texture-based detected results shown as black spots on QuickBird image.
