Effect of Topographic Reliefs on Building Damage Distribution in Boumerdes City during the 2003 Algeria Earthquake

This study highlights the effect of topographic reliefs on the observed damage distribution in the city of Boumerdes after the 2003 Algeria earthquake. Supported by field observations and using a 15-meter grid cell dimension ground digital elevation model (DEM), the topographical situation of the city is simplistically generalized to three possible terrain positions: small hill-tops, steep slopes, and plains. The results of analyses shows that the damaged buildings, mostly mid-rise RC moment frame systems, were located on steep slope and on a small hill-top along a river valley. The measured H/V ratios of free-field microtremor observations did not show clear results, expected to be influenced by the topographic reliefs. Whereas, the same structural characteristics of buildings located on plain situations did not suffer much damage, and clear H/V peaks were observed. The results show the importance of considering the amplification effects of topography when designing new buildings for earthquake resistance.

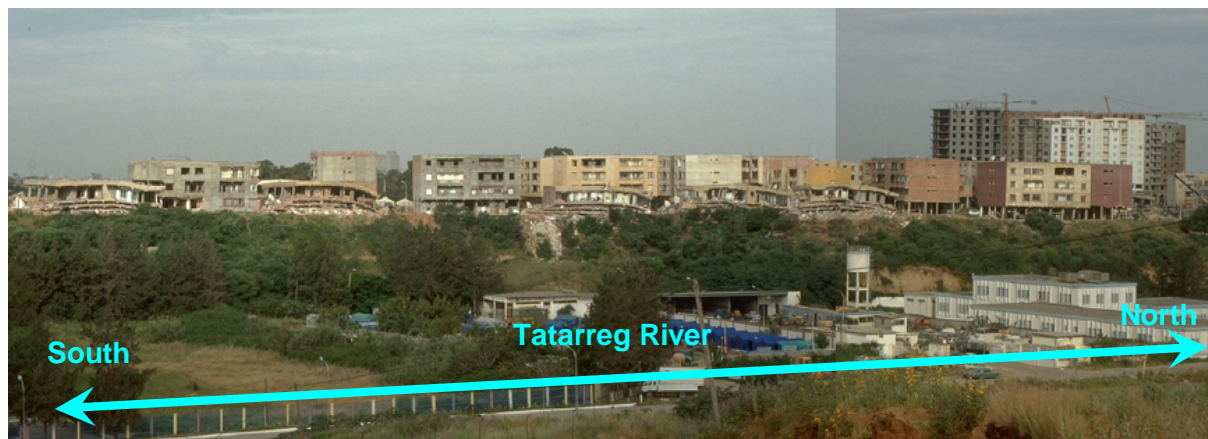
Figure 5. Photograph showing the heaviness of damage occurrence for buildings located on hill-tops in Zone 1A along Tatarreg river valley (see Figure 15). Also we can see that the buildings located very close to scarp edge were totally collapsed, while those located with distance away from scarp edge were partially collapsed or suffered extensive damage to structural elements, columns, and beams

As mentioned above, according to the damage assessment after the 2003 earthquake, the zones with high damage—Zones 1, 2, and 4—were located on hilltops and steep slopes along the Tatarreg River valley (Fig. 4). The damage extended 160 to 200 m from the scarp edge of the slope. The damage extended 160 to 200 m from the scarp edge of the slope. Fig. 5 shows some of the collapsed buildings located on hilltops in Zone 1A along the Tatarreg River valley. Several past earthquakes around the

The damage rate increased for mid-rise RC moment-frame buildings located up to 200 m from slopes. In fact, in Zones 1 and 2 along the Tatarreg River valley, the buildings located very close to the scarp edge of the slope totally collapsed, while those located some distance away from the scarp edge either

partially collapsed or suffered extensive damage to their structural elements, columns, and beams, as shown in Fig. 5. As mentioned by Géli et al. (1988), topographic effects generally result in larger amplitudes of ground motion toward ridge crests, which can increase damage to the buildings in these locations. In addition, the microtremor measurements in Zone 1 showed no clear results for H/V ratios, suggesting that the ambient noise records were strongly influenced by the topography, which concurs with the possibility that the amplitude of the ground motion was strongly affected, leading to extensive damage (Fig. 8). For Zone 2, microtremor measurements showed H/V ratios with smoothed peaks, suggesting that the ambient noise records in this zone were not as strongly influenced by topographic effects as in Zone 1. However, it can clearly be seen that there was a higher rate of damage in Zone 2 than in Zone 1, as shown in Fig. 8. Even though the local subsoil conditions (thickness of layers) in Zone 2 are probably different to those of Zone 1, the fact that the damaged buildings in Zone 2 were five-story structures built in 1970 (before the publication of seismic design codes in Algeria) may explain the difference in the damage rate between these two zones. In Zone 1, most of the damaged buildings were four-story structures built in 1996 using the seismic code published in 1988.

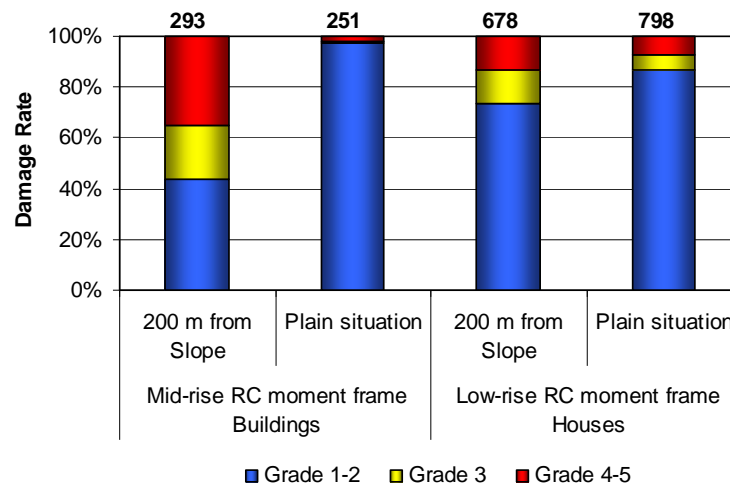
Figure 6. Damage rate for RC moment frame structures with respect to topographic position.

Considering the damage rates with respect to topography, mid-rise RC moment-frame buildings and RC moment-frame houses (low-rise) constituted the only groups with a large sample size. Fig. 6 shows that for mid-rise RC moment-frame buildings located up to 200 m from slopes, the damage rate increased considerably, mostly for four- and five-story buildings, and became insignificant for those buildings located on flat ground. The damaged RC moment-frame houses mostly had three stories, which suggests, as mentioned earlier, that these building had fundamental period values close to those of the damaged four- and five-story buildings.
