Detection of damage to building side-walls in the 2011 Tohoku, Japan earthquake using high-resolution TerraSAR-X images

Fumio Yamazaki*^a, Yoji Iwasaki^b, Wen Liu^c, Takashi Nonaka^d, Tadashi Sasagawa^d

Keywords: TerraSAR-X, layover, side-wall, 2011 Tohoku earthquake, building damage, tsunami

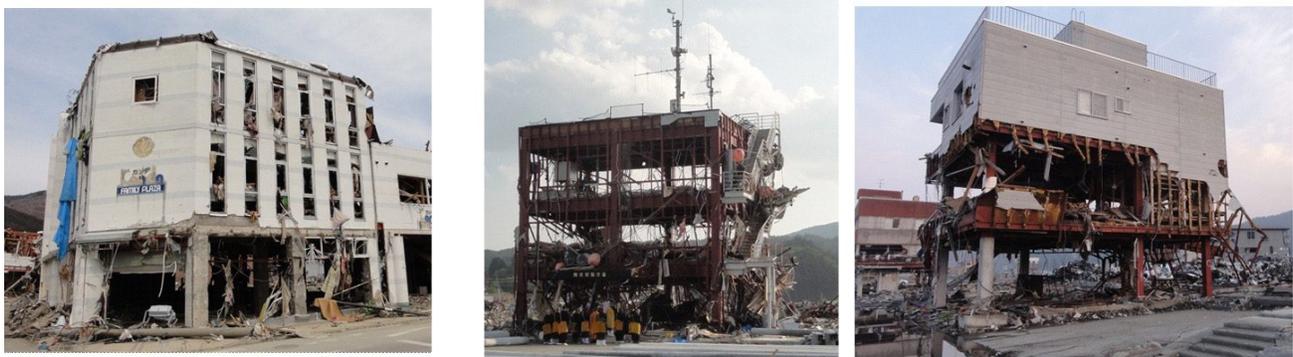
Figure 1. Typical tsunami damage to reinforced concrete and steel-frame buildings observed in our field survey after the 2011 Tohoku earthquake in Onagawa, Minami-Sanriku, and Ohtsuchi towns. The damage was concentrated to side-walls and lower stories of buildings.

The Tohoku earthquake triggered extremely high tsunamis of up to 40.5 m run-up in Miyako, Iwate Prefecture, and caused huge loss of human lives and destruction of infrastructure. According to the GSI, areas totaling approximately 561 km² were flooded by tsunamis following the earthquake [12]. Due to the huge tsunami, about 107 thousands buildings were washed away or collapsed. In this regard, the present authors [10] conducted the extraction of flooded areas due to the tsunami and identified washed-away buildings using the pre- and post-event TSX intensity images. Typical building damages due to the 2011 Tohoku earthquake tsunami in our field survey were shown in Fig. 1. The characteristic building damage by tsunami is that damage was caused to building side-walls or lower parts, which is not the same with damage caused by strong earthquake shaking. We try to detect this kind of damage to building side-walls using the side-looking nature of SAR. The strongest backscattering echoes from the side-walls and double-bounce with the ground may be reduced after this type of damage.

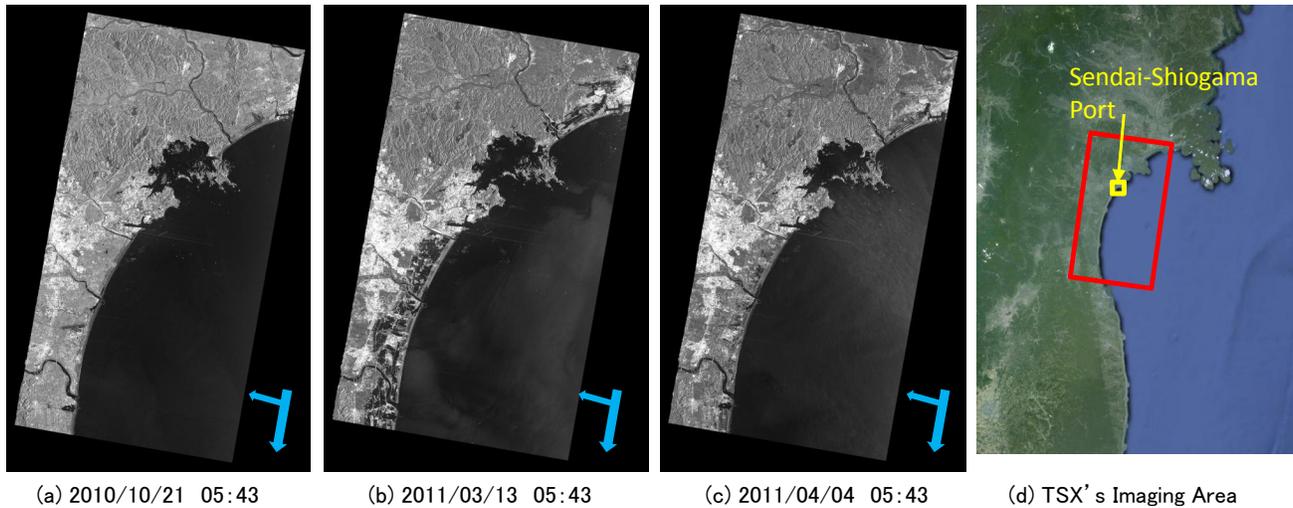
Figure 2. The pre-event TSX image taken on October 21, 2010 (a), the post-event images taken on March 13, 2011 (b) and April 4, 2011 (c), and the TSX's imaging area along the Pacific coast of Tohoku, Japan including the Sendai-Shiogama Port (d)

In this study, we focus on the coastal zone of Tohoku, Japan, as shown in Fig. 2, which was one of the most severely affected areas during the 2011 Tohoku earthquake. Three temporal TSX images taken before and after the earthquake are shown in Fig. 1(a-c), which we used previously for detecting crustal movements [13] and identifying flooded areas [10]. The pre-event image was taken on October 21, 2010 (local time), while the post-event ones were taken on March 13 (two days after the earthquake) and April 4, 2011. There is a 37.31° incidence angle at the center of the images. All the images were captured with HH polarization and in a descending path. The images were acquired in the StripMap mode, and so the azimuth resolution was about 3.3 m while the ground range resolution was about 1.2 m. The images were orthorectified multi-look corrected products (EEC) where the image distortion caused by variable terrain height was compensated for by using a globally available DEM (SRTM). Therefore, they have been resampled and projected to a WGS84 reference ellipsoid with a square pixel size of 1.25 m.

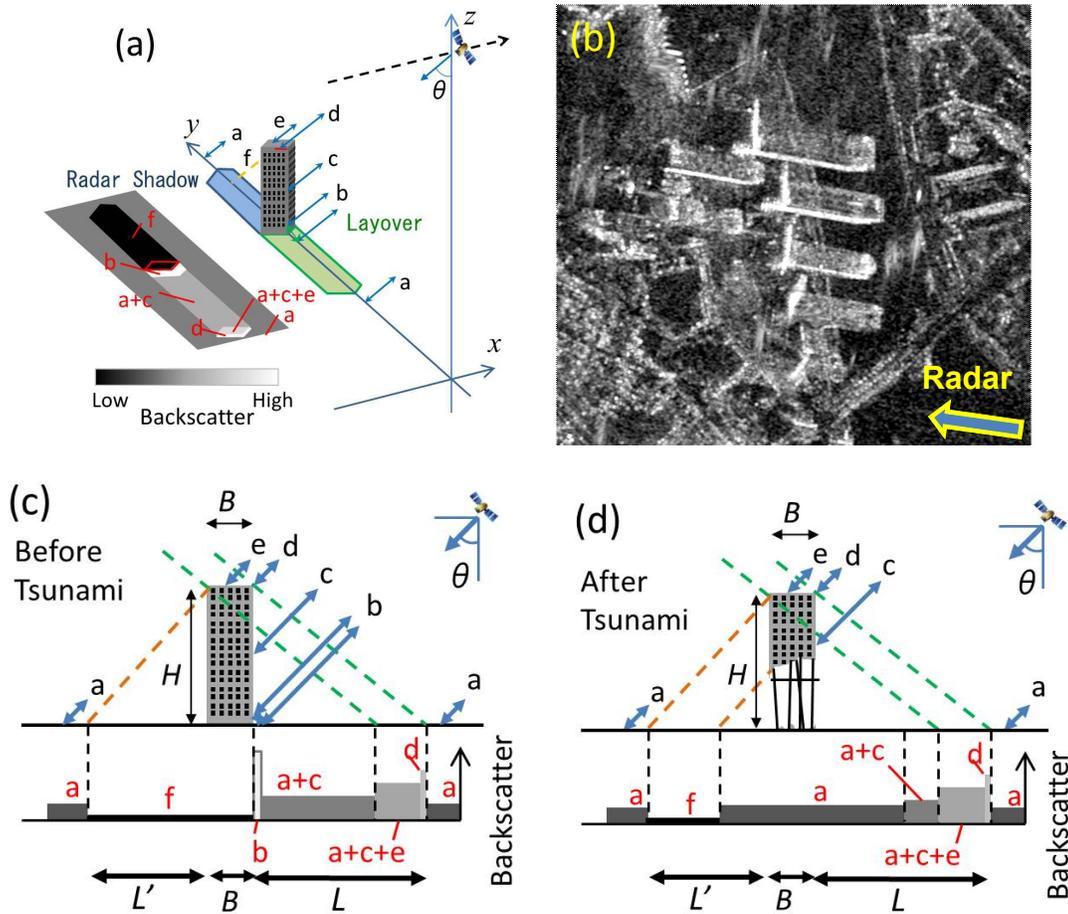
Figure 3. Schematic figure of SAR observation for an ideal tall flat-roof building. 3D layout (a), an actual TSX intensity image for the central Tokyo (b), the amplitude of backscatter from an intact building (c), and the amplitude of backscatter from a damaged building due to tsunami (d).

Backscattering echoes from buildings in very high-resolution (VHR) SAR images include the information on the three-dimensional shapes of buildings. Reconstruction of flat-roof and gable-roof buildings from VHR SAR images were carried out by several researchers [7, 11, 16, 17]. Due to the side-looking geometry of SAR sensors, the backscattering echoes of VHR SAR from a stand-alone building can be shown schematically in Fig. 3.

If a building stands alone on a flat ground, the backscatter from the building shows layover on the ground range. In a usual case, the fringe of the roof-top exhibits strong backscatter (blue arrow *d* in (a) and (c)) and it leans toward to the direction of SAR illumination. The foot fringe of a building also exhibits strong backscatter (blue arrow *b*) due to the double-bounce of radar from the ground and building's side-wall. The backscatter from the building side-wall (blue arrow *c*) together with the double-bounce component, the layover area corresponding to the building side-wall is generally distinguishable in the ground-range SAR intensity image. Thus the height of the building, H , can be calculated from the length of the layover area, L , as

where θ is the incidence angle of SAR. A similar geometrical relationship is obtained for a radar shadow area (area *f* behind the building corresponding to $L'+B$ with B = the building width). If the radar shadow is clearly observed as in Fig. 3 (b), the building height is also estimated by the length of the radar shadow L' as

In other words, if the height of a building is known, the areas of layover and radar shadow can be estimated on the ground range SAR intensity image. If the lower part of a building side-wall is damaged as represented by Fig. 3 (d), the area of layover due the side-wall ($a+c$) will be reduced or the backscatter intensity of the area will get smaller. The area of radar shadow (f) will also become small for a damaged building.

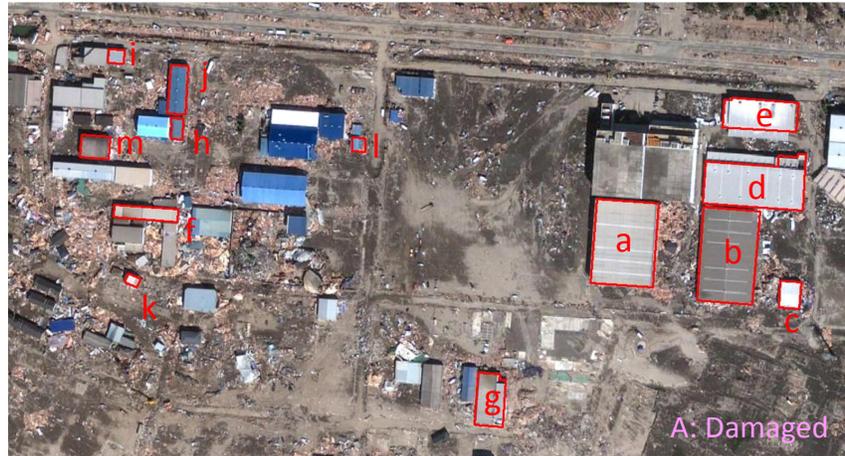
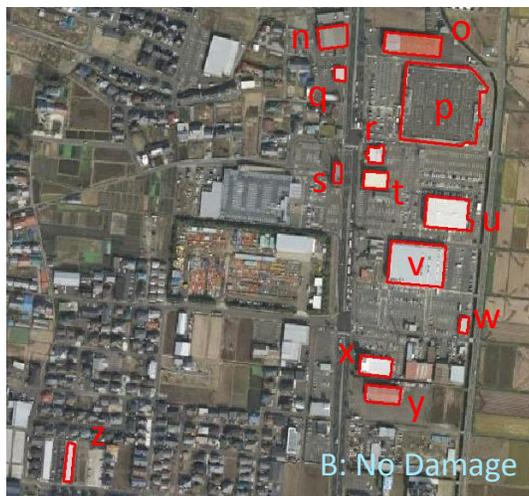
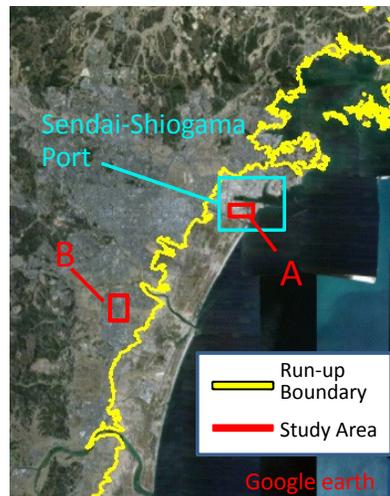
Figure 4. Aerial images of Sendai-Shiogama Port and its surroundings after the tsunami attack. Area A within the tsunami inundation zone was severely affected and area B was located outside of the zone.

The Sendai-Shiogama Port, which was severely hit by the 2011Tohoku earthquake tsunami, was selected as a case study site of building damage detection from SAR images since there were many large buildings and warehouses damaged by the tsunami attack. Figure 4 shows aerial images (adapted from Google Earth) of the Sendai-Shiogama Port and its surroundings after the tsunami attack. Area **A** was located within the tsunami inundation zone and area **B** outside of the zone. Thirteen (13) damaged buildings were extracted from area **A** and thirteen non-damaged ones were selected from area **B**.

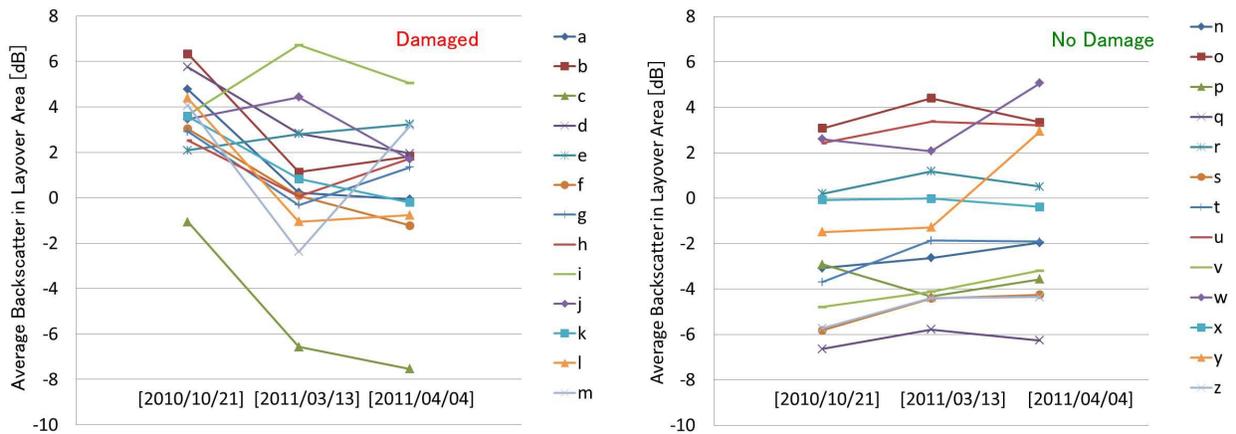
Figure 5. The average value of the backscattering coefficient within the layover area of each building for the 13 damaged buildings in Area A and 13 non-damaged buildings in Area B at the three time instants of SAR image acquisition.

The average value of the backscattering coefficient within the layover area was calculated for the 13 damaged and 13 non-damaged buildings for the three time instants as shown in Fig. 5. It is observed that for the damaged buildings, the average backscattering coefficient within the layover area tends to be lower in the post-tsunami TSX images while the average value is almost unchanged for the non-damaged buildings.

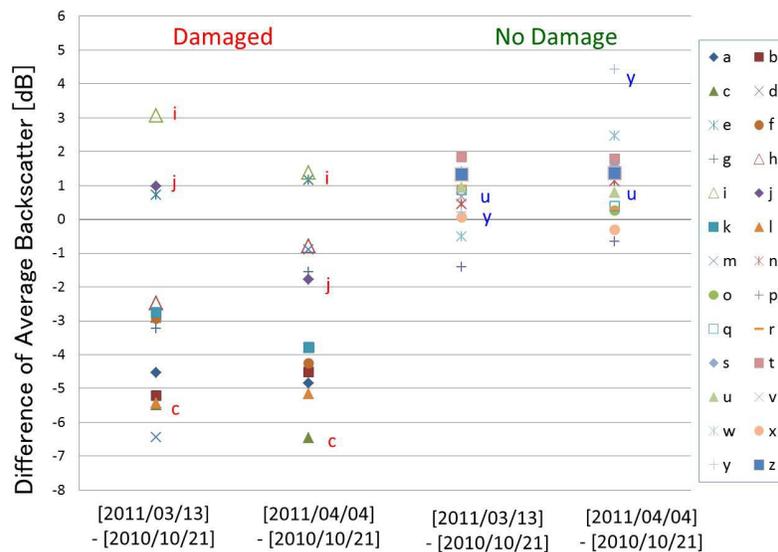
Figure 6. The difference of the average values of the backscattering coefficients within the layover area of each building before and after the tsunami attack for the 13 damaged buildings in Area A and 13 non-damaged buildings in Area B.

The difference of the average values of the backscattering coefficients within the layover area of each building before and after the tsunami attack is plotted in Fig. 6 for the 13 damaged buildings (a-m) in Area A and 13 non-damaged buildings (n-z) in Area B. This figure further confirms the trends seen in Fig. 5. The two post-event TSX data were used to calculate the change in the backscatter within the layover area. The 2011/3/13 image was captured only two days after the tsunami attack, and hence the effect of debris spread on the ground might raise the backscatter there and canceled out the effect of side-wall damage. In the 2011/4/04 image, some debris had been cleared but vehicles and some other objects might exist in the layover area. Due to these possibilities, the difference values are not the same for the two time intervals.

In Fig. 6, the backscatter within the layover area was decreased for most of the damaged buildings. Figure 7 compares the close-up of the TSX images and the optical images of similar acquisition dates for damaged buildings **c**, **i** and **j**. Building **c** suffered from severe tsunami attack on its side-wall and the wall was lost almost completely. Due to this damage situation, the backscatter from the wall as well as the double-bounce component reduced significantly.

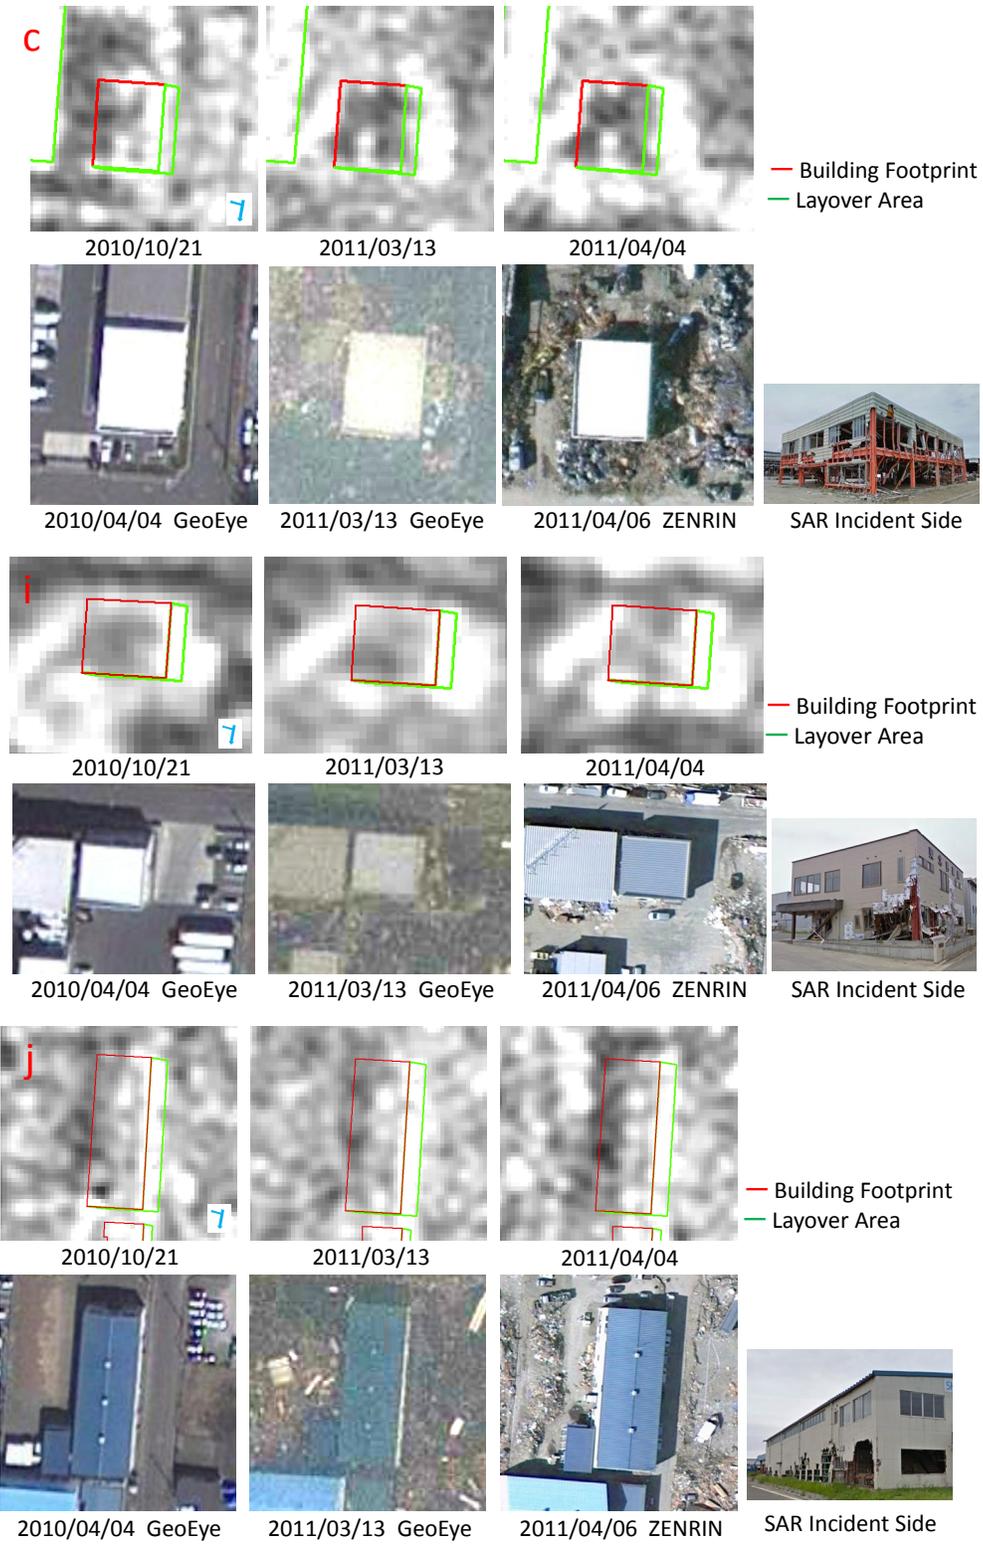
Figure 7. Close-up of the TSX images at the three acquisition dates and the optical images of similar acquisition times for damaged buildings c, i and j in Area A. The ground photo of SAR reflection side of each building extracted from Google Street View was also shown.

Buildings **i** and **j** were outliers of the damaged building category, where the backscatter increased after the tsunami attack. The close-up of these buildings in Fig. 7 shows the spread of debris in their layover areas. Due to relatively small damage to their side-walls and the existence of debris, the backscatter increased in their SAR image on 2011/3/13. The debris was seen being cleared on 2011/4/04, and thus the backscatter of the layover area for building **j** reduced to the level lower than that at the pre-event time. On the contrary, the backscatter for building **i** on 2011/4/04 was still higher than the pre-event time value. This fact may be explained by the exposure of steel frame seen on the side-wall in the ground photo of building **i**. Note that strong radar returns are expected from direct reflection from objects with high dielectric constants, i.e. conductors such as steel [18].

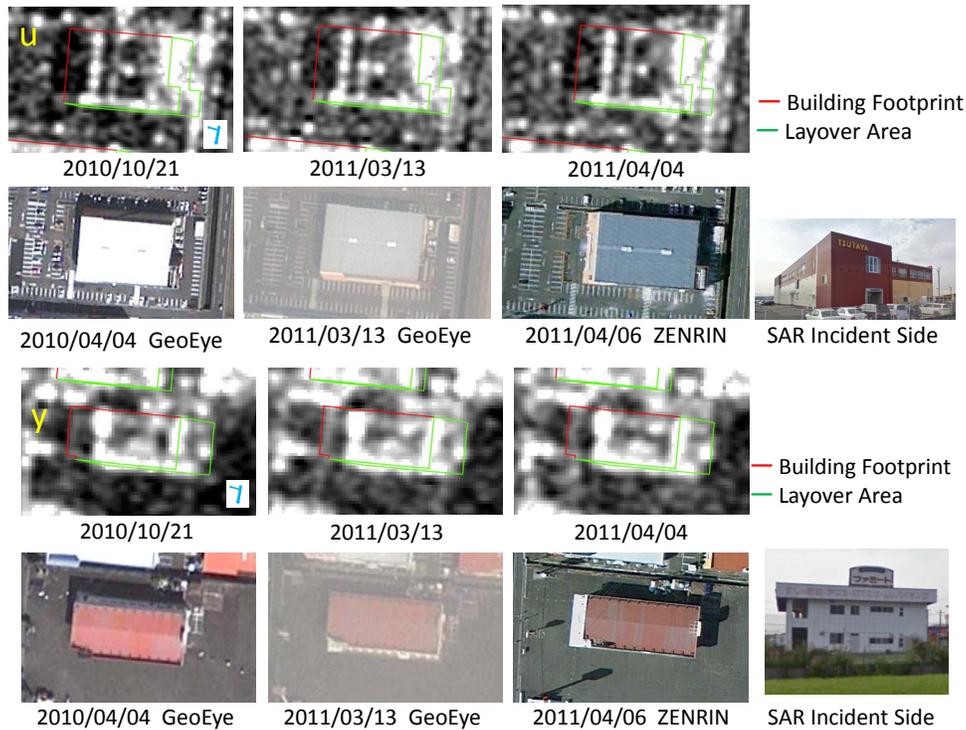
Figure 8. Close-up of the TSX images at the three acquisition dates and the optical images of similar acquisition times for damaged buildings **u** and **y** in Area **B**. The ground photo of SAR reflection side of each building extracted from Google Street View was also shown.

Figure 8 shows the close-up of the TSX images and the optical images for non-damaged buildings **u** and **y**. Building **u** is a typical non-damaged building, where no significant change was seen in its layover area. Building **y** is the only outlier out of the 13 non-damaged buildings, where the increase of backscatter was seen in the TSX image on 2011/4/04. No particular object is seen in the corresponding optical image, but its acquisition date and time was different from that of the TSX image. Since a parking lot exists in the surrounding of the building, parking vehicles might be responsible for this temporary increase of backscatter.
