# THE ROLE OF URBAN DEVELOPMENT PATTERNS IN MITIGATING THE EFFECTS OF TSUNAMI RUN- UP

**ABSTRACT:** This study seeks to understand the relationship between urban development patterns and the extent of physical damage caused by widespread tsunami run-up. The project had four major objectives: 1) to perform field studies to collect perishable data on coastal community performance following the 2011 Tohoku earthquake, 2) to develop an understanding of the “data landscape” in post-earthquake Japan, 3) to quantify the effect of user experience in interpreting remotely-sensed images on the accuracy of post-event damage assessments, and 4) to develop a preliminary understanding of the role that urban development patterns played in either mitigating or exacerbating tsunami-induced impacts.

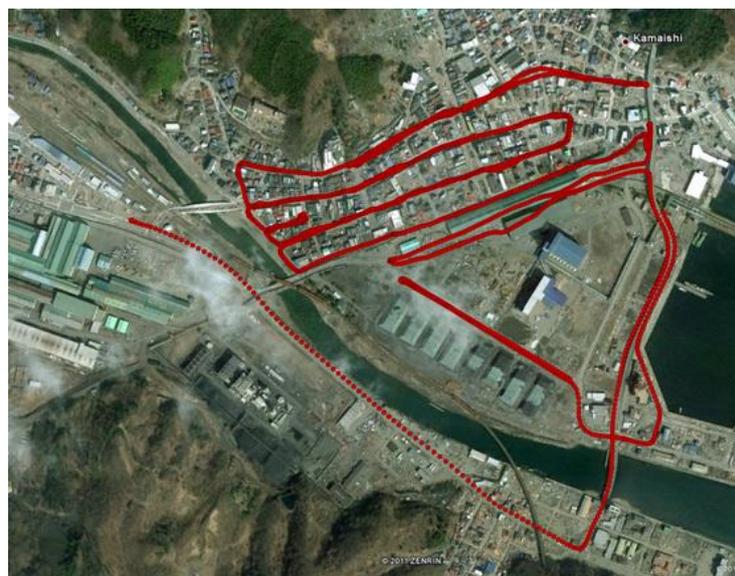
Fig. 1 Sample City Route and GPS Trail

Approximately four months after the March 2011 event, the ImageCat team along with Professor Shunichi Koshimura of Tohoku University and Professor Fumio Yamazaki of Chiba University, performed ground surveys of those areas affected by the tsunami. The survey lasted six days and included 11 communities which spanned from Chiba (in the south) to Miyako (in the north). These communities ranged from small fishing villages to moderately large industrial ports. The goal was to select a range of communities that would help understand what factors led to extreme vulnerability to tsunami effects, and what factors led to strong resistance. As part of this survey, approximately 1000 GPS-stamped photos were taken and several hours of video were captured. The communities studied include: Ishinomaki, Kamaishi, Kesennuma, Matsushima, Minamisanriku, Miyako, Ofunato, Onagawa, Otsuchi, Rikuzentakata, Sendai and Yamada. A sample of the extent of the survey and GPS routes is shown in Fig. 1.

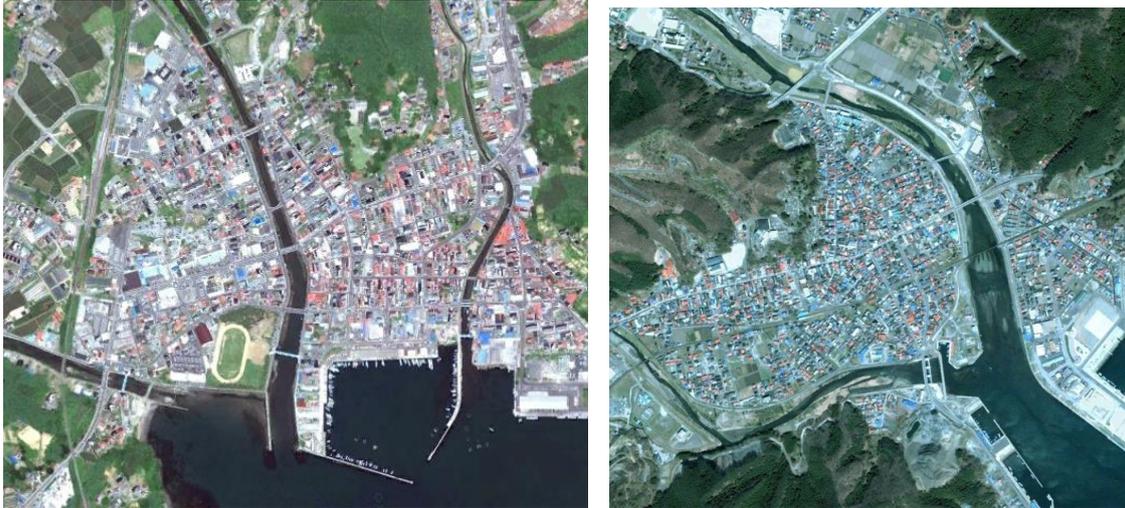
Fig. 4 Minamisanriku (left) and Otsuchi (right) waterfronts

To understand the effects of the urban environment, the team first identified those areas without commercial/industrial fronts that would serve as protection. These communities included: Kesennuma, Minamisanriku, Ofunato, Onagawa, Otsuchi, Rikuzentakata, Sendai and Yamada. Residential communities were either exposed directly to the initial and subsequent impacts of the tsunami waves or the urban configuration was such that it provided no relief from the hydrodynamic forces. The communities shown in Fig. 4 are Minamisanriku and Otsuchi. It can be observed that there is not an abundance of fishing warehouses or commercial/industrial mid-rise structures along the waterfront, leaving the residential properties fairly exposed.

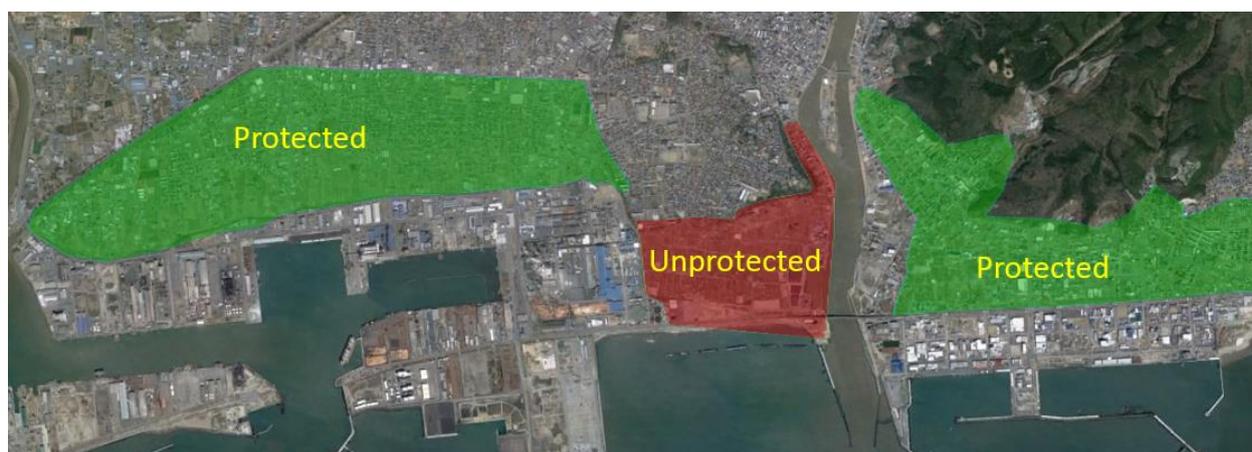
Fig. 5 Ishinomaki “Protected” and “Unprotected” Residential Areas

Ishinomaki had a population of approximately 160,000 and was largely known as a shipping port with a large fish market. According to published records, approximately 46% of the city was inundated by the tsunami. The areas of focus for the study were directly east and west of the Kitakami River. To the west of the river lies large industrial factories. The east side is composed mainly of commercial/industrial areas. Both areas are populated by large steel industrial warehouses with the occasional reinforced-concrete commercial building. Single family residences are essentially non-existent in these areas. The residential areas directly north of the two industrial ports were considered “protected” for the analysis, as the water was forced through these areas before making contact with any of numerous wood-framed, single-family communities behind. A pocket of exposed, coastal residential structures can be found between these two areas, not protected by the larger commercial/industrial buildings, and exposed directly to the water. These areas were considered “unprotected” and can be found in Fig. 5.

The residential structures in the “protected” areas behind the commercial/industrial waterfronts recorded damage rates of 18% and 26% at 5.4m and 5.6m maximum depths, respectively. Approximately 83% of the residential structures in the “unprotected” residential coastal region however were destroyed. Using Table 1 as a general benchmark, it is expected that close to 95% of structures should be destroyed around the 5-6m mark (for the “protected” areas) and 98% should be destroyed at the 7m mark (“unprotected” area). Neglecting varying flow velocities and debris levels, a strong correlation between reduced damage within the community and a commercial/industrial front is inferred.

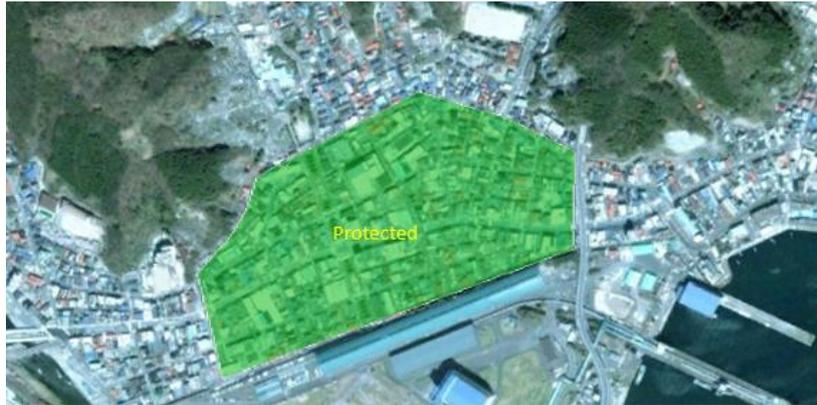
Fig. 6 Kamaishi “Protected” Areas

Kamaishi had a population of approximately 41,000 and is largely known for their steel production. Prior to the 2011 events, it was also known as a fishing port. Kamaishi was of particular interest because of the large, steel-framed, industrial warehouse with corrugated metal siding. Directly beyond the structure, a mix of single-family residences and low-rise mixed use populated the area, which can be seen in Fig. 6.

The structures behind the industrial warehouse (blue roof in Fig. 6) had a damage ratio of approximately 13% with an observed maximum height of 7.3 m. The city as a whole, experienced total damage of up to 88% of their structures at that same height, which can be found in Table 1.

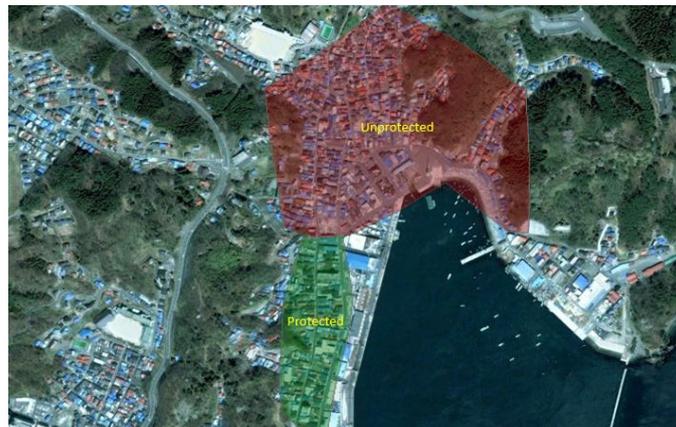
Fig. 7 Miyako “Protected” and “Unprotected” Areas

Miyako had a population of approximately 60,000 people when the tsunami occurred and was known predominately as a fishing village. The shore along the Miyako fishing coast was lined with steel warehouses protecting both single-family residences and mixed-use structures. An area north of these protected areas which had no commercial/industrial front was also analyzed to compare results.

The analysis shows that those structures in the “protected” areas recorded a damage ratio of 32% with a maximum water depth of 7.9 meters. Areas in the “unprotected” areas were subject to the same water depth (7.9 m), however had a damage ratio of 75%.
