RECONSTRUCTION MONITORING OF BAM CITY AFTER THE 2003 EARTHQUAKE BASED ON SATELLITE IMAGES, STATISTICAL DATA AND FIELD OBSERVATIONS

Seyed Omid Hashemi Parast¹ and Fumio Yamazaki²

ABSTRACT

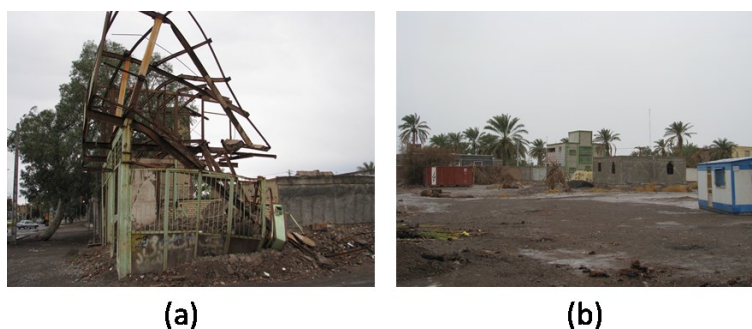
1. The debris could still be seen in some damaged areas. (Fig. 2a). In addition in some regions, especially in the center and northern part of the city, debris had been removed, but construction has not been taken place and there are still bare lands. (Fig. 2b)

Figure 2. (a) Desolate building in the northeast of Bam and (b) bare land in the center of Bam

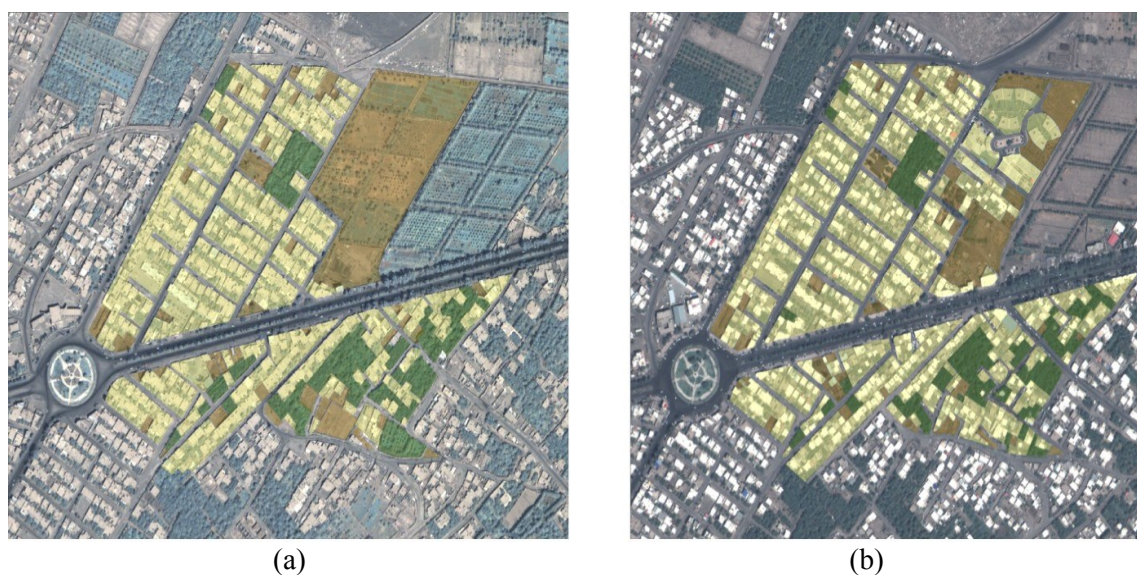
Fig. 5 shows the satellite images covering the station 1 in 2003 and 2012. The area and percentage for the three land-covers are presented under each image. A clear increase in the percentage of buildings and a decrease of ground in 2012 can be observed.

2003		2012	
	area (m ²)	percentage	area (m ²)	percentage
Vegetation	42396	14	32712	12
Ground	90291	30	41976	15
Building	168608	56	207041	73

Figure 5. (a) Satellite image and land-covers at the station 1 in 2003 and (b) those in 2012. The area (m²) and percentage of *buildings*, *vegetation* and *ground* in (c) 2003 and (d) 2012.
