Construction of 3D models of buildings damaged by earthquakes using UAV aerial images

F. Yamazaki, T. Matsuda, S. Denda & W. Liu

Chiba University, Chiba, Japan.

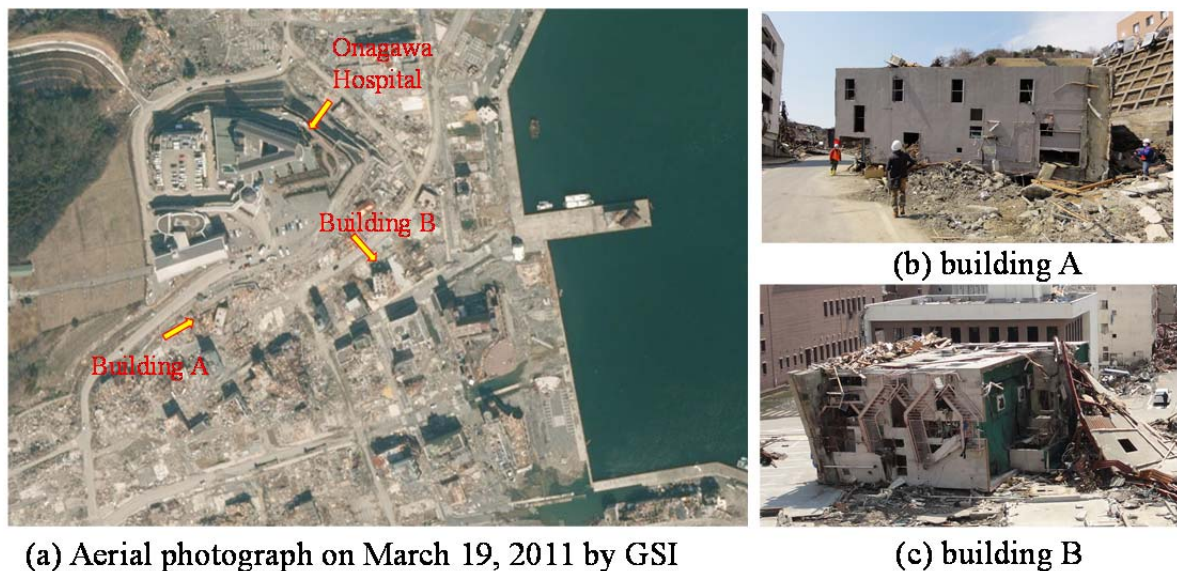
The most remarkable observation in this area is that six reinforced-concrete (RC) buildings were overturned by the tsunami, and some of them were washed away from their original positions as shown in **Figure 1(b, c)**. These ground photos were taken by the first author on March 29, 2011 in his first visit after the disaster. The authors have visited Onagawa Town several times in the last 4 years after the 2011 Tohoku earthquake and monitored the stage of restoration.

Figure 1 Aerial photograph of Onagawa Port area by the Geospatial Survey Institute (2011) on March 19, 2011 (a) and ground photos of overturned buildings by the tsunami taken on March 29, 2011 (b) & (c)

The Mw 9.0 Tohoku earthquake occurred on March 11, 2011, off the Pacific coast of northeastern (Tohoku) Japan, and caused gigantic tsunamis, resulting in widespread devastation (Suppasri *et al.*, 2012; Liu *et al.*, 2013). Onagawa Town, approximately 50 km northeast of Sendai city, is one of the most severely affected municipalities in the 2011 Tohoku earthquake. Onagawa is located along the ria coast of the Pacific Ocean and a part of the Oshika Peninsula, and is surrounded by Ishinomaki City. The town was hit by repeated tsunamis after about 15:30 on March 11, 2011. The maximum tsunami height (from the sea level) observed at Onagawa Hospital was higher than 18 m (Suppasri & Mas, 2013). Even the ground floor of the hospital, located on a hill, was inundated up to about 2 m. **Figure 1(a)** shows an aerial photograph taken by the Geospatial Survey Institute (GSI), Japan on March 19, 2011.

When the authors revisited the town on November 14, 2014, only the overturned building B was left and the other overturned buildings had been demolished and removed. Thus we selected the building B in **Figure 1** as the target of UAV aerial shooting and 3D-model reconstruction. In this visit, we brought small multicopter “DJI Phantom 2 vision +”, the most selling drone in the world, for aerial surveying.

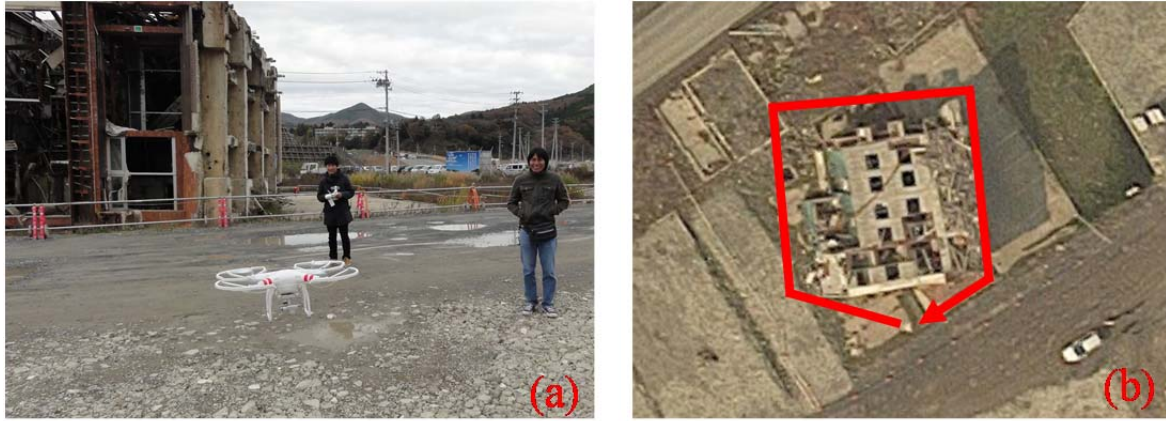
Figure 2 shows the scene of the take-off and the flight route of the drone. A GPS-guided auto-pilot function was used to fly over the building with the altitude of 30 m from the ground. The camera angle was set to the vertical direction, and thus the upper surface of the turned-down structure was seen well. But by this shooting condition, the side-faces of the structure could not be captured well. Since the building was stand (left) alone, we took the photos of all the side-faces from the ground.

Figure 2 Scene of the take-off of the drone (a) and the flight route over the building B in Onagawa on November 14, 2014.

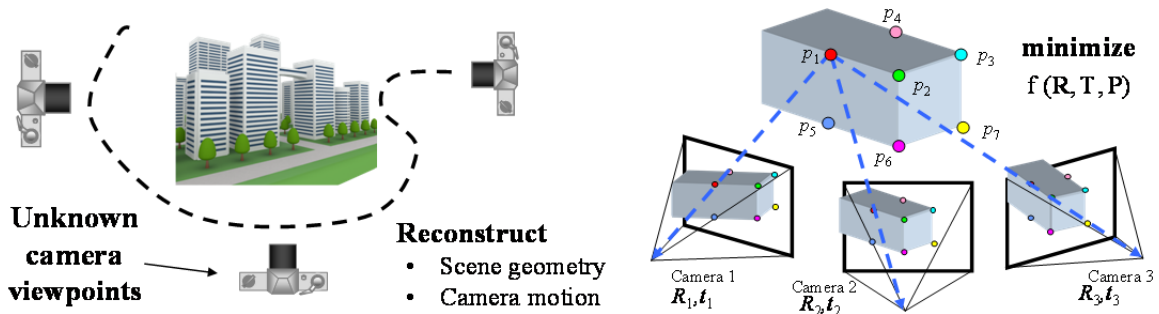
Figure 3 Schematic concept of the Structure-from-Motion (SfM)

The Structure-from-Motion (SfM) is a range imaging technique to reconstruct three-dimensional structures and camera positions and orientations simultaneously from two-dimensional image sequences as shown in **Figure 3**. The method has been studied extensively in the fields of computer vision and visual perception (Lowe, 2004). A large number of research works have been carried out to construct 3D models of buildings and various objects (Snavely *et al.*, 2007; Daffry *et al.*, 2015). In this study, the Agisoft's *PhotoScan* software is used for constructing 3D models of buildings based on the SfM technique.

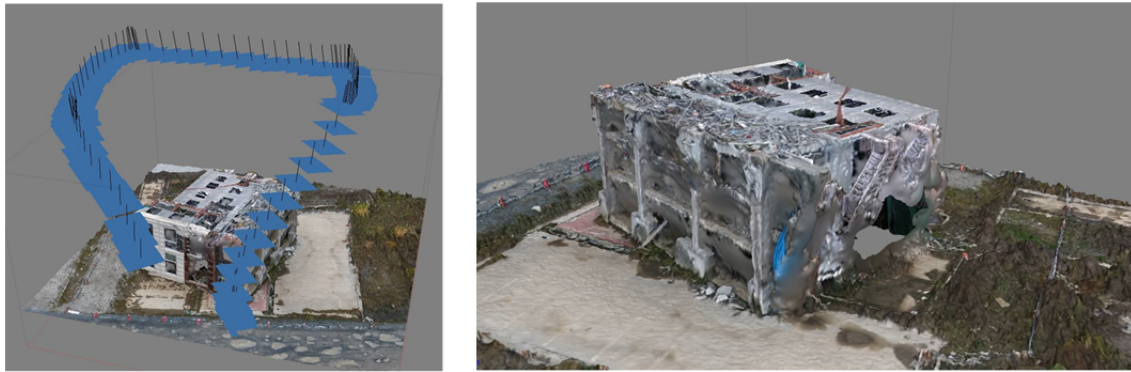
Using a set of aerial images taken from the UAV over the building B in Onagawa Town, a 3D building model was developed. One hundred (100) snapshots were captured from the aerial video and they were used for this purpose. **Figure 4** shows the estimated camera positions and developed 3D model. Since the camera angle was almost to the vertical direction, the top surface of the building was modelled well. But the side faces of the building could not be modelled so well. In order to produce a more complete 3D model, the drone should fly also at a lower altitude with an oblique camera angle.

Figure 4 Estimated camera positions (left) and developed 3D model (right) from the aerial images.

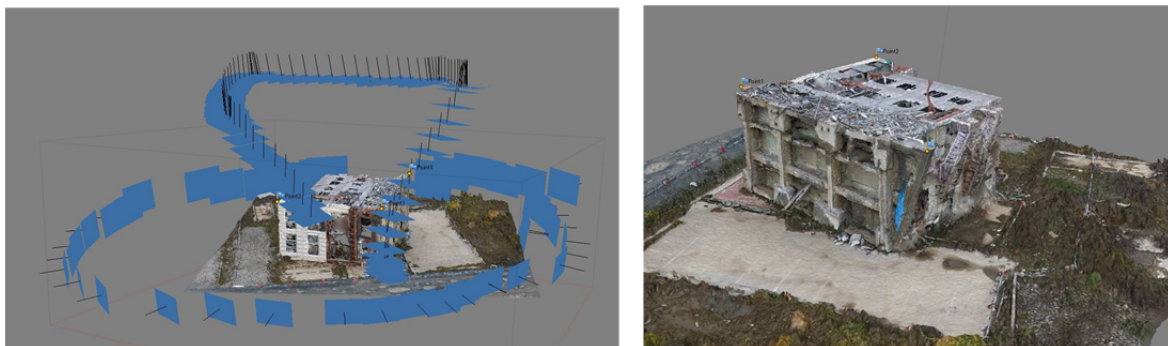
A 3D model was also made using both the aerial images and ground photos, and assigning a few ground control points (GCPs) as shown in **Figure 6**. By combining the two sets of images, the constructed 3D model was found to be most complete, compared with the previous two cases. This example demonstrates the usefulness of the SfM technique to depict damage situation of buildings.

Figure 6 Estimated camera positions (left) and developed 3D model (right) using both the aerial images and ground photos.

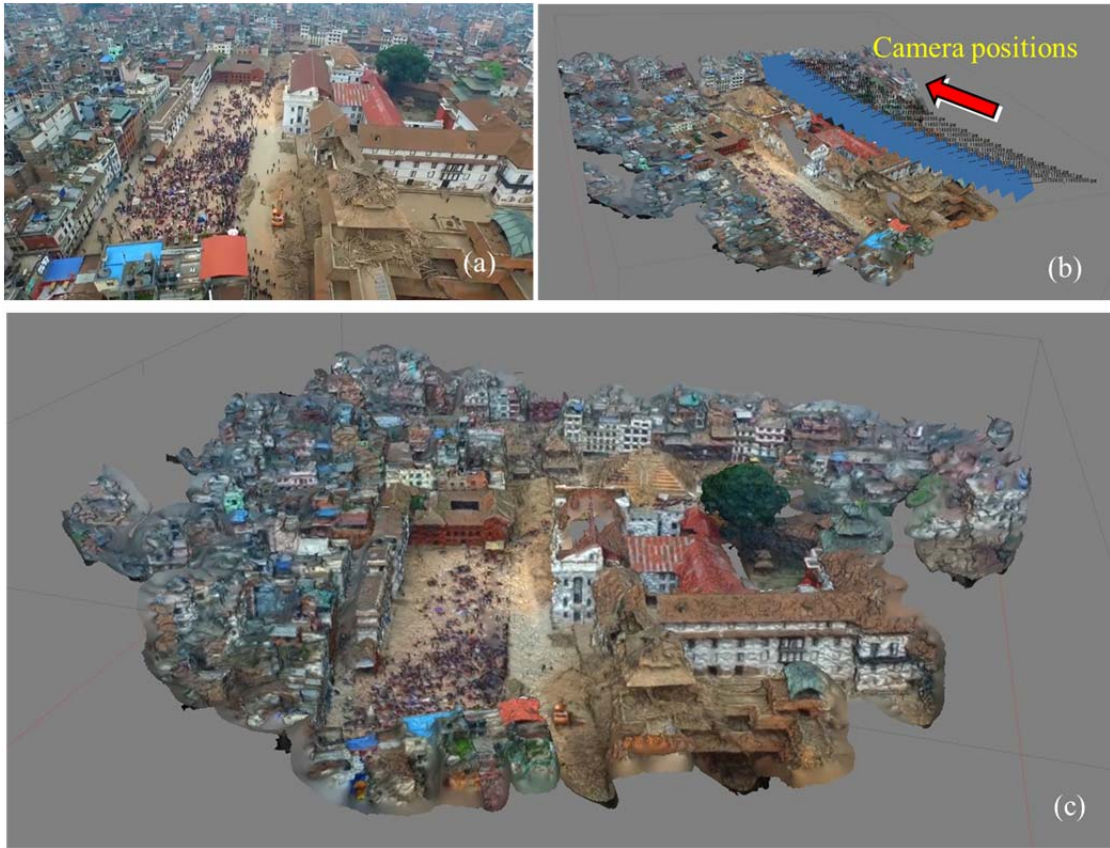
Durbar square in Kathmandu is one of the world heritage sites out of seven monument zones in the Kathmandu Valley. Using a video from UAV (<https://www.youtube.com/watch?v=N52LX1GZYWs>), we produced a 3D model of Durbar square area as shown in **Figure 8**. It is recognized from the video that, the drone flew from the east to the west over the square. The estimated camera positions (**b**) by *PhotoScan* software agrees with this observation. Since the quality of the video is high, the developed 3D model can demonstrate the damage situation of this world heritage zone quite well.

Figure 8 A snapshot of video footage over Durbar Square in Kathmandu (a), estimated camera positions by SfM (b) and developed 3D model of the district (c).

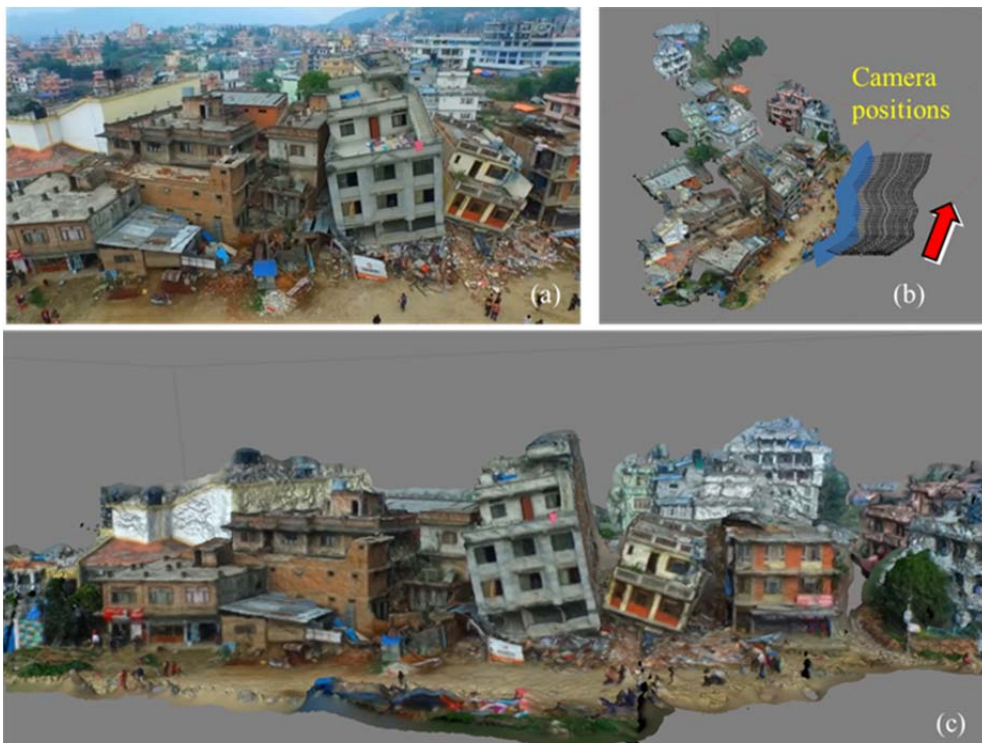
Figure 9 shows another example at Sitapaila (<https://www.youtube.com/watch?v=yWZDv8cz790>) in Kathmandu. The damage condition of each building was modelled in a 3D space, and hence the technique is considered to be useful to assess the damage situation of city blocks in detail.

Figure 9 A snapshot of video footage over Sitapaila in Kathmandu (a), estimated camera positions by SfM (b) and developed 3D model of the district (c).
