# REMOTE SENSING TECHNOLOGIES FOR POST-EARTHQUAKE DAMAGE ASSESSMENT: A CASE STUDY ON THE 2016 KUMAMOTO EARTHQUAKE

Fumio YAMAZAKI and Wen LIU

**ABSTRACT:** In the recent years, remote sensing technologies become important tools in disaster management, especially in the aftermath of destructive natural disasters. In this paper, various remote sensing data acquired after the  $M_w$ 7.0 Kumamoto earthquake, Japan are introduced. Airborne optical and Lidar data as well as satellite optical and SAR data were captured by various international space agencies and aerial survey companies. Preliminary research results using these remote sensing data are demonstrated, comparing with the data from field surveys and GNSS observation, and seismic records.

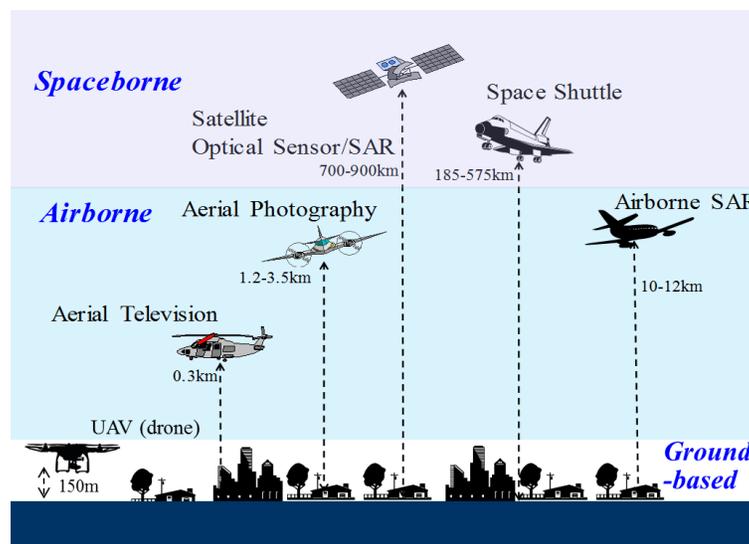
**Figure 1. Various platforms and sensors used for remote sensing**

UAVs have been used in recent decades for several civilian purposes, such as pesticide spraying, inspection of infrastructures such as bridges and towers, reconnaissance of hazardous areas (Nonami et al. 2010). Together with a 3D model construction technique called SfM (Structure-from-Motion), video footages from UAVs were used to depict the damage situation of affected buildings in Bologna, Italy (Fernandez et al. 2015) and that of affected urban areas due the 2015 Gorkha, Nepal earthquake (Yamazaki et al. 2015). The schematic figure of these platforms and sensors is shown in **Figure 1**.

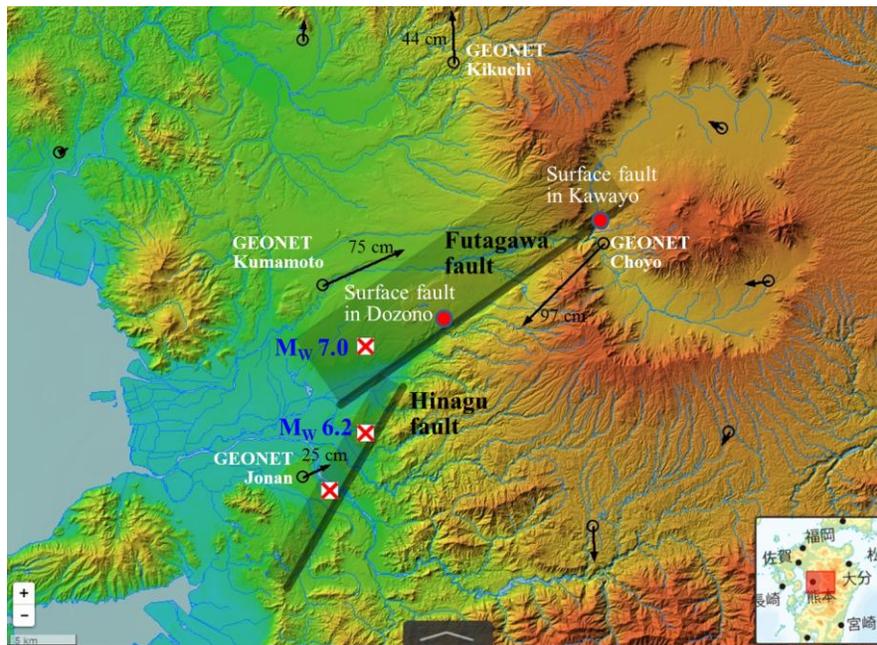
**Figure 2. Epicenters, causative faults, and GEONET stations in the source zone of the 2016 Kumamoto, Japan earthquake**

**Figure 2** shows the location of these causative faults and Japanese national GNSS Earth Observation Network System (GEONET) stations in the source area (Geospatial Information Authority of Japan (GSI) 2016). Note that the GEONET system has about 1,300 stations covering Japan's territory uniformly. The displacement of 75 cm to the east northeast (ENE) was observed at the Kumamoto station while that of 97 cm to the southwest (SE) was recorded at the Choyo station during the  $M_w$ 7.0 mainshock. These observations validated the right-lateral strike-slip mechanism of the Futagawa fault.

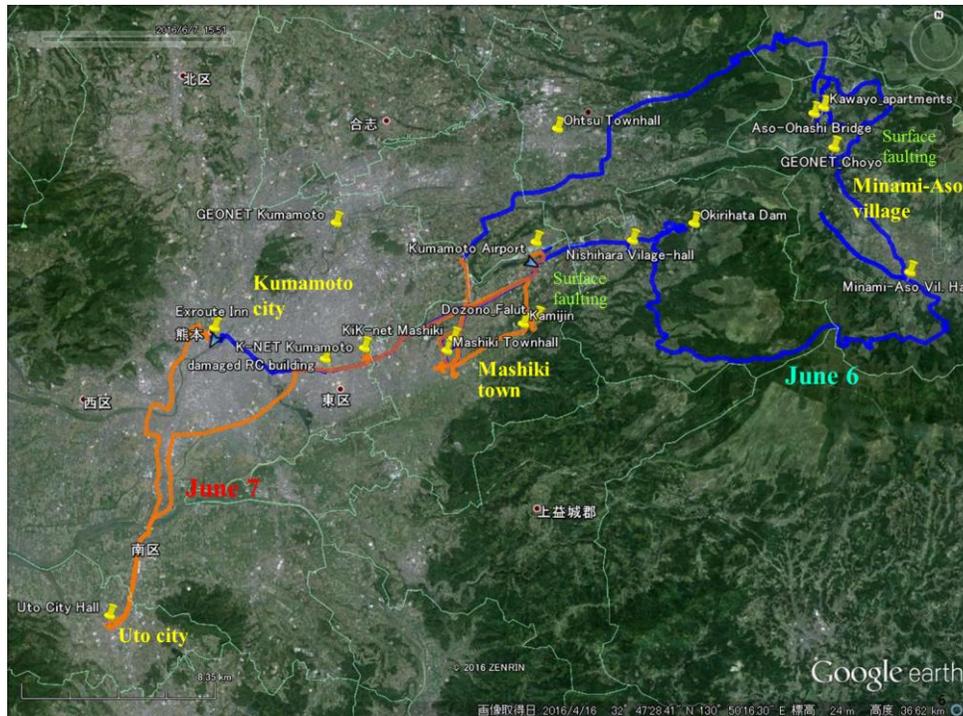
Figure 3. Route and visited sites in the author's field survey on June 6 and 7, 2016

The first author has carried out field investigation of the affected areas three times: April 15 to 17 (experienced the mainshock in Kumamoto city), June 6 and 7, and July 3 and 4. **Figure 3** shows the route and visited sites in the field survey on June 6 and 7. **Figure 4** shows a surface rupture observed at the Dozono district in Mashiki town and the largest landslide observed at the Kawayo district in Minami-Aso village. The Aso-Ohashi bridge with 206-m span and 8-m width fell into the Kurokawa river by this landslide.

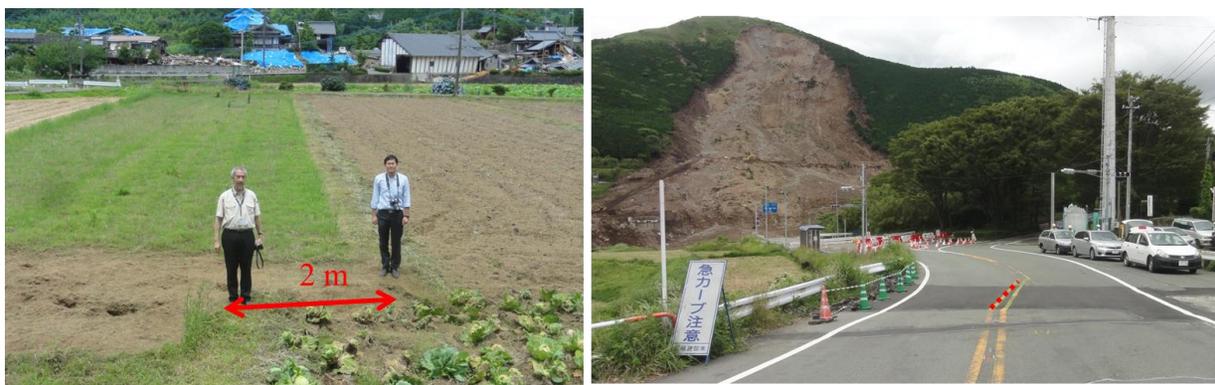
Figure 4. Surface rupture observed in Dozono district, Mashiki town (left) and the largest landslide observed from the Kawayo district, Minami-Aso village (right)

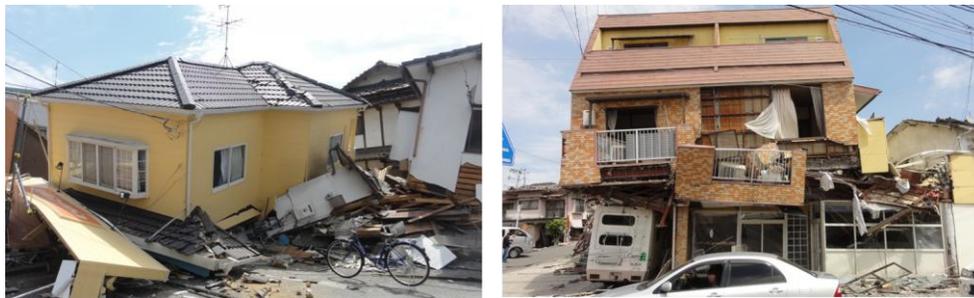
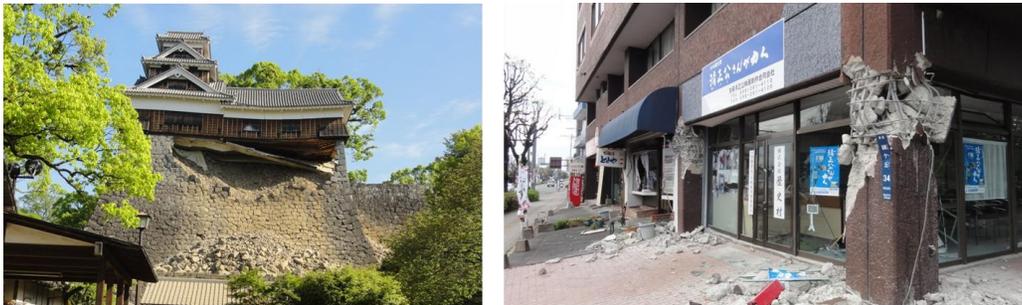
(a) Mashiki town: wooden house (left) and steel-frame (right)

(b) Kumamoto city: Iidamaru tower of Kumamoto castle (left) and RC building (right)

**Figure 5. Damage situation of buildings in Mashiki town (a) and Kumamoto city (b)**

**Figure 5** shows the damage situation of buildings in Mashiki town (a) and Kumamoto city (b). In Mashiki town, the peak ground acceleration (PGA) observed at the KiK-net Mashiki

(KMMH16) station was  $925 \text{ cm/s}^2$  in the foreshock and  $1,314 \text{ cm/s}^2$  in the mainshock. Due to the repeated very strong shocks, a large number of buildings were collapsed or severely damaged, as shown in the figure.

In Kumamoto city, the PGA at K-NET Kumamoto (KMM006) station, which is located in the eastern part of the city, was  $580 \text{ cm/s}^2$  in the foreshock and  $843 \text{ cm/s}^2$  in the mainshock. As seen in the photos, historical Kumamoto castle was severely damaged to its stone walls/foundations and roof-tiles. Some RC buildings suffered from structural and/or non-structural damage, but the most buildings in the city had minor or no damage.

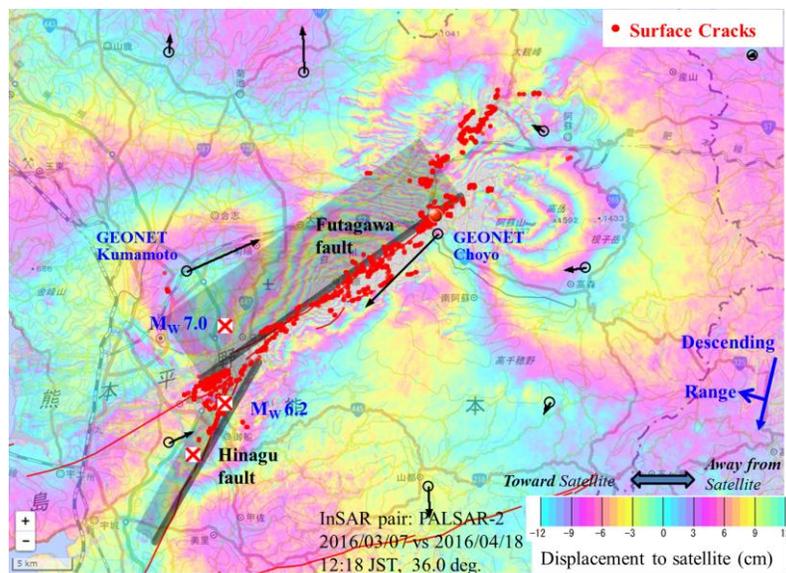
**Figure 6. Result of InSAR analysis using a pair of PALSAR-2 data by GSI (2016)**

Dense fringes, showing the relative displacement between the two time-instants toward the satellite direction, can be observed along the Futagawa fault line. Surface cracks, representing surface faulting and local soil displacements observed by aerial photo-interpretation (GSI 2016), are also plotted by red circles in the figure.

Soon after the occurrence of the first event, JAXA (Japan Aerospace Exploration Agency) carried out intensive monitoring of the source area using PALSAR-2 sensor onboard ALOS-2 satellite. **Figure 6** shows a result of Interferometric SAR (InSAR) analysis using a pair of PALSAR-2 data acquired on pre-event (2016/03/07) and post-mainshock (2016/04/18) times (GSI 2016).

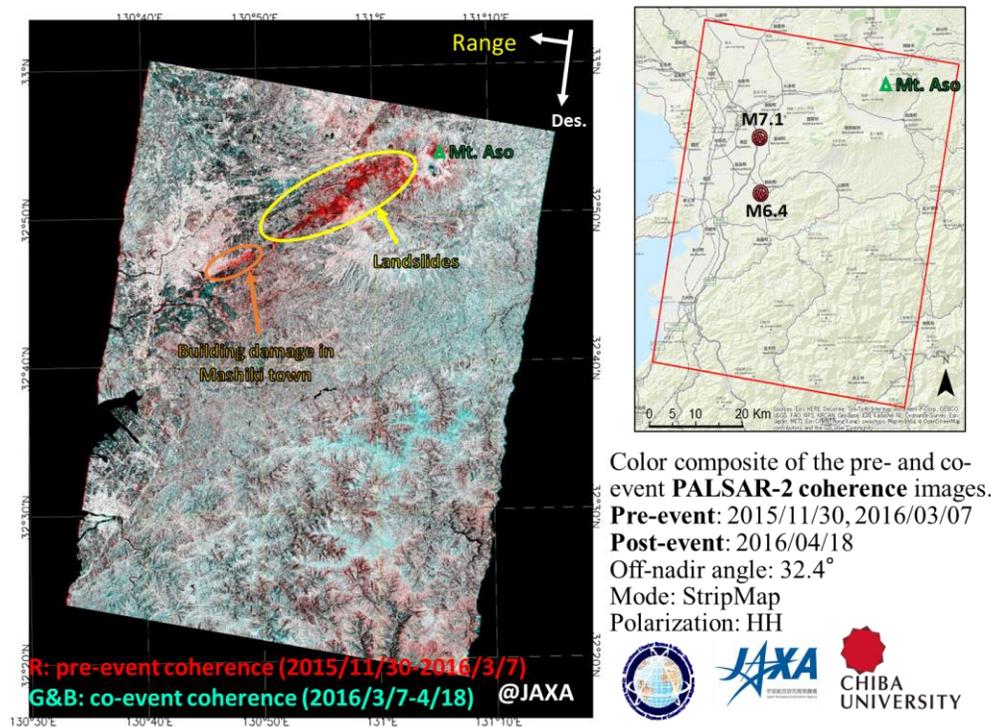
**Figure 7. Color-composite of the pre- and co-event coherence values of PALSAR-2 data.**

Using the pre-event PALSAR-2 pair (2015/11/30, 2016/03/07) data and the co-event PALSAR-2 pair (2016/03/07, 2016/04/18) data, the present authors calculated the spatial coherence values. **Figure 7** shows the color-composite of the pre-event and co-event coherence values, in which red color indicates the change of SAR backscatter in the co-event pair. Extensive landslides and severe building-damage areas along the fault line are clearly highlighted in the figure.

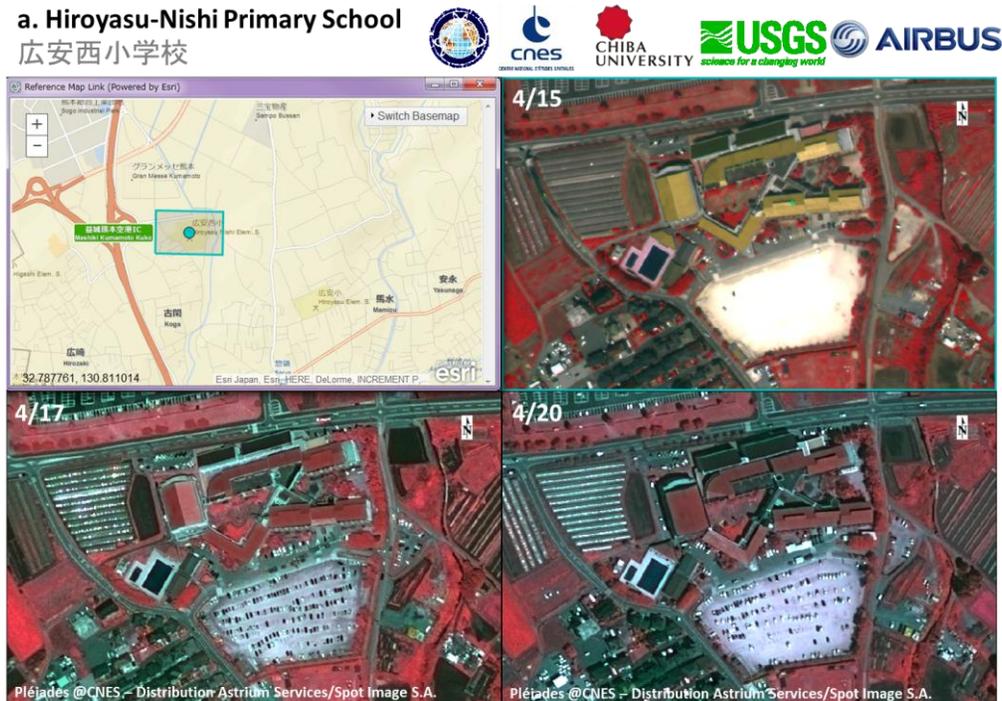
**Figure 8. Comparison of close-ups of VHR optical satellite images for an evacuation site in Mashiki town, produced by Chiba University and provided to the Space Charter.**

An international cooperation scheme for responding major natural disaster was activated soon after the foreshock of the Kumamoto earthquake based on the request of the Cabinet office of Japan (International Charter: Space and Major Disasters 2016). **Figure 8** shows one of the outputs of satellite data analysis which the present authors' group provided to the Space Charter. The figure compares the close-ups of high-resolution optical satellite images for an evacuation shelter in Mashiki town. In this event, a lot of residents in the affected area evacuated to shelters, designated by the local governments. The gymnasiums of public schools and facilities were assigned as shelters, which is the common practice in Japan. Since most people evacuated by car in the rural areas, the number of cars parking on the school ground could be a good estimate for the number of evacuees. In this school, the ground was seen to be full of evacuee's cars for a few days after the mainshock.

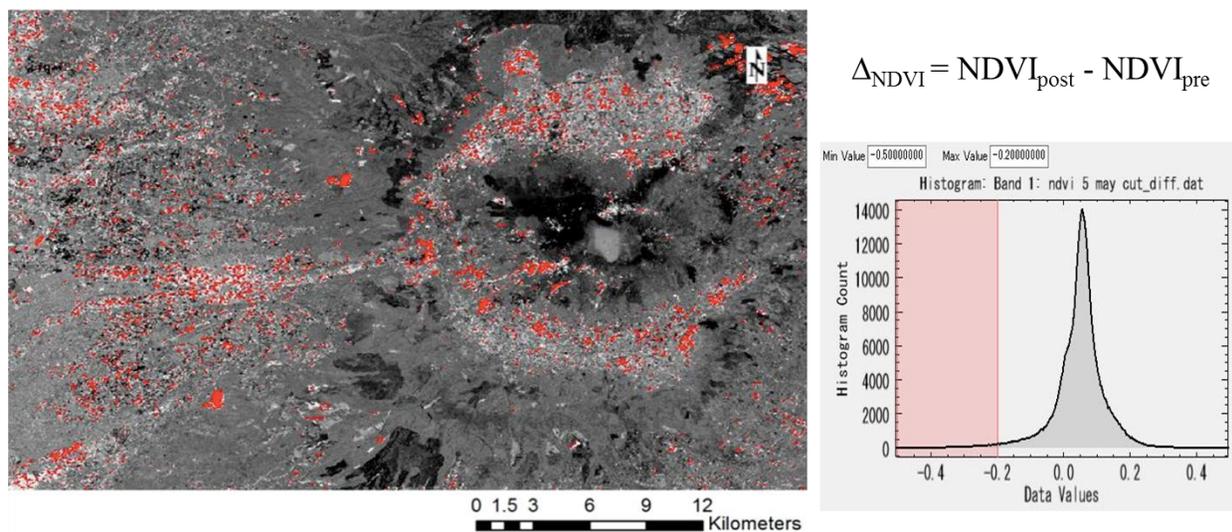
**Figure 9. Extraction of landslides by the difference of NDVI values from Landsat-8 images**

In order to grasp the locations of large scale landslides, moderate-resolution optical satellite images are useful, as demonstrated in case of the 2015 Gorkha earthquake (Tsuchida et al. 2015). For the Kumamoto earthquake, pre-event (2015/05/05) and post-event (2016/5/23) Landsat-8 images were used to extract pixels (15-m square after pan-sharpening), whose surfaces changed from vegetation to soil. The Normalized Difference Vegetation Index (NDVI) was employed to extract vegetated areas by the following equation:

where R and NIR are the reflectance of the red and near-infrared bands, respectively. The NDVI is a simple and reliable index to identify the existence of vegetation, and therefore widely applied to assess the characteristics of the earth surface (Kouchi and Yamazaki 2007). **Figure 9** shows the difference of the pre- and post-event NDVI values for the Kumamoto area. The removal of vegetation by landslides, represented by the reduction of NDVI values, can be observed extensively along the fault line and around the outer rim of Mt. Aso's crater.

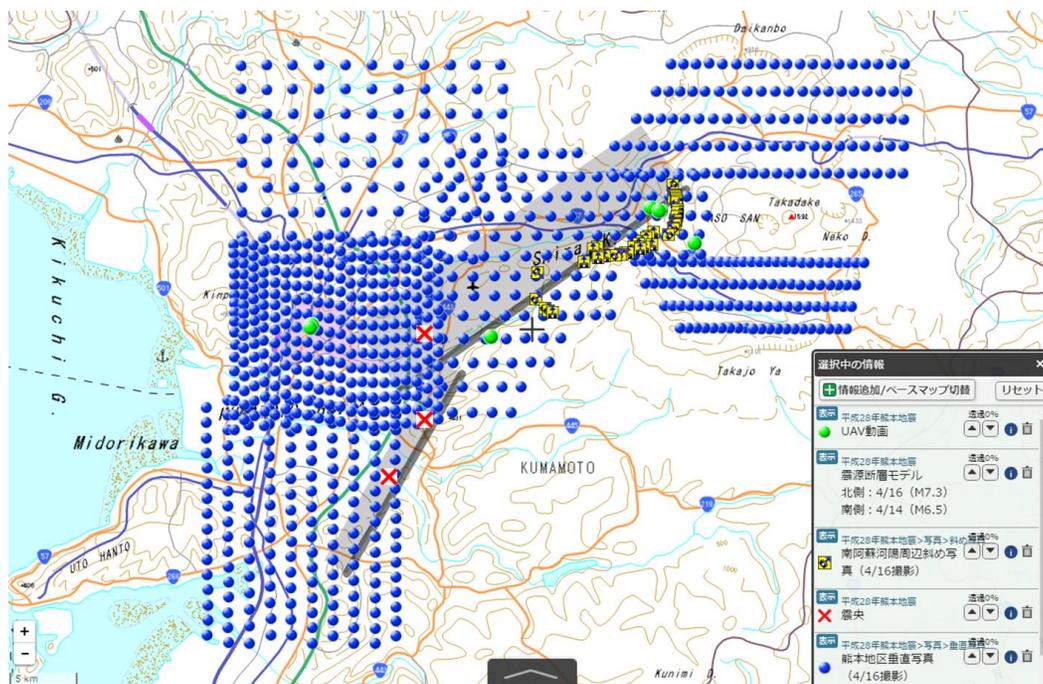
**Figure 10.** Map showing vertical aerial photo shooting points (blue dots), oblique photo shooting points (yellow symbols), and UAV flights (green points) conducted by GSI

From the next morning of the foreshock, a lot of aerial surveying flights were carried out by government agencies and aerial survey companies in Japan. **Figure 10** shows vertical aerial photo shooting points (blue dots) conducted by the Geospatial Information Authority of Japan (GSI) on April 16, 2016 (the day of the mainshock). Many aerial photos were also acquired by GSI on April 15 (after the foreshock) and days after the mainshock.

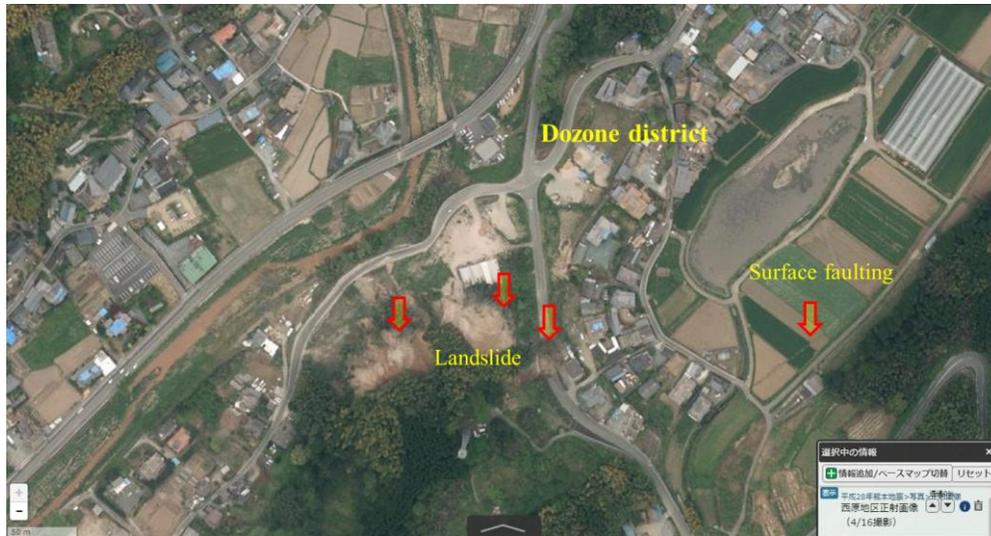
**Figure 11. Orthorectified photo taken on April 16 by GSI over Dozone district. The surface faulting shown in Figure 2 and several landslides can be recognized.**

Orthorectified images were produced from them and all the imagery data have been uploaded on the GSI's web map server (<http://maps.gsi.go.jp/>). **Figure 11** shows an example of orthorectified photos, over the Dozono district in Mashiki town. The surface faulting shown in **Figure 2** can be observed as well as landslides and collapsed buildings.

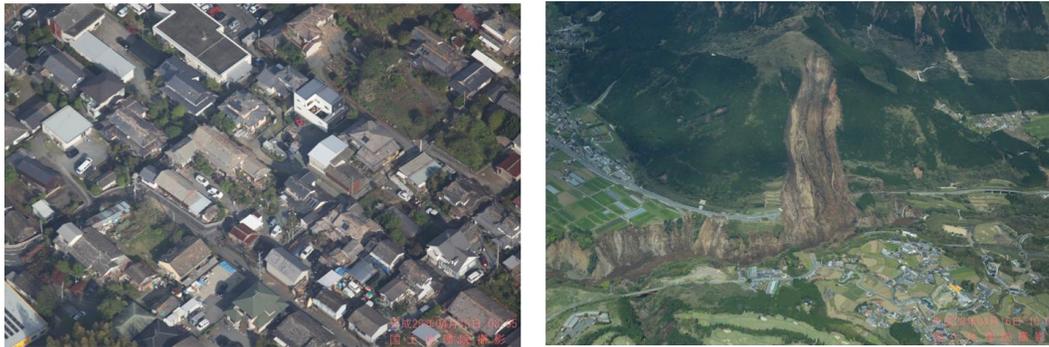
**Figure 12. Oblique photos including collapsed buildings in Mashiki town (left, on April 15) and the largest landslide in Minami-Aso village (right, April 16) taken by GSI (2016).**

Oblique photos were also acquired by GSI at several locations including major damage situations. **Figure 12** shows the photos including collapsed buildings in Mashiki town (on April 15) and the largest landslide in Minami-Aso village (on April 16). These oblique photos can characterize the damage situations well since the 3D information is included.

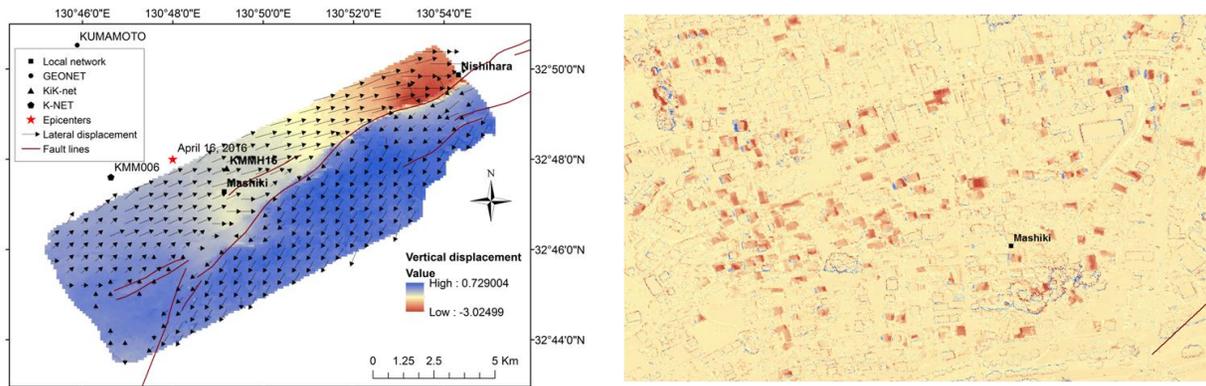
(a) Crustal movement estimated from Lidar data (b) enlargement around Mishiki town hall  
**Figure 13. Detected horizontal (arrow) and vertical (color) displacements between the two Lidar data (a) and its enlargement around Mishiki town hall (b)**

The spatial correlation coefficient of the two Lidar data was calculated using a 101 x 101 pixels window, as described in our companion paper (Moya et al. 2016). The location of the maximum value relative to the center of the window is two pixels (100 cm) to the west and one pixel (50 cm) to the south, which is consistent with the displacement time history calculated from the double integration of acceleration records. **Figure 13** shows the detected horizontal (arrow) and vertical (color) displacements between the two Lidar data (a) and the enlargement around Mishiki town hall (b), in which red color corresponds to the settlements due to building collapse.

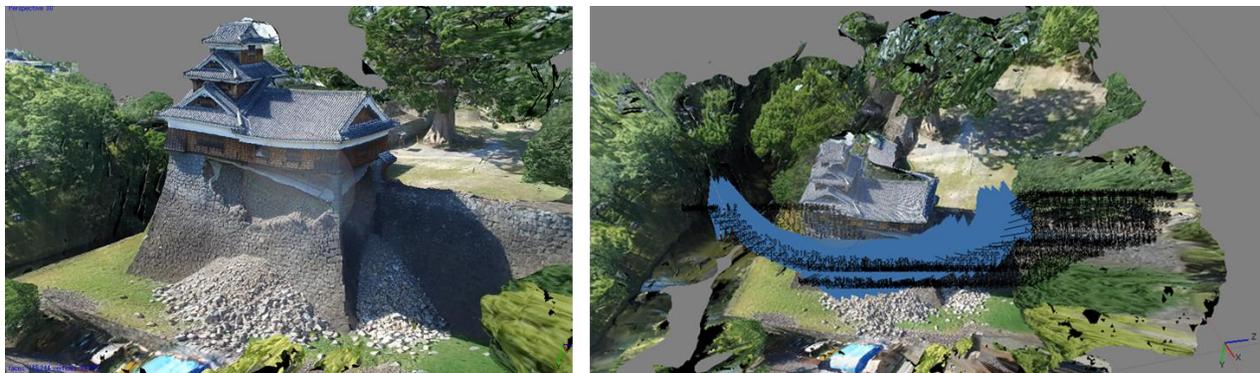
**Figure 14. Developed 3D model of the Idamaru tower of the Kumamoto castle (left) and the estimated camera positions of the snapshots used in the SfM (right, blue squares)**

The GSI engaged in video shooting over disaster affected sites in Kumamoto prefecture, such as the Kumamoto castle and collapsed Aso-Osashi bridge. Using these video footages, the authors' group produced 3D models as shown in **Figure 14**. In the figure, the developed 3D model (left) of the Idamaru tower of the Kumamoto castle and the estimated camera positions (right) of the snapshots used in the SfM (Structure-from-Motion) technique are presented. In the study, the Agisoft's *PhotoScan* software was used for 3D model construction.
