Damage extraction of buildings in the 2015 Gorkha, Nepal earthquake from high-resolution SAR data

Keywords: The 2015 Nepal earthquake, TerraSAR-X, building damage, change detection

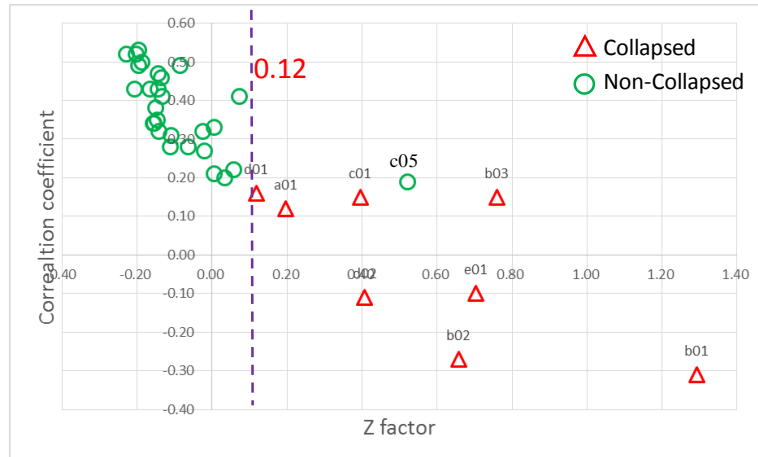
Figure 7. Relationship between correlation coefficient and z-factor of two-temporal sigma-naught values for 36 buildings

The difference of backscatter (the sigma naught value) is reduced because a double-bounce component from the building wall becomes small after the collapse or significant damage [5]. But in some situations, collapsed buildings may return stronger backscatter than intact flat-roofs do. Debris surrounding collapsed buildings also gives stronger backscatter than bare ground does. Considering these situations, the current authors introduced the z-factor, which can cope with both increased and decreased backscatter from severely damaged or washed-away buildings [15]. The relationship between the correlation coefficient and z-factor of the two-temporal sigma-naught values is shown in Figure 7. In this plot, the z-factor for the collapsed buildings are larger than 0.12 while that for non-collapsed ones are less than 0.12 except for one

building (c05). This building is the only outlier in Figure 6 also. Although the building looks like no damage from the vertical optical images, there is a possibility of some changes, especially in its layover area because of the reduced backscattering coefficient. Since the z-factor represents both the difference and correlation coefficient, it was affected by the change in the difference also. On the contrary, this outlier did not affect the correlation coefficient and hence, its threshold was perfect for the training data used in this study.

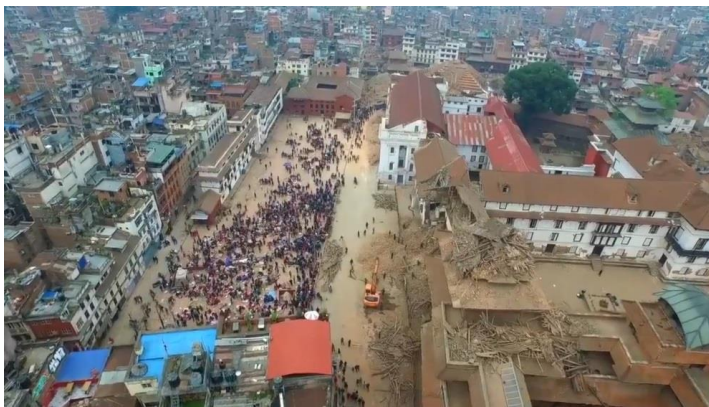
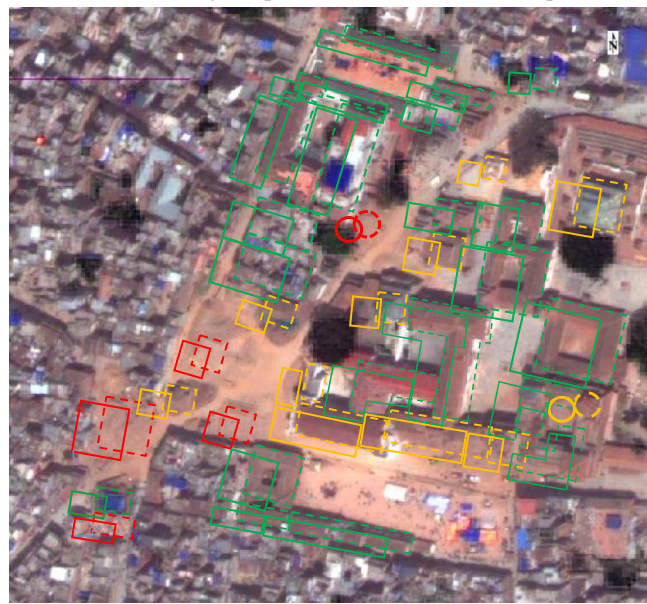
(a) Drone video footage of Durbar Square area

(b) Damage map of monuments in Durbar Square

(c) Pre-event WV3 image with reclassified damage level

(d) Post-event GE1 image with reclassified damage level

Figure 8. Truth data of building damage in Kathmandu Durbar Square. A snapshot of drone video footage (a), damage map of monuments by Kathmandu city government (b), the pre-event WorldView-3 (c), and the post-event GeoEye-1 images (d) of the Durbar Square with reclassified building damage level.

The threshold values to extract individual collapsed buildings were tested for the area that was not used to determine these values. "Durbar Square" means plazas and areas opposite the old royal palaces in Nepal. Three Durbar Squares, Kathmandu, Patan, and Bhaktapur, are located in the Kathmandu valley, and all the three have been designated as the world heritage site out of seven monument zones in the Kathmandu valley. Since Hanuman Dhoka (Kathmandu) Durbar Square is the most famous tourist site in Nepal, mass media broadcasted the damage situation of this site frequently. A video taken from UAV [18] showed the damage situation of the Durbar Square quite well, as shown in a snapshot in Figure 8 (a). Using the video footage, we developed a 3D model of this area with the aid of Agisoft's *PhotoScan* software [19]. Another reason of selecting this site for validation is that a damage situation map of the monuments in the square, shown in Figure 8 (b), was found in the field survey trip in September 2015 by the third author. This map was made by the local government, and three damage levels, *totally damaged*, *partially damaged*, and *safe monument*, were assigned.

The close-up of this area from the pre- and post-event high-resolution optical images is also shown in Figure 8 (c) and (d). From these vertical optical images, damage situations of some "totally damaged" buildings are not easy to recognize. Using also the aerial video footage and the photos taken from the ground, the "totally damaged" buildings were reclassified into two levels, collapsed (5 buildings, red) and major damage (11 buildings, yellow), as shown in Figure 8 (c) and 8(d). From the structures in the palace and buildings facing to the square, 22 minor-damaged buildings were also assigned as in green frames. A total of 38 buildings were used from the validation of the damage extraction method.
