## **REMOTE SENSING TECHNOLOGIES FOR EARTHQUAKE AND TSUNAMI DISASTER MANAGEMENT**

**Fumio Yamazaki and Masashi Matsuoka**

**ABSTRACT:** This paper highlights the use of remote sensing technologies in disaster management, notably post-earthquake/tsunami damage detection due to the 2003 Bam Earthquake and the 2004 Indian Ocean Tsunami, and seismic risk assessment based on land use classification in Metro Manila, the Philippines. QuickBird (QB) images taken before and after the 26 December 2003 Bam Earthquake were used in visual damage interpretation based on the European Macroseismic Scale (EMS-98) building by building. An automated damage detection method was also applied to the post-event Ikonos and QB images. The results of these damage inspections were compared with field survey data and the accuracy and limitation of visual and automated damage detections were presented. QB images and GPS-synchronized photo/video were employed in the damage survey after the 2004 Indian Ocean Tsunami in the south Thailand. Terra-ASTER images were also used to identify tsunami inundation areas comparing the pre-event and post event images. For demonstrating the use of satellites images to urban

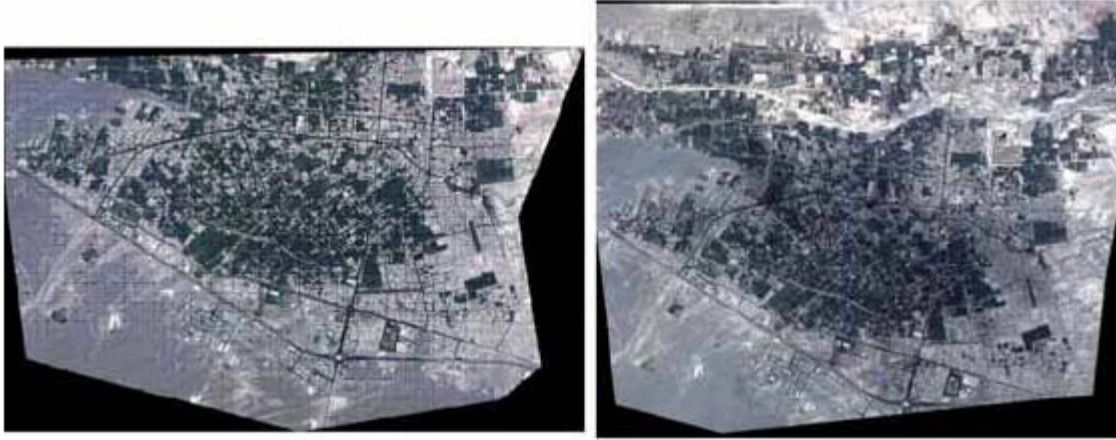
**Figure 1. Pan-sharpened natural color QuickBird images of Bam City captured on 30 September 2003 (left: pre-event) and on 03 January 2004 (right: post-event)**

In order to observe target areas in a short time interval, QB can change the view angle of its sensors. Thus, the two images of Bam have different off nadir view angles: 10 degrees (pre-event) and 24 degrees (post-event). Hence it is not so easy to superimpose these images exactly and to perform automated change detection. The difference in building

shadow and vegetation in the different acquisition date images gives additional difficulty. Thus visual damage interpretation was performed first. Pan-sharpened images were produced by combining panchromatic images of 0.6m resolution and multi-spectral images of 2.4m resolution, as shown in Figure 1. By this image enhancement, buildings, cars and debris can clearly be seen.

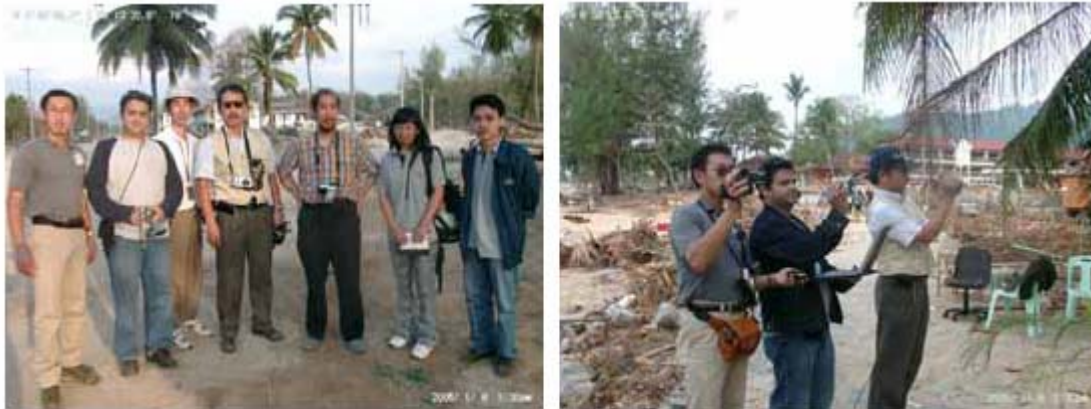
**Figure 8. (a) Members of the international survey team and (b) panorama-VIEWS shooting in the field survey of south Thailand by 3 videos**

Honzawa). The primary objective of our survey is to gather geo-referenced tsunami inundation and damage information, and hence we brought several digital video cameras and digital still cameras. Figure 8(b) shows a scene of geo-referenced video shooting using three video cameras. The field survey was carried out from 8 to 11 January 2005, covering hard-hit areas, e.g. Khao Lak, Phuket Island, Phi Phi Island. Please refer the survey reports in Ghosh et al. (2005) and Yamazaki et al. (2005).

In this tsunami survey in Thailand, the field-based damage assessment was conducted using VIEWS. These ground-based observations can be later used to validate damage characteristics identified on satellite imagery. It is envisioned that such perishable data will be invaluable for

future research in evaluating damage from tsunami hazards. We brought several video cameras in our field survey in Thailand. Thus, a new data collection approach was adopted (Figure 8(b)) by deploying three video cameras that simultaneously captured footage for three directions (front, left, and right) in some heavily affected areas. This streamlined the video collection process and provided a wider view of the area. We named this new system as “Panoramic-VIEWS”.

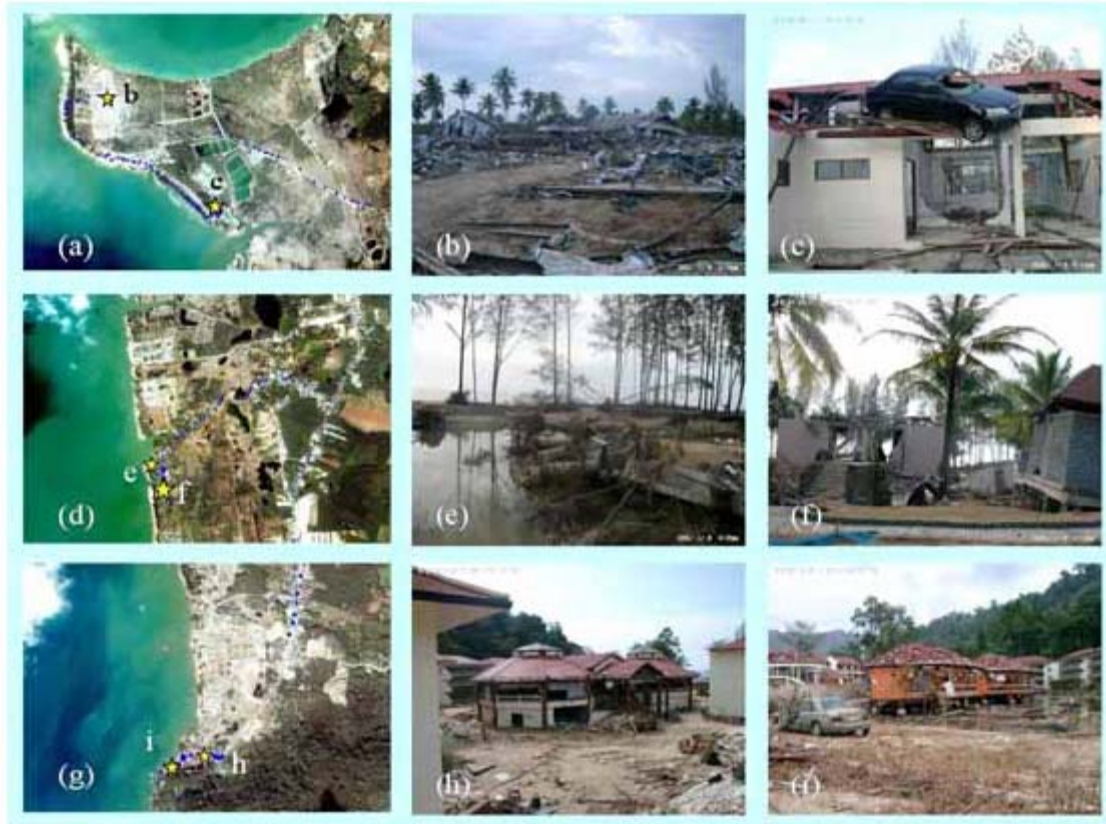
**Figure 9. Post-tsunami Ikonos image of Khao Lak and photos taken during the field survey. Blue dots show the location of geo-reference photo shooting. (a) Phakarang cape area, (b) devastated Bamboo Orchid Resort on Phakarang cape, (c) a car on the roof, (d) mid Khao Lak area near Weather Station, (e) a collapsed bridge by tsunami, (f) destroyed cottages in a resort, (g) Nang Thong Beach area in lower Khao Lak, (h) & (i) Similana Resort devastated by tsunami**

Figure 9 shows the post-tsunami Ikonos images of Khao Lak and photos taken during the field survey. Blue dots in Ikonos images are the location of geo-referenced photo shooting. Figure 9(a) is Ikonos image of Phakarang cape area with 1m resolution, (b) is the photo of devastated Bamboo Orchid Resort on Phakarang cape, (c) shows a car thrown on the roof by tsunami. If we enlarge the Ikonos image, several black pixels corresponding to this car can be identified. Figure 9(d) is Ikonos image of mid Khao Lak

and (f) shows destroyed cottages in a resort. Figure 9 (g) shows Nang Thong Beach area in lower Khao Lak, and Figures 9(h) and (i) are photos taken in Similana Resort, which was devastated by tsunami of about 5m high.

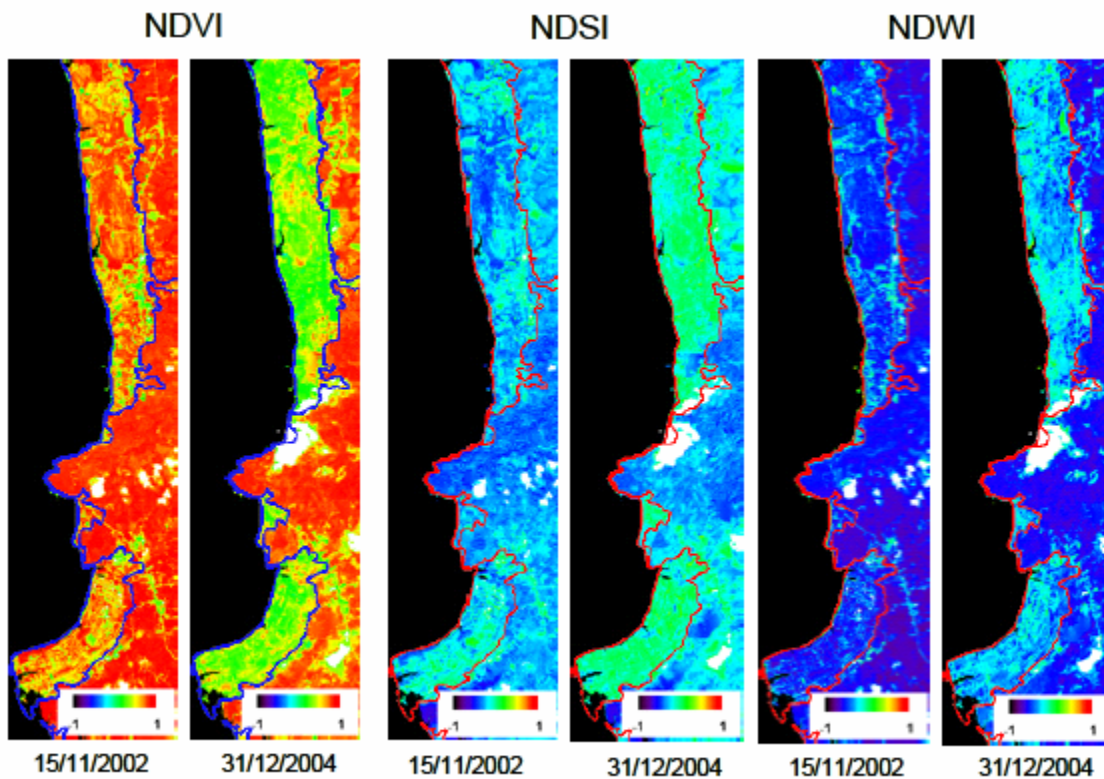
**Figure 12. Thematic maps of NDVI, NDSI, and NDWI**

The thematic maps of NDVI, NDSI, and NDWI are shown in Figure 12. The greater NDVI becomes, the more probable it is that the area is covered with vegetation. It is also the case with NDSI for soil and NDWI for water. The results demonstrate clear difference in the indices for the affected areas before and after the tsunami and difference between the affected areas and the other areas after the tsunami. These differences could be good indicators of tsunami inundation. Hence, the analysis on the characteristics of the indices depending on damage states is important for considering the applicability of these indices to tsunami damage detection.

Obtaining the distribution of the three indices in the affected areas and the other areas from the data acquired after the tsunami, the ranges of indices that characterize the damage were evaluated. Based on the change of each index before and after the tsunami, the areas affected by the tsunami were identified in the companion paper (Kouchi et al. 2006), after removing the effects of shadow by clouds. The identified areas are in good agreement with the visually detected areas from the pre-event and post-event Ikonos images (Vibulsreth et al. 2005). Although the identified areas include some man-made changes in the period, it can be concluded that moderate-resolution optical satellite images are quite useful to identify tsunami inundation areas.

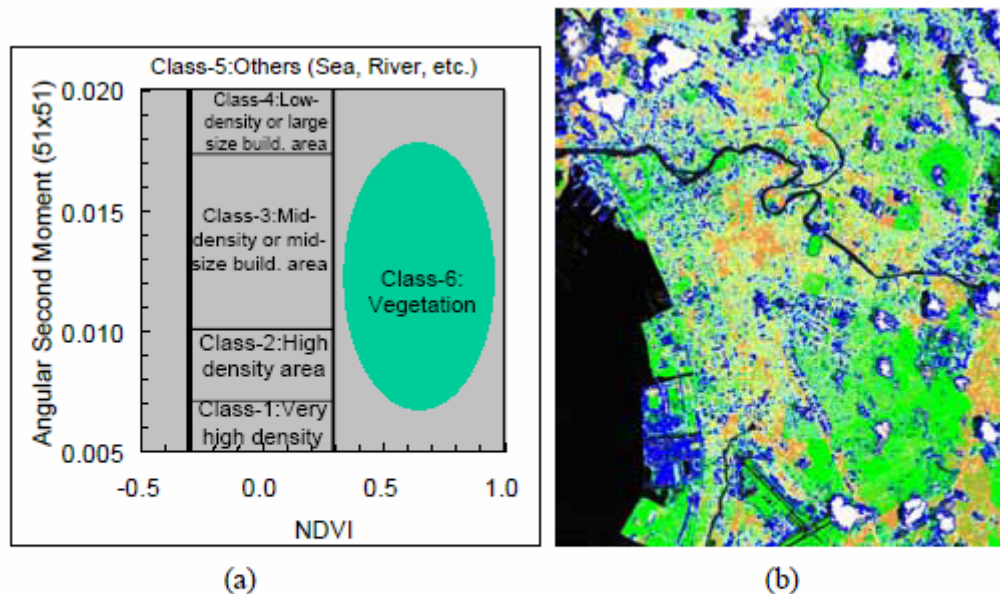
**Figure 15 (a) Urban classification in terms of NDVI and texture used for the level slice method and (b) result of microscopic classification in Old Manila using pansharpened Ikonos Image; orange: very high-density area, yellow: high-density area, light blue: mid-density or mid-size building area, blue: low-density or large size building area, green: vegetation area, and black: others.**

The classification category for the Ikonos image was determined as shown in Figure 15(a) based on a scatter diagram for NDVI and  $T_a$  for training data. Then the level slice classification was carried out and the result is shown in Figure 15(b). It is seen in the figure that many high-density areas with low-rise buildings exist in the east and southeast of Old Manila, such as Pandacan and San Andres. Commercial areas with moderate size buildings locate in the south of Chinatown. The result for low-density or large-scale building areas, such as Makati and Mandaluyong, seems to be relatively in good agreement with the actual situation. On the whole, the result is relatively in good agreement with the actual built environment, except for the areas affected by clouds.
