A CHARACTERIZATION OF SAR IMAGES IN THE 2009 L'AQUILA ITALY EARTHQUAKE

Keywords: The 2009 L'Aquila Earthquake, SAR imagery, Damage detection

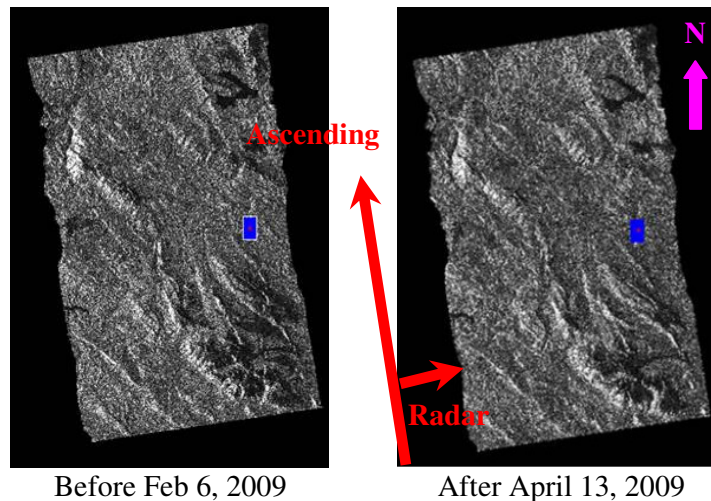
Fig. 3: SAR data of L'Aquila area (the blue portion is the area of concern)

Data employed in this research is from the TerraSAR-X (X- band) satellite system. This X-band data has the wavelength of 3.1 centimeter with the frequency of 9.6 Gigahertz. Data include one pre-seismic data (Feb 6, 2009) and other post-seismic (April 13, 2009) as shown in Fig. 3. Acquisition mode of these data is strip with polarization HH (single). Incidence angle is 39.2 degree. The path of satellite is ascending with right look. These images have spatial resolution of 1.25 meter. The employed data was standard product (2A) and it was radiometrically corrected, sensor corrected, geometrically corrected and mapped to a cartographic projection by the data provider.

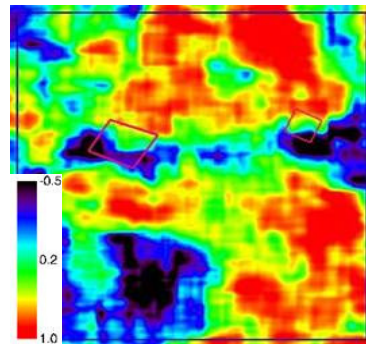
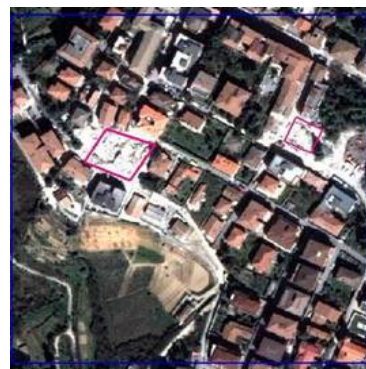
(a) Color Composite

(b) Correlation

(c) Difference

(d) QuickBird (2009.4.8)

Fig. 8: Correlation and difference map of a damaged area corresponding to the area (iv) in Fig.6

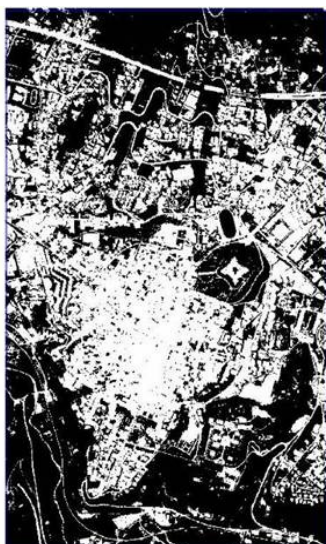
(a) SAR 2009.4.13
 $r \leq 0.3$

(b) 2009.4.8
 $NDVI \leq 0.16$

(c) Overlay of
correlation over NDVI

Fig. 9: NDVI and correlation map of L'Aquila area

We also used the post event QuickBird optical image (multispectral, four bands) to calculate normalized density vegetative index (NDVI). We also prepared images from low correlation values ($r \leq 0.3$) and low NDVI values (≤ 0.16) as seen in Fig. 9(a) and 9(b).
