# Development of automated extraction method for building damage area based on maximum likelihood classifier

Hajime Mitomi, Fumio Yamazaki & Masashi Matsuoka  
*Earthquake Disaster Mitigation Research Center, RIKEN, Japan*

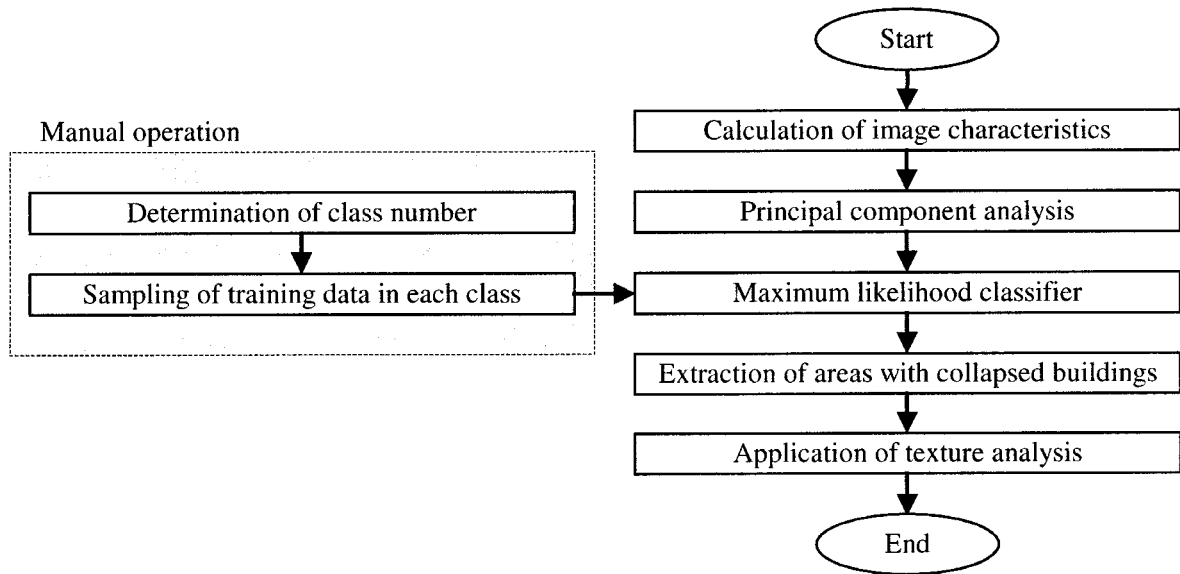
Figure 1. Flowchart of the method proposed in this study.

Figure 1 shows the flowchart for this method. After a linear conversion, rationing and HSI transformation were performed on each input image, the characteristics of damage to wooden buildings were defined based on hue, saturation, brightness, edge intensity and variance of edge intensity. Color indices were not averaged by 7 x 7 pixels as done in the previous studies, because features of each input image should be maximally reflected. The edge intensity was calculated by a general gradient filter with a 3 x 3 pixel window. The variances in the edge intensity were evaluated for the area of 7 x 7 pixels.

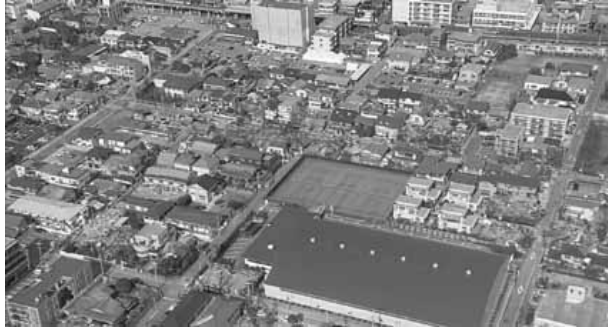
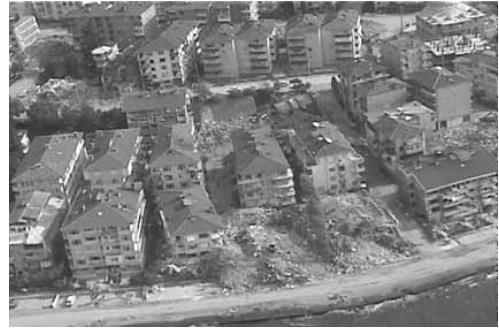
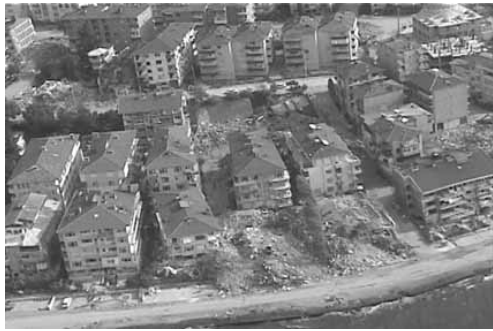
Kobe HDTV image (Nishinomiya)

Turkey television image (Golcuk)

Taiwan HDTV image (Chungalio)

Figure 2. Images used in this study.

The Kobe, the Kocaeli, Turkey and the Chi-Chi, Taiwan earthquakes occurred on January 17, 1995, August 17, 1999 and September 21, 1999, respectively. Aerial imaging of areas damaged by the Kobe earthquake was started shortly after the event by the Japan Broadcasting Corporation (NHK). The Japanese Geotechnical Society took images of stricken areas a few weeks after the Turkey earthquake using a digital video camera from a helicopter. Two and four days after the Taiwan earthquake, NHK obtained images of severely damaged areas using a HDTV camera from a helicopter. In this study, we used images taken at Nishinomiya after the Kobe, Golcuk after the Kocaeli, Turkey, and Chungliao after the Chi-Chi, Taiwan earthquakes, which had suffered severe earthquake damage. These images are shown in Figure 2. Table 1 shows the results of the principal component analysis to each input image. Hue was the most influential characteristic of the five factors used for automatic detection of building damage. The cumulative variance from the first to the third principal component was more than about 90% in all input images, but the edge intensity and its variance make almost no contribution to the images. Some training data were determined as a

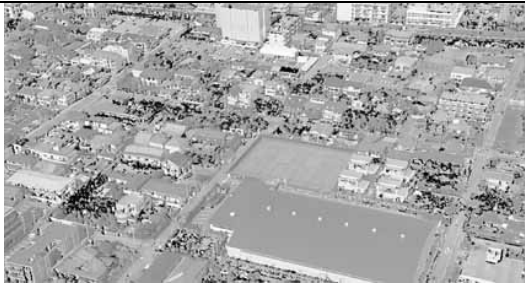
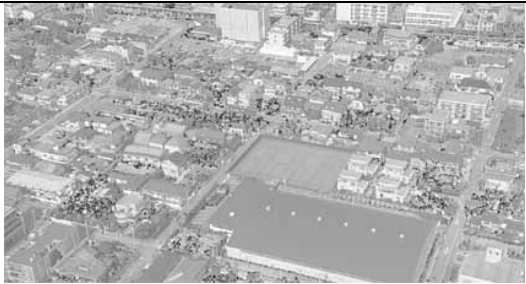
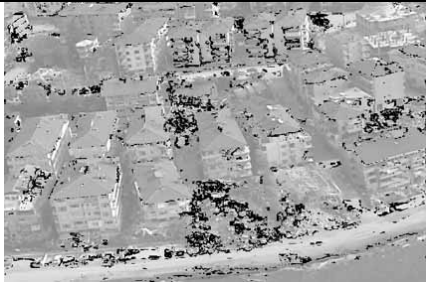
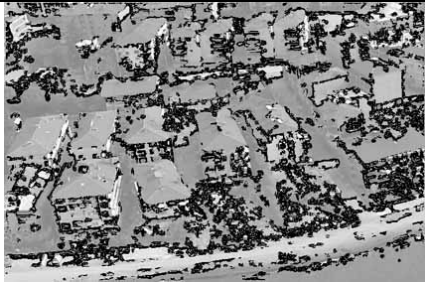
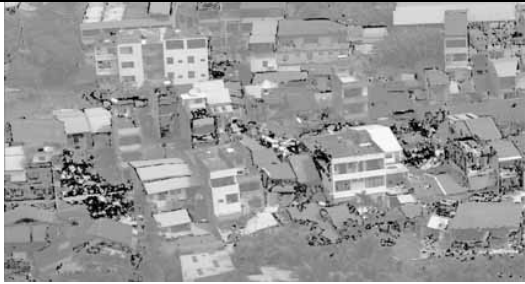
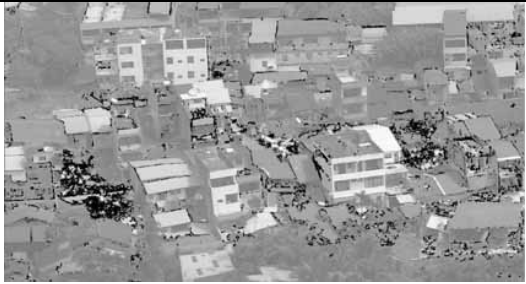
Class-1 areas derived in this study	Results of previous studies
Kobe HDTV

Figure 3. Comparison of the results of application of the maximum likelihood classifier and those by previous studies

buildings had a  $Dr$  value ranging from 60 to 80%. However, some classes had a low ratio because of misreading, since a pixel should be assigned to some class according to the maximum likelihood classifier. The distribution of class-1 by the maximum likelihood method and the results of the previous studies are shown in Figure 3. The results of this study seem to be clearer than those of the previous studies and are in good agreement with the actual situation. However, in the Turkey image, parts of class-1 were misread as class-2 because characteristics of class-1 were similar to those of class-2, and the classification of class-1 to class-2 was analogous to that of the previous study.

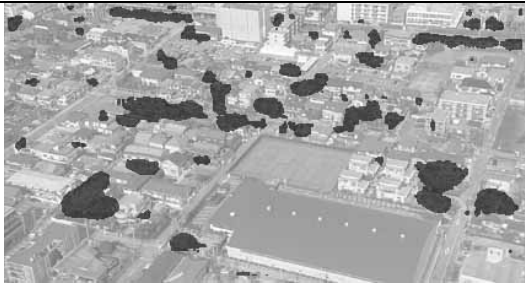
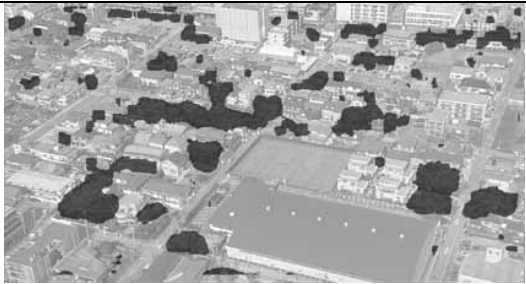
Class-1 areas derived in this study	Results of previous studies
Kobe HDTV

Figure 4. Comparison of the results of application of texture analysis and those by previous studies.

A spatial filtering operation may be necessary to decrease surplus pixels and make areas with building damage easy to understand. In the previous study, the local density of the selected pixels was calculated by a texture analysis. In the Kobe HDTV image, 31 x 31 to 63 to 63 pixel windows were selected to be proportional to the image scale, depending on the location of the area. The pixel

blocks whose density values were smaller than 14%, and larger than or equal to 14% were assigned as belonging to undamaged and collapsed buildings, respectively. A 31 x 31 pixel window as the minimum size applied to the Kobe image was used in the Turkey and Taiwan images, then, threshold values for the texture analysis were set to 43% and 30%, respectively.

In order to detect areas with building damage, the window size and threshold value for the texture analysis must be established in advance. As the window size corresponding to one building generally depended on factors such as the resolution of the image and built environment, each window size was decided based on the same method as for the Kobe image. It was changed from 57 x 57 to 83 x 83 pixels for the Turkey image, and set at a constant of 83 x 83 pixels for the Taiwan image. The threshold value between damaged and undamaged building areas was tentatively considered as 20% in all images. Figure 4 represents preliminary results from this study and from the previous studies. It is interesting that the distribution of areas with building damage in this study was in good agreement with the actual areas with building damage in spite of applying a common threshold value, 20%, in all images. We can hence obtain a good distribution of areas with building damage for every image using a constant threshold value for texture analysis, if we determine the window size to correspond to one building for every image.
