Use of digital aerial camera images to detect damage to an expressway following an earthquake

Yoshihisa Maruyama & Fumio Yamazaki

Department of Urban Environment Systems, Chiba University, Chiba, Japan.

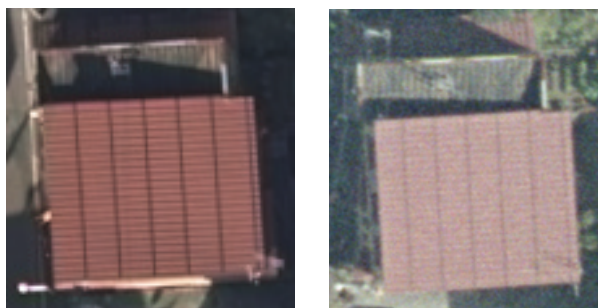
(a) Digital aerial image (108×113 pixels) (b) Analog aerial photo (167×187 pixels)

Figure 1. Comparison of (a) digital and (b) analog aerial images captured after the 2004 Mid-Niigata earthquake.

Figure 1 shows the roof of a wooden house captured by both digital and analog aerial cameras in Kawaguchi town, Niigata, which was subject to severe ground motion during the Mid-Niigata earthquake (Honda *et al.* 2005). The Geographical Survey Institute, Japan, took analog aerial photos on the morning of October 24, 2004 (one day after the earthquake) and Asia Air Survey Co., Ltd. obtained digital aerial images using DMC on the afternoon of the same day. Some salt-and-pepper noise is present in the analog aerial photo although there are more pixels than in the digital image. Figure 2 shows the histogram of pixel values of the two images in Figure 1. The pixel values of the digital aerial image are distributed from about 25 to 200 without any gaps, whilst those of analog image show discontinuities

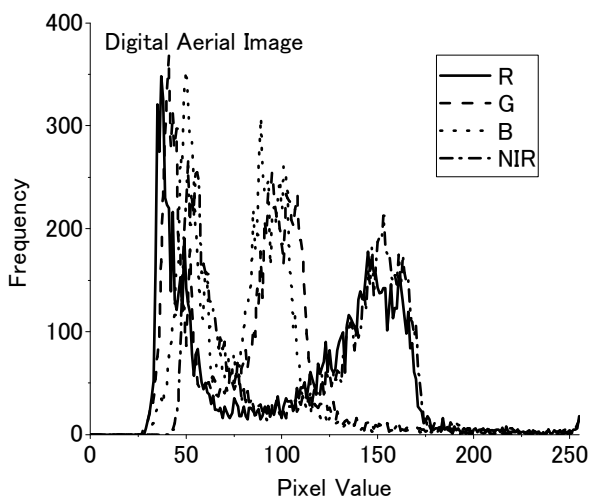
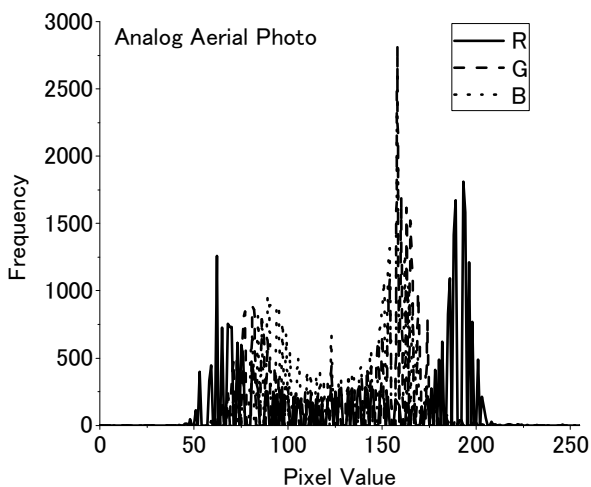
Figure 2. Histograms of pixel values of (a) digital and (b) analog aerial images shown in Figure 1

due to analog-digital conversion. The discontinuous distribution of pixel values results in a smudged appearance of the image.

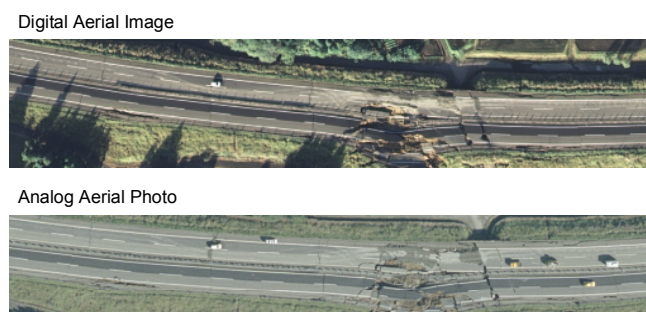
Figure 4. Comparison of the (a) digital and (b) analog aerial images showing the damaged section of the expressway.

Figure 4 shows the damaged section of the expressway captured by digital and analog aerial images following the 2004 Mid-Niigata earthquake. Assuming the availability of proper training data, a conventional pixel-based classification was carried out based on the maximum likelihood method, the most common supervised classification method. Figure 5 shows the classification results for the two images. Salt-and-pepper noise was still present after processing the analog photo, but less noise was present in the processed digital aerial image. Detection of vegetated areas was simple for the digital image because it has a NIR band.

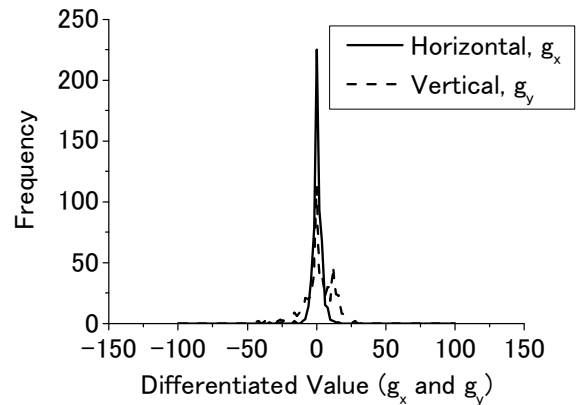
Figure 9. Histogram of differentiated values for horizontal and vertical directions obtained from the road surface of the digital aerial image.

where g_x and g_y are horizontally and vertically differentiated values, respectively, and c is the threshold value to identify the road surface, which is set at 25 (Figure 9).

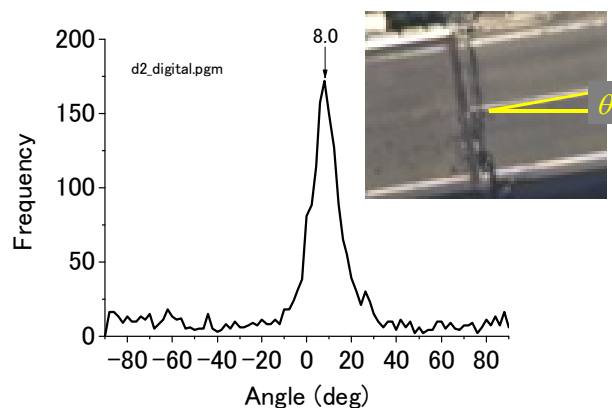
Figure 10. Histogram of edge angles obtained from the digital aerial image.

The direction of the road angle was determined from the histogram of the edge angles (Figure 10). If the edge angle was in a range of ten degrees centered at the mode, the pixel was considered to be a road component, such as the centerline.

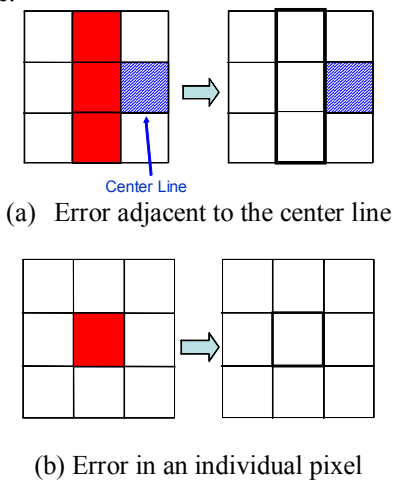
(a) Error adjacent to the center line

(b) Error in an individual pixel

Figure 13. The rules to reduce error in the detection of damage (a) adjacent to the center line and (b) in individual pixels.

an edge angle perpendicular to the road angle. To reduce these errors, two rules were applied in image processing, as shown in Figure 13. Firstly, if the pixel lay beside the centerline, it was not regarded as road damage (Figure 13(a)), and secondly, if only one pixel was recognized as damage in a 3 x 3 pixel window, the result was assumed to be an error (Figure 13(b)).

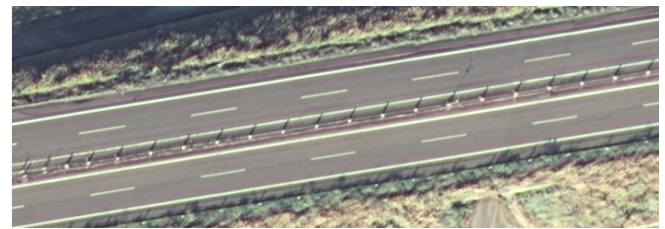
(a) Original digital aerial image

(b) Result of image processing

Figure 14. The result of image processing for non-damaged section of expressway. The blue pixels show the result of image processing before removing the errors and the red pixels are obtained after removing the errors.

The effects of these rules were assessed through a series of image processing performed on a non-damaged section of the expressway. Figure 14 shows the original digital aerial image and the result of image processing. The blue pixels were misinterpreted as damage before the errors were removed. The red pixels show the result of image processing after applying the two rules. Some errors remain, however, the rules are effective in improving the accuracy of the result.

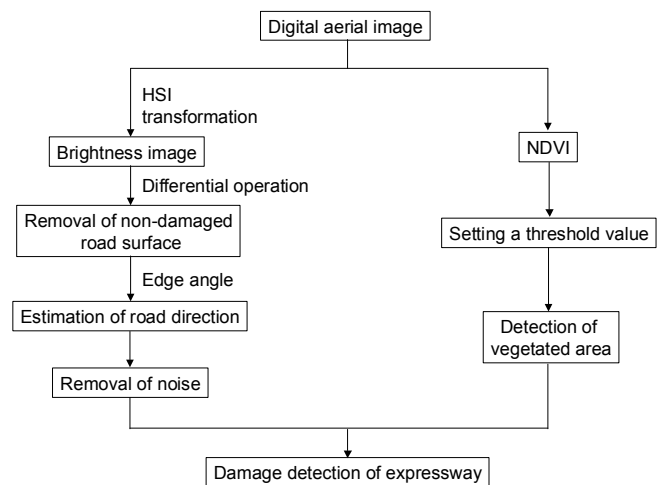
Figure 15. Flowchart of proposed method for detection of expressway damage using digital aerial images.

An extended analytical procedure for the detection of expressway damage using digital aerial images is proposed, based on the methods presented in the previous section. Figure 15 shows a flowchart describing the automated damage detection technique.

The median filter was not used in the image processing of the digital aerial image, instead, the errors adjacent to the centerlines and in individual pixels were identified according to the rules given above, and included in the procedure shown in Figure 15. Figure 17 compares the result of image processing with that of visual damage inspection. Almost all damaged sections of the expressway were properly detected through the series of image

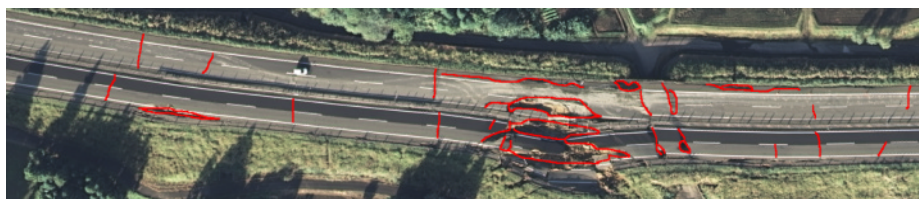
(a) Result of image processing

(b) Result of visual inspection

Figure 17. Comparison of the results of (a) image processing of the digital aerial image and (b) visual damage inspection. Damage to the expressway is shown in red.
