RECONNAISSANCE REPORT OF
PAKISTAN-AFGHANISTAN EARTHQUAKE ON FEBRUARY 1, 1991

MALIHA FATIMA
Graduate Student
Institute of Industrial Science
University of Tokyo
7-22-1 Roppongi, Minato-ku,
Tokyo 106, JAPAN

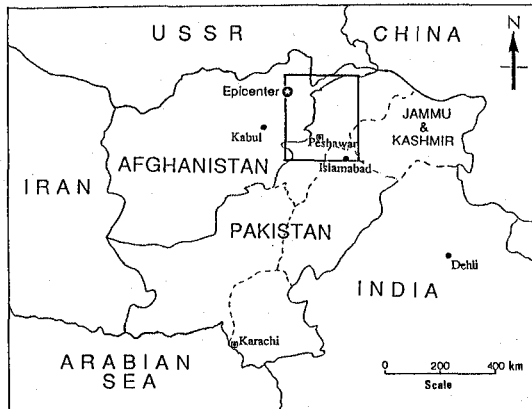
On February 1, 1991, an earthquake with the magnitude 6.8 on the Richter scale had hit northern parts of Pakistan. The epicenter was located in the Hindukush range at 36.2° N and 70.2° E with a focal depth of 125 km. It was severely felt in the North-west Frontier Province (NWFP) of Pakistan, Afghanistan and Soviet Central Asia. It also shook northern Iran, central Pakistan and northern India (Fig. 1).

Fig. 1 Epicenter and the surrounding areas

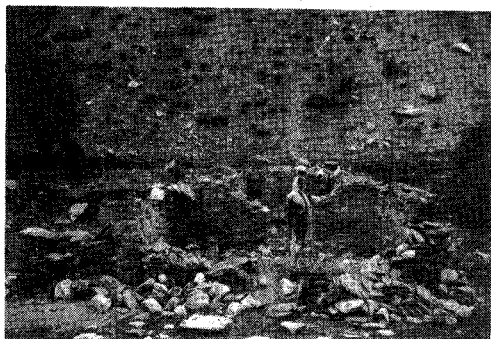
Photo 1 Collapsed dry masonry wall

reinforced with straw, in-place erected clay walls, wall erected by slate like stones without any mortar (Photo 1), round stone wall with or without mortar, block or irregular shaped stones embedded in clay mortar without any plaster (Photo 2), or by constructing the wall partially with stones and partially with clay, etc. The thickness of the walls varies from 400 to 600mm. The survey was conducted after three months of the disaster. Some of the damaged houses were already reconstructed or repaired by that time but still damaged structures can be well speculated.

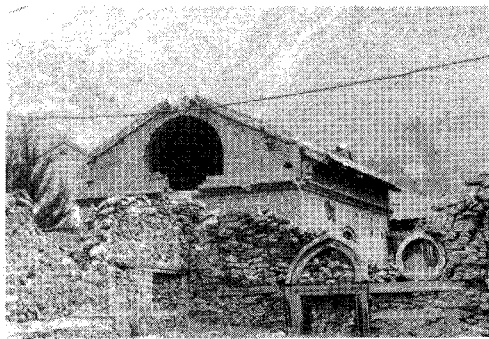
Photo 2 Different types of construction

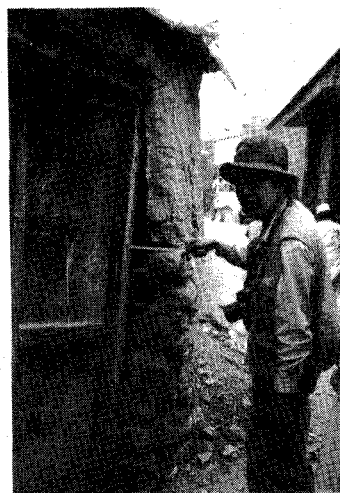
The Kucha type of construction received the majority of damage from complete collapse to minor damage. In most cases, the houses collapsed when the earthquake struck. However, in some cases they received major damage and came down afterwards when the rains had started. The main causes for the damage were the heavy weight, very low tensile and shearing stresses, weak connection between the walls and roof and wall.

One of the failure patterns of walls seems to be shear failure (Photo 3).

Photo 3 A wall failure mode

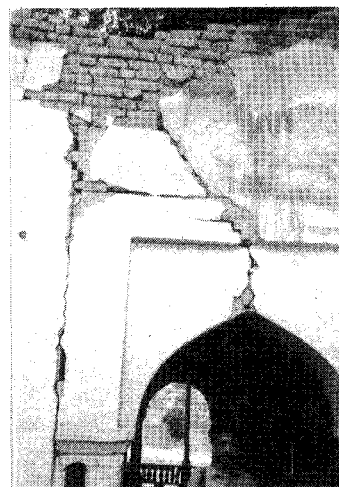
The standard of construction around the city is comparatively good with 30% by Pucca. About 20% of Pucca buildings have received non-structural damage like wide diagonal cracks in the masonry (Photo 4), falling down of parapet wall, spalling of plaster, damage to roof chimneys, collapse of boundary walls, etc. Some of the old constructed houses had been rather severely damaged.

Photo 4 Old Fort, Chitral

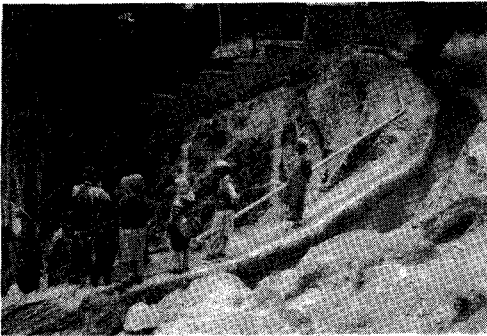
The Kucha buildings in this vicinity are made mainly from clay blocks or stones embedded in mud mortar with horizontal timber reinforcement at regular intervals. About 90% of such type of construction had received some damage with 20% totally collapsed. In a village near to the city area, houses were built on a man-made terrace. Out of 260 dwellings, 26 were completely destroyed and 160 had received major damage (Photo 5,6).

Photo 5 Village built on hillside, Chitral

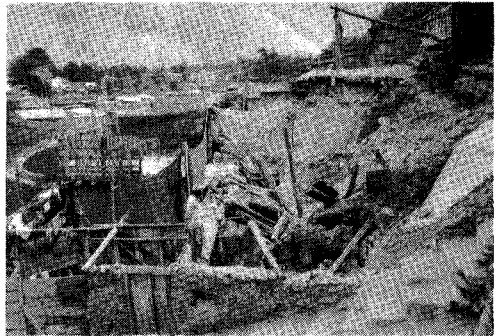
Photo 6 26 houses collapsed in this village

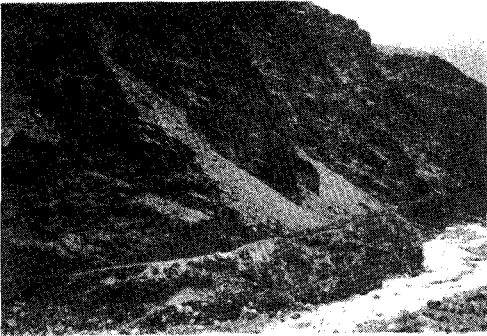
Ayun is a village located about 20 km southwest of main Chitral. The intensity felt was IX in MM scale, with 90% damage to the Kucha and 20% damage to the Pucca buildings. Excessive rockslides took place around Ayun and in the Kalash valley (Photo 7,8). Afghan refugees' dwellings also received considerable damage in this area.

Photo 7 Rockslide in the Kalash valley

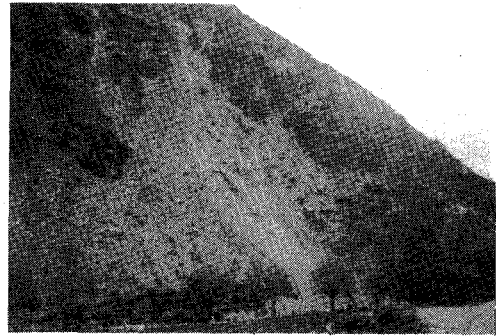
Photo 8 Rockslide near Ayun

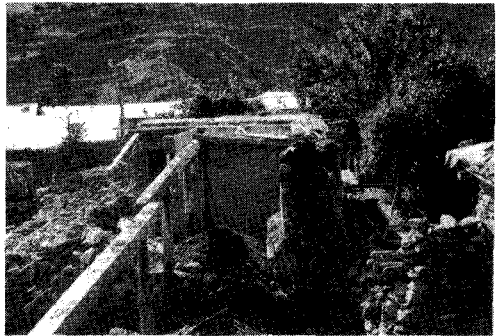
Drosh is located 30 km south of Chitral. The intensity was IX in the MM scale, 90% of Kucha buildings and 15% of Pucca buildings were damaged. Most of the Kucha buildings are made from irregular shaped stones with or without mud mortar (Photo 9). Among the Pucca buildings, the Meteorological observatory building was partly damaged with the retaining wall totally destroyed. The Civil hospital also received non-structural damages like spalling of plaster, wide cracking in the masonry and collapse of internal walls.

Photo 9 Collapsed house in Drosh

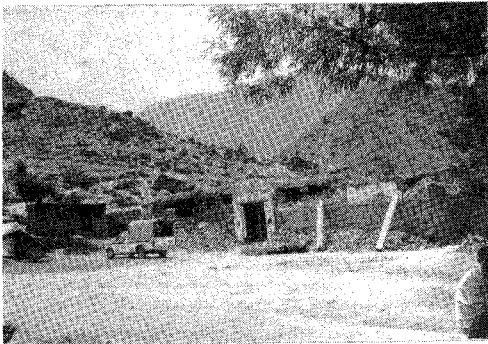
Photo 10 Damaged police station, Arandu

afterwards due to major damages. The police station building also collapsed (Photo 10). The boundary wall of a hospital, which was built from rectangular shaped stone blocks embedded in cement mortar fall down (Photo 11). A village having 300 dwellings was completely razed to the ground (Photo 12). A number of slides were found on the mountain jeepable trail leading to the place (Photo 13).

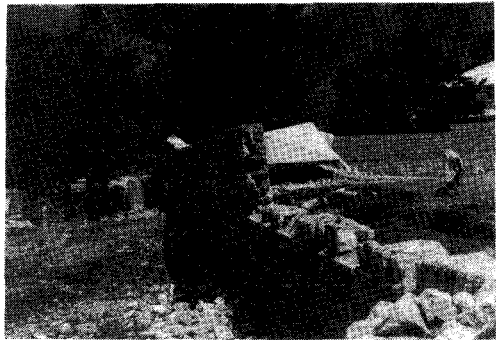
Photo 11 Blocked stone boundary wall, Arandu

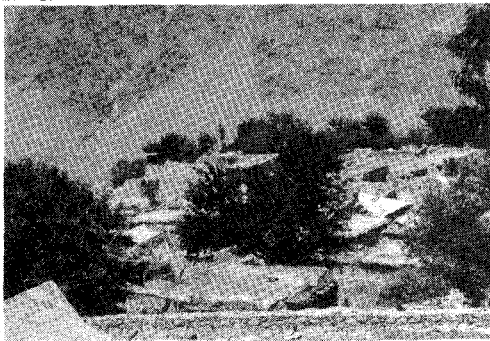
Photo 12 Aradu, reconstructed village

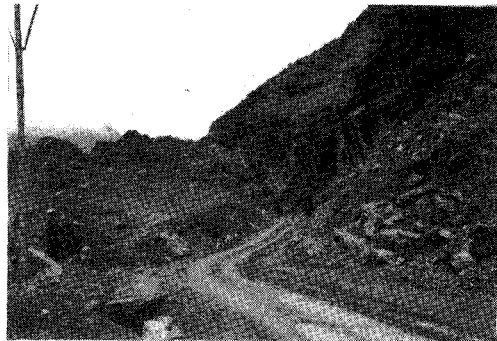
Photo 13 Rockslide on way to Aradu

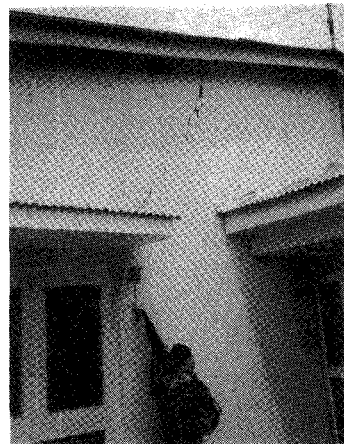
In the walls of the Governor House by Pucca, cracks developed with spalling of the plaster (Photo 14). Most of the damage in upper Chitral were due

Photo 14 Governor House, Gram Chashma

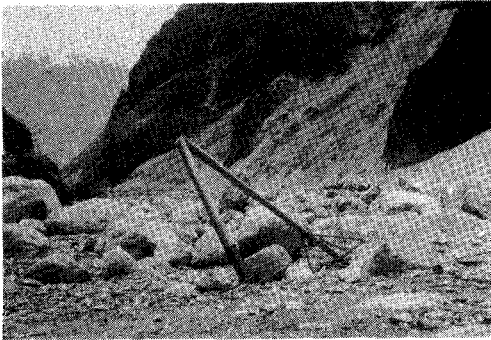
Photo 15 Fallen pole hit by boulder

to rockfalls from the steep valley. In many instances, large boulders fell on the roofs of the houses which had suffered no structural damage by ground shaking (Photo 15,16). The structures destroyed by shaking were mostly built of dry masonry with walls more than half meter thick, often of balanced round stones. Very few of such walls fall sideway as a unit, but most of them collapsed due to crumbling.

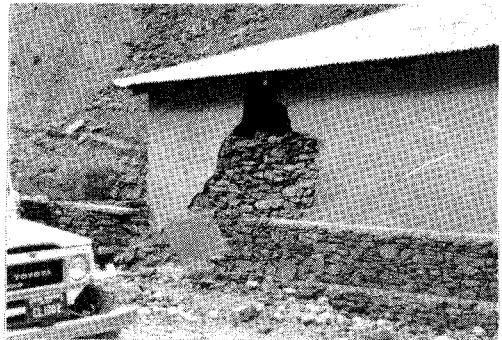
Photo 16 Wall breached by boulder which is still inside this building

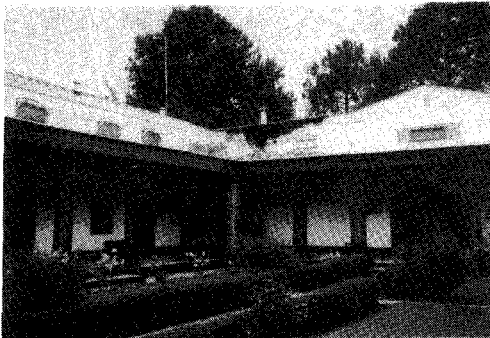
Swat district is the eastern part of Malakand division. Saidu, the divisional center is about 250 km from the epicenter. The construction quality is better compared to other places. Mingaora was the worst damaged place of the district, with about 300 collapsed houses. In Saidu, most of the Pucca buildings had suffered non-structural damages (Photo 17). In Nawagai village in Barikot, a place south of Swat, ground had started to settle down after the earthquake. One month after the earthquake, rain had started which triggered the ground settlements. The progressive settlement, which is still continuing, results in structural failures (Photo 18,19). Some landslides had been reported in upper Swat which damaged the Karakorum Highway.

Photo 17 A damaged Pucca hotel in Saidu

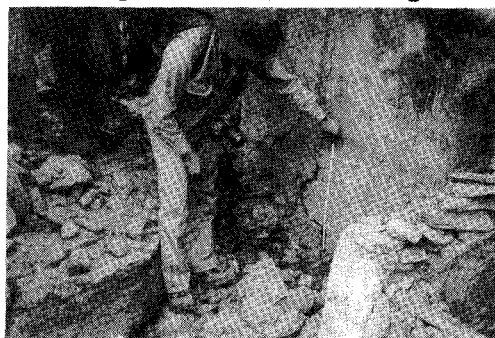
Photo 18 Uneven ground settlement, Barikot

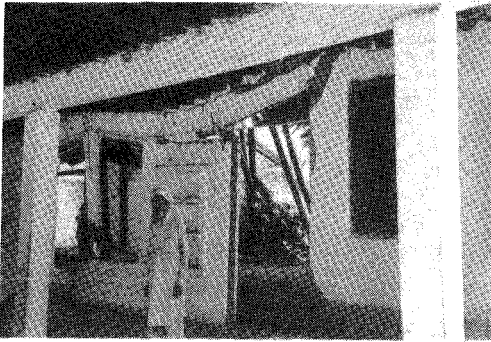
Photo 19 Structural damage due to ground settlement in Barikot

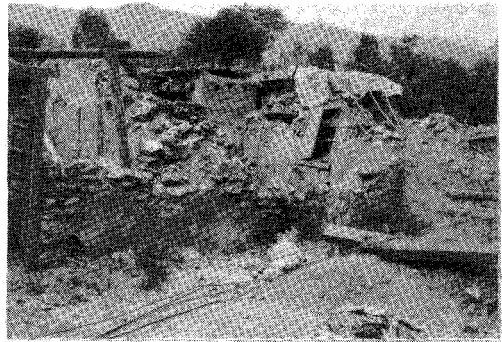
Photo 20 Damaged houses in Bhattai, Buner

severe intensity throughout the district. However, the northern parts were more damaged by the ground shaking (Photo 20). Some of the collapsed houses fell down after the earthquake because of rain which started one month after the earthquake and continued for about two months. In the south of Buner, water had come out of the ground which experienced excessive settlement. At such places like Rega, Karappa and surrounding areas, collapse of houses and continuous settlement of roads have been reported.
