Building Damage Detection Using Satellite SAR Intensity Images for the 2003 Algeria and Iran Earthquakes

Abstract— An earthquake occurred in the coast of Algeria on May 21, 2003. The cities of Boumerdes and Zemmouri were the most extensively damaged areas. Canadian SAR satellite, RADARSAT, observed Boumerdes area by the fine-beam mode, on 4 days after the event. European SAR satellite, ERS, also observed the same area on June 7, 2003. On December 26, 2003, another strong earthquake occurred beneath the city of Bam, Iran. Severely damaged areas were found widely being distributed in the city from high-resolution optical satellite images obtained after the event. ENVISAT also captured the hard-hit areas on January 7, 2004. In this paper, we investigated the characteristics of damaged areas in these SAR images by visual interpretation and clarified the effect of spatial resolution for the detection of damaged buildings. Then, we applied our automated damage detection technique, which was developed based on the data set of the 1995 Kobe earthquake, to the SAR images of Algeria and Iran.

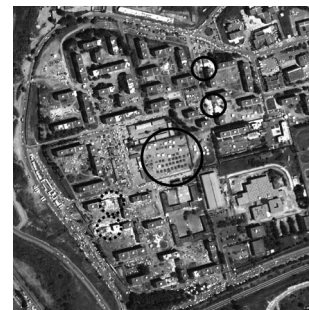
Figure 3. Panchromatic QuickBird image of a part of Boumerdes city acquired on May 23, 2003.

Figures 1 and 2 show the zoom-up images of pre- and post-event by RADARSAT and ERS, respectively, for a typical area in Boumerdes city, where totally collapsed buildings are identified in an image taken by Quickbird satellite on 2 days after the earthquake, as shown in Fig.3. The images acquired on February 20, 1998 by RADARSAT and July 27, 2002 by ERS were used for the data prior to the event. The locations of collapsed buildings determined by visual inspection using the QuickBird image are marked as small circles in these figures. As seen in Fig.1, it is found that the backscattering intensity of buildings circled by small solid line in the post-event image is smaller than that in the pre-event image. Generally, man-made structures show comparatively high reflection due to the cardinal effect of structures and ground. Open spaces or damaged buildings have comparatively low reflectance because microwaves are scattered in different directions (see in Fig.4) Buildings may be reduced to debris by an earthquake, and in some cases, the debris of buildings may be removed, leaving the ground exposed. Thus, the backscattering coefficient determined after collapse is likely to be lowered compared to that obtained prior to the event.

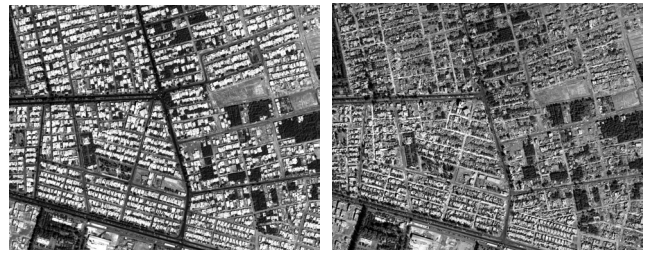
Figure 5. QuickBird images of the southeast part of Bam city taken before (left) and after (right) the Iran earthquake

Regarding the SAR images of Bam, Iran earthquake, we found that the above-mentioned reverse characteristics are dominant in some severely damaged areas in the southeast of Bam city. Figures 5 and 6 show the area of pre- and post-earthquake images by QuickBird and ENVISAT, respectively. The pre-event ENVISAT image was acquired on December 3, 2003. Many orderly houses with flat roof were densely located prior to the earthquake, but the most of them were damaged by the event. According to the ENVISAT images, the backscattered echoes became stronger in the post-earthquake image. When uniform buildings stand very close each other, specular bounces on the flat roofs cause the weak reflection. Then, if some buildings located in the near-range to a satellite were collapsed due to an earthquake, the cardinal effect against other buildings could cause strong reflection. The debris of collapsed buildings could also create relatively higher

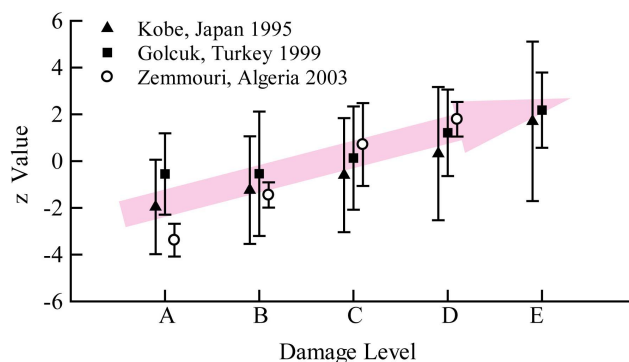
Figure 8. Relationship between z value and damage level for SAR images from the three earthquakes. The damage level classified into A, B, C, D, and E, corresponding to the collapsed building ratio of 0-6.25, 6.25-12.5, 12.5-25, 25-50, and 50-100%, respectively.

25%, should be detected [8]. Therefore, this result shows good agreement with our previous experiences for other earthquakes. By using ERS images of the Algeria earthquake, damaged areas are clearly detected in the city of Zemmouri and not in other cities. The relationship between the damage level [7] and z value in Zemmouri city is shown in Fig.8. As observed in the Kobe and the Turkey studies, the z value in the Algeria case is also seen to increase as the damage level increases.
