Earthquake Damage Detection Using High-resolution Satellite Images

Abstract— QuickBird observed the city of Zemmouri, Algeria, before and after the May 21, 2003 Algeria earthquake. Using the pre-event and post-event pan-sharpened images, visual inspection of building damage was carried out by the five authors of this paper individually. A total 1,399 buildings were classified into five damage levels of European Micro-seismic Scale. The results from the different interpreters were reasonably close for collapsed buildings but the difference becomes larger for smaller damage levels. The locations of refugee tents in the two post-event images were also identified. These observations indicate that high-resolution satellite images can provide quite useful information to emergency management after natural disasters.

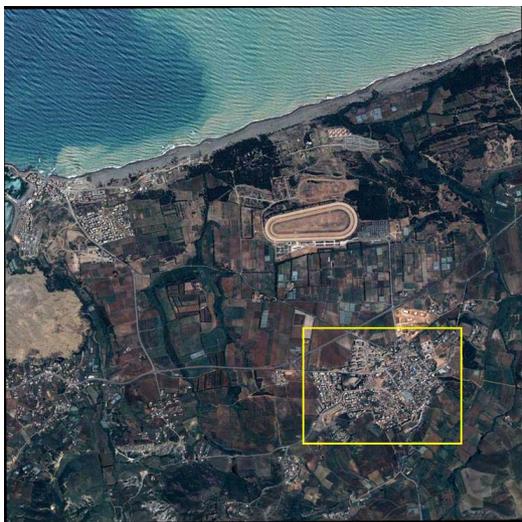
Figure 1. Pan-sharpened QuickBird image of Zemmouri on May 23, 2003

First, three pan-sharpened images (one pre-event on May 13, 2003, and two post-event images on May 23 and June 13, 2003) were produced (Fig. 1) and they were used in visual inspection of building damage. Figure 2 shows the urbanized

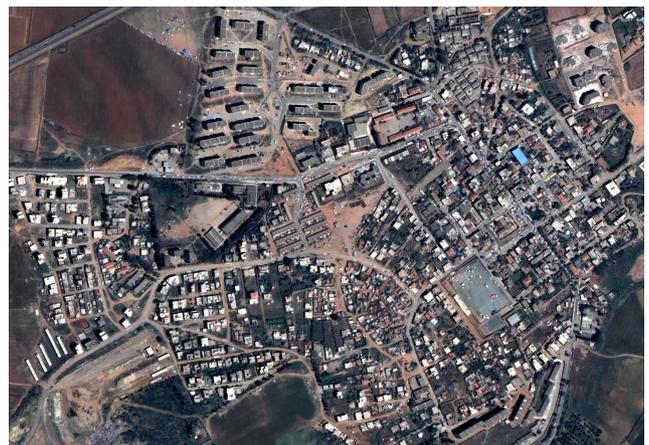
Figure 2. Central part of Zemmouri City on May 23, 2003

area of Zemmouri on May 23, two days after the earthquake, in which many collapsed buildings are observed.

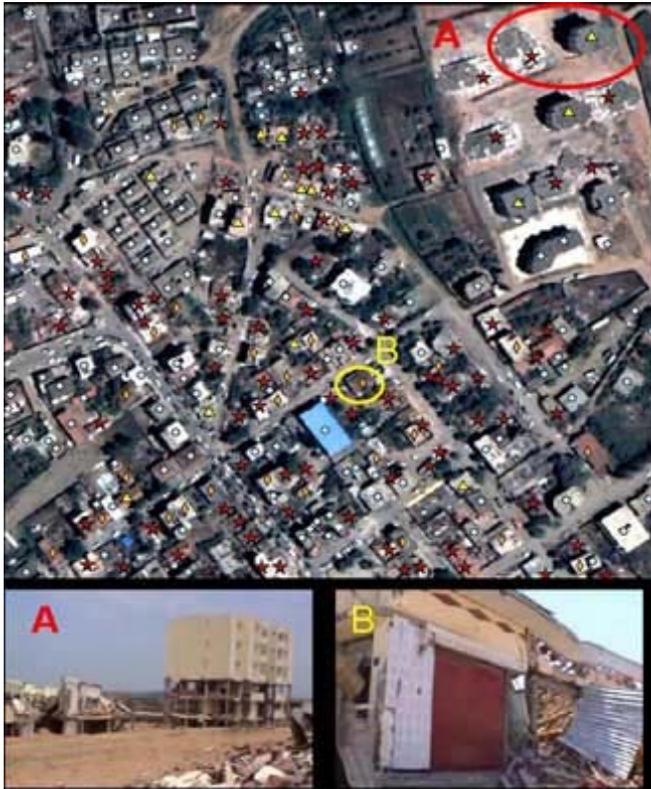
Figure 3 shows comparison between the satellite image and the on-site video pictures. In the satellite image, a circle symbol means “Grade 1 or 2”, a triangle symbol “Grade 3”, a diamond symbol “Grade 4”, and a star symbol “Grade 5”, respectively. The lower pictures show damaged/collapsed tall buildings (A) and a damaged low-rise house (B), which are examples that the detection results using satellite images were verified by ground photographs.

Figure 3. Comparison between the satellite images and on-site video (by courtesy of National Earthquake Engineering Center of Algeria).

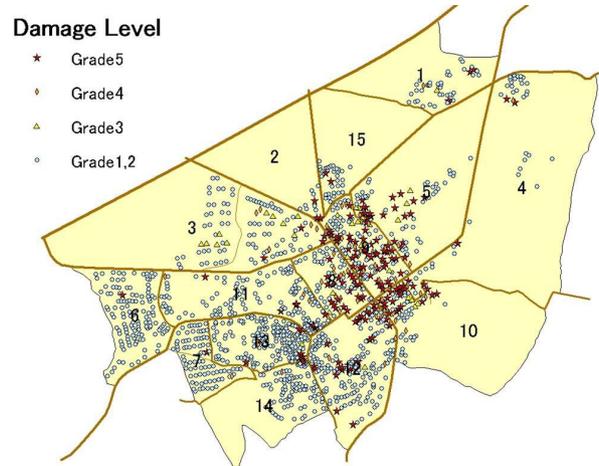
Figure 4. 1,399 buildings classified based on their damage grades

A total of 1,399 buildings in the central part of Zemmouri City were classified based on their damage grades as shown in Figure 4. The damage ratios of buildings in each city block (a total 15 blocks) were calculated. Figure 5 shows the damage ratio of Grade 5 for each city block. It is seen that the heavy damage zone is concentrated in the central part of the urban area. The distribution of tents can clearly be observed in QuickBird images of Zemmouri. The locations of tents in the two post-event images were plotted in Fig. 6.

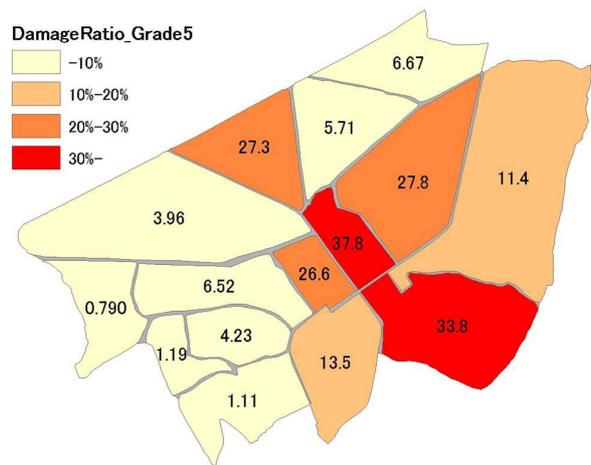
Figure 5. Ratio of Grade 5 buildings in each city block

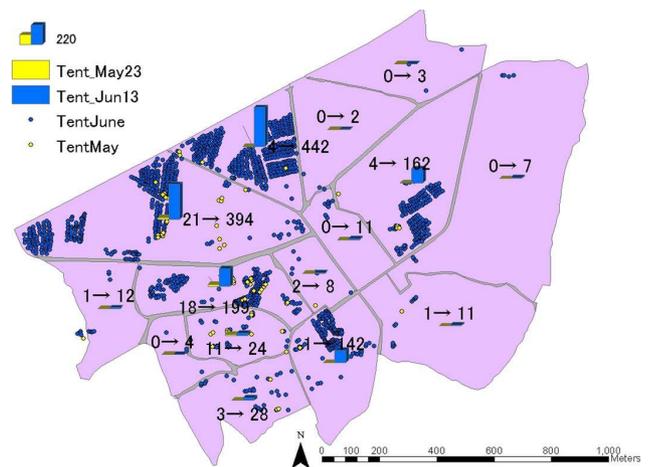
Figure 6. Location of tents in the two post-event images

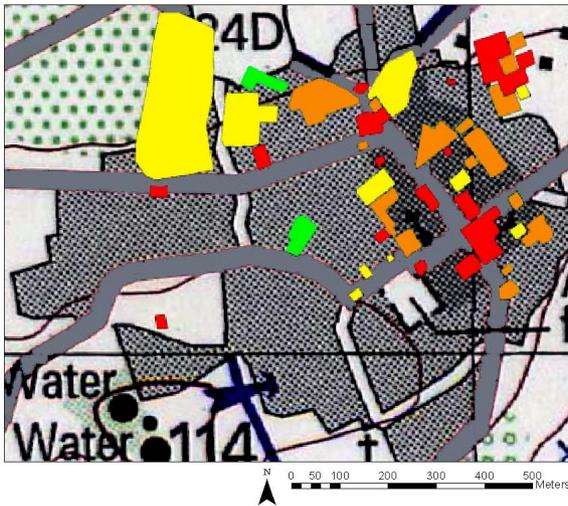
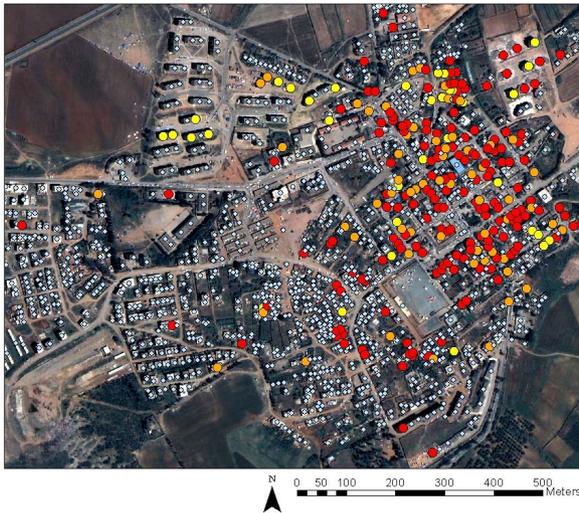
Figure 7. Comparison of damage map made by US Government and this study

(a) Damage map for Zemmouri evaluated by the United States Government (UN-OCHA, 2003)

(b) Visual damage detection by this study

The damage map in Zemmouri evaluated by the United States Government is available on Internet (UN-OCHA [3]). Figure 7 compares the damage map in Zemmouri evaluated by the United States Government and the result of this study. We contacted UN-OCHA about the data source, but only reply we received is “It used a variety of classified and unclassified aerial and satellite remote sensing images.” Although the map by US Government is very close to our interpretation, there is possibility that they also used QuickBird images as a part of data source.
