APPLICATION OF AUTOMATED DAMAGE DETECTION OF BUILDINGS DUE TO EARTHQUAKES BY PANCHROMATIC TELEVISION IMAGES

ABSTRACT

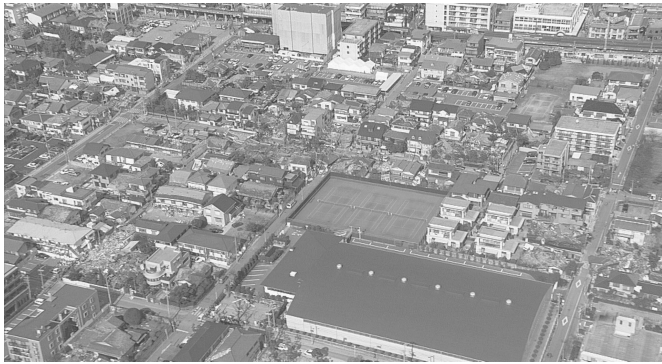
Figure 1. Aerial HDTV image.

Aerial shooting from helicopters of areas affected by the Kobe earthquake was performed shortly after the event by the Japan Broadcasting Corporation (NHK). These images were taken at a 30-45 degree angle from the vertical direction, from a height of about 300m using NHK's HDTV cameras. In this study, we used some of these images taken 10 days after the event. The HDTV images were converted to RGB image data with a bitmap format, and the panchromatic images were fabricated from the method to obtain the brightness signal for NTSC, which is one of the image transmitting systems used for television. One of the images used in this study is shown in Figure 1. The spatial resolution of this image is approximately 9cm to 17cm for near to far distances from the camera, respectively.

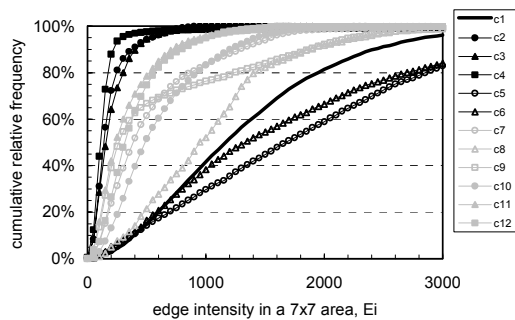
Figure 3. Cumulative relative frequency of E_i for training data.

7x7 pixel window. Also, the ratio of the predominant direction of edge elements in a 7x7 pixel window, Ed , was calculated. Figures 3, 4 and 5 show cumulative relative frequencies of Ei , Ev and Ed , respectively, for each set of training data. The roofs of undamaged buildings, (c2-c4) including many of the non-edge areas, consist of extremely small values of Ei and Ev . The exterior walls of undamaged buildings (c5, c6) have stronger edge elements than other training data, due to attachments such as balconies, windows, and outlines of buildings. The distribution of Ed of railways (c8) has more pixels with the same edge direction than other training data. In the case of collapsed buildings (c1), the distributions of the values for Ei and Ev are broad, and the distribution of the value for Ed is similar to that of other training data, excepting railways.

The curve of each cumulative relative frequency for the collapsed buildings (c1) shown in Figs 3, 4, 5, 9 and 10 was approximated by a regression line based on the cumulative data between 20% and 80% of the collapsed buildings. If this line intersected 0% and 100% on the graph of the cumulative relative frequency, the threshold value was determined to be the value at these intersection points for each characteristic (Aoki 2001). When each threshold value for Ei , Ev , Ed , Ta and Te was applied, a ratio of pixels extracted as the collapsed buildings in each training data was attained as shown in Figure 11. In both cases of Ei and Ev , most of the pixels of

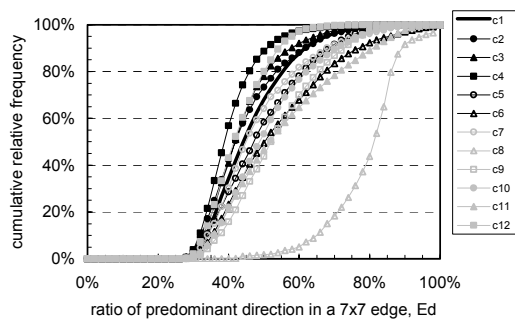
Figure 5. Cumulative relative frequency of E_d for training data.

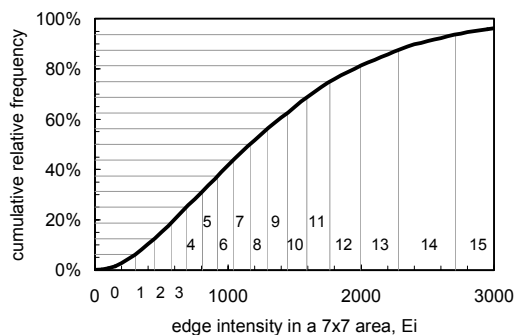
Figure 6. Cumulative relative frequency of Ei for the collapsed buildings, and derivation of cEi with 16 grades.

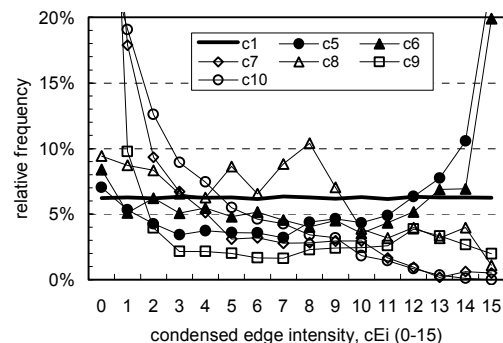
Figure 7. Relative frequency of cEi for some training data.

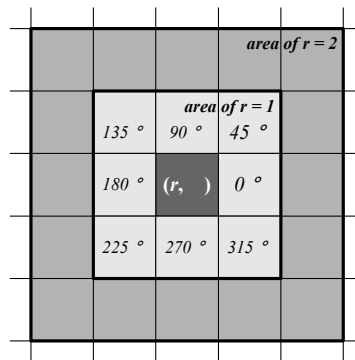
Figure 8. Relationship between a reference pixel and neighboring pixels with $r=1$ and eight directions.

An occurrence probability $P(k, l)$ means the probability that pixel value l appears in a relative position $\delta = (r, \theta)$ from a reference pixel whose value is k , where r and θ of δ are relative distance and direction from the reference pixel, respectively. The occurrence probability $P(k, l)$ is calculated for all combinations of pixel values (k, l) against some constant δ . This matrix is called a co-occurrence matrix (Takagi and Shimoda 1991), because column k line l in the matrix represents a co-occurrence probability of pixel values (k, l). Some of the textures due to the co-occurrence matrix are often used to classify land cover in urban areas (Zhang et al. 2001). In this study, characteristics of the collapsed buildings were investigated with edge textures derived from a co-occurrence matrix based on edge intensity, Ei . The cumulative relative frequency of the collapsed buildings (c1) was converted to 4-bit data representing a condensed edge intensity, cEi , as shown in Figure 6. Figure 7 shows relative frequencies for representative training data. By this approach, the same number of pixels for the collapsed buildings in cEi was obtained in all digital numbers of 4bits. On the other hand, exterior walls (c5, c6) have strong elements in cEi , and some of the other training data, such as blue vinyl canvas sheets (c7), asphalt roads and parking lots (c9), and bare ground (c10) contain many weak elements in cEi . Using these characteristics, two textures were calculated for the condition of $r=1$, which indicates neighboring pixels around a reference pixel, and four directions of 0-180, 45-225, 90-270, and 135-315 degrees. Figure 8 is a schematic diagram representing the relationship between

the reference pixel and other neighboring pixels of distance r and direction θ from the pixel. The maximum value for the directions was defined as a representative value of the texture. In addition, a 7×7 pixel area was used as the window size for the texture analysis.

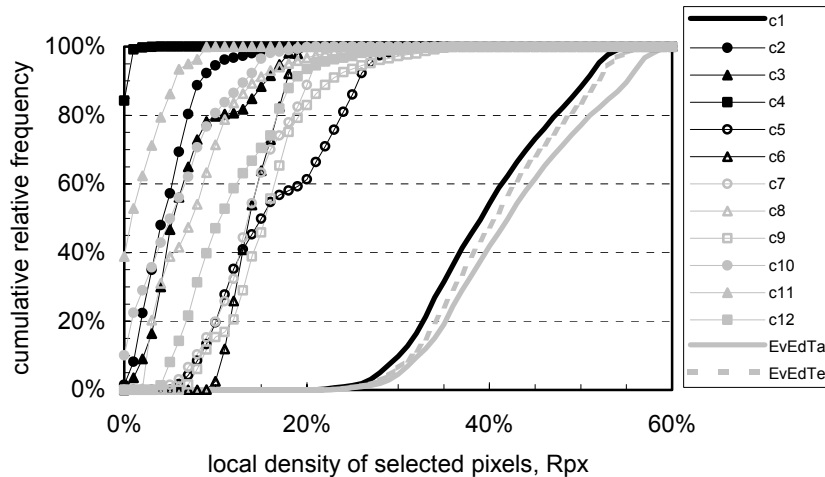
Figure 13. Cumulative relative frequency of Rpx for each set of training data. “ $EvEdTa$ ” and “ $EvEdTe$ ” are the distributions of c1 in $EvEdTa$ and $EvEdTe$, respectively.

The extracted pixels corresponding to the collapsed buildings (c1) were further synthesized to decrease surplus pixels and make areas with building damage easy to identify. This analysis was introduced to calculate the local density of extracted pixels (Rpx) as in a previous study (Aoki 2001). Rpx is defined as the ratio of the pixels extracted by the four threshold values versus the number of pixels in a window approximating one building size. Windows of 31x31 to 63x63 pixels were selected to be proportional to the resolution of the ground surface. Figure 13 shows the cumulative relative frequency of the training data. Next, a regression line was derived from the same method as used for obtaining the threshold value on edge information, and the threshold value of Rpx was defined as the intersection point between the regression line of Rpx for the collapsed buildings and the horizontal axis. In all cases of $EvEdTaTe$, $EvEdTa$, and $EvEdTe$, Rpx 30% was derived as the threshold value to distinguish between the collapsed buildings and the other imaged objects. A percentage of areas detected as the collapsed buildings in all training data is shown as $Darea$ in Table 1. In all cases, correctly detected pixels in the collapsed buildings were more than 90%. However, a small number of pixels for asphalt roads and parking lots (c9), brown exterior walls (c5), and woods (c12) were incorrectly detected by this approach. Therefore, the areas with building damage were estimated using $EvEdTaTe$, because these areas had the least number of incorrect pixels in the three cases. Figures 14 and 15 show the results estimated in this study and the results of ground survey and

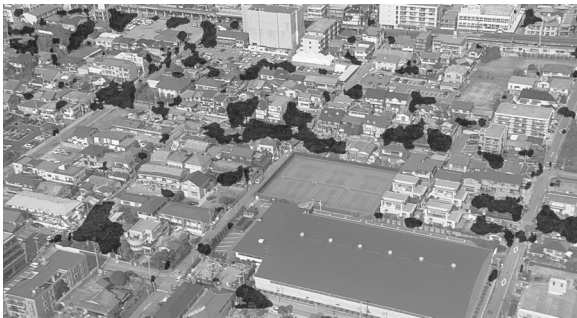
Figure 14. Result of estimated areas with building damage based on *EvEdTaTe* and *Rpx30%*.

visual inspection (Hasegawa 2000), respectively. The black and white areas in Fig.15 represent the collapsed and the severely damaged buildings, respectively. In the dotted circle, the blue vinyl canvas sheets are covered with parts of the damaged buildings. Most of the building debris was detected correctly, although pedestrian crossings, cars and parts of exterior walls were incorrectly detected as collapsed buildings. Figures 16 and 17 show the result of this method applied to the adjacent image and the distribution of severely damaged buildings due to ground survey and visual inspection, respectively. The distribution of the detected area shown in Figure 16 roughly agreed with that in Figure 17. These results indicate that it may be possible to apply the method based only on edge information from a sample image to several similar images spanning large areas.

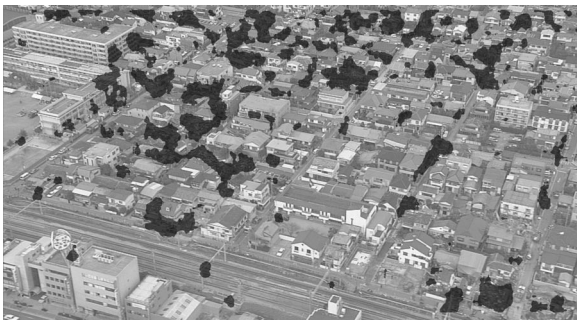
Figure 16. Result of application of the threshold value for Fig.14 to an adjacent image.
