Accuracy of Building Damage Detection from QuickBird Satellite Images in the 2003 Boumerdes, Algeria Earthquake

A. Meslem, F. Yamazaki & Y. Maruyama

Department of Urban Environment Systems, Chiba University, Chiba, Japan

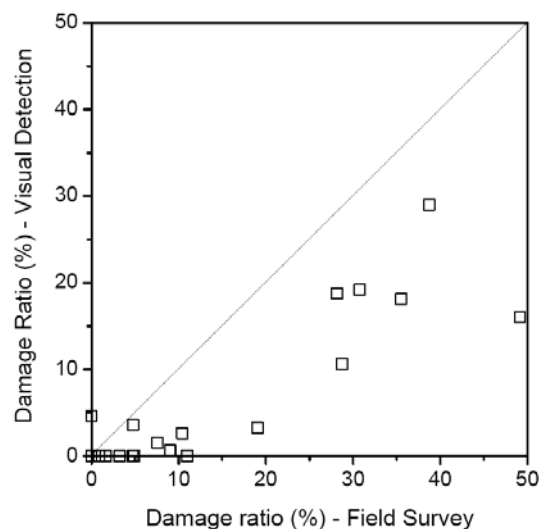
Figure 5. Comparison of damage ratios computed using damage data from mission of field survey with that computed using estimated damage data from QuickBird satellite images by visual detection.

Basically, it is clearly seen that in zone level mapping the result of visual detection from QuickBird images is very close to that from ground truth data from field survey. In building level mapping, the very heavy damages seem to be well localized from satellites images through visual detection. Figures 4 and 5 show comparison of damaged building ratios of very heavily damaged and collapsed (Grades 4 and 5) between the field survey and the visual detection from the satellite images. The damage ratios based on the visual damage detection would be underes-

timated compared with those based on the field survey. The buildings suffering from damage Grade 3 and also some buildings with damage Grade 4 were incorrectly judged from visual detection.

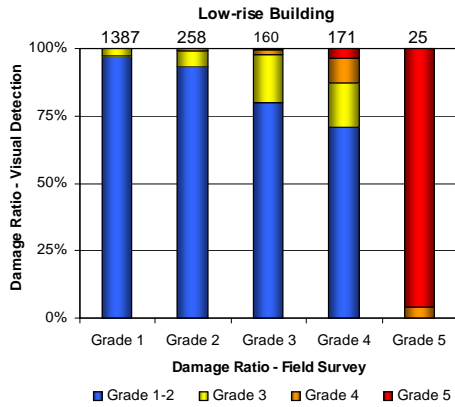
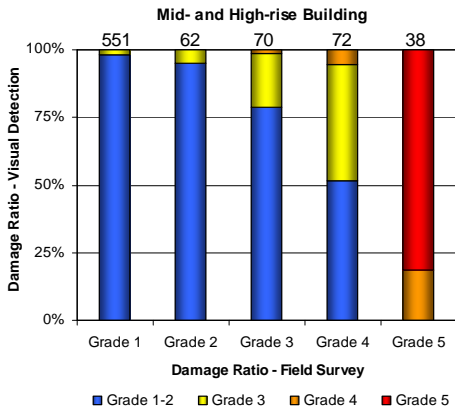
Field survey	Grade 1	Grade 2	Grade 3	Grade 4	Grade 5	Total
QuickBird						
Grade 1 & 2	1346	240	128	121	0	1835
Grade 3	38	16	28	28	0	110
Grade 4	1	2	3	16	1	23
Grade 5	2	0	1	6	24	33
Total	1387	258	160	171	25	2001
Omission Error (%)	0	0	80	87.1	4	--
Commission error (%)	3	7	2.5	3.5	0	--
Accuracy (%)	97	93	17.5	9.4	96	--

a) Damage Grades accuracy for low-rise buildings.

Field survey	Grade 1	Grade 2	Grade 3	Grade 4	Grade 5	Total
QuickBird						
Grade 1 & 2	540	59	55	37	0	691
Grade 3	11	3	14	31	0	59
Grade 4	0	0	1	4	7	12
Grade 5	0	0	0	0	31	31
Total	551	62	70	72	38	793
Omission Error (%)	0	0	78.6	94.4	18.4	--
Commission error (%)	2	4.8	1.4	0	0	--
Accuracy (%)	98	95.2	20	5.6	81.6	--

b) Damage Grades accuracy for mid- and high-rise buildings.

Figure 6. Accuracy of distinguished building damage Grades from high resolution imagery in relation to building height classes.

We have examined the accuracy of using QuickBird images, for detecting damage Grades considering the nature of urban environment and building height classes. Figure 6 shows the comparison of damage Grades detection in relation to building height classes between low-rise buildings with mid- and high-rise buildings.

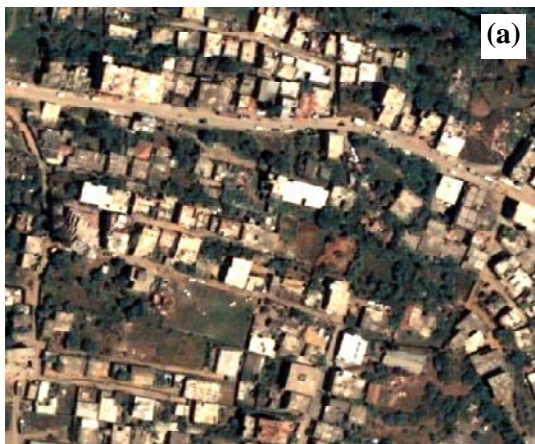
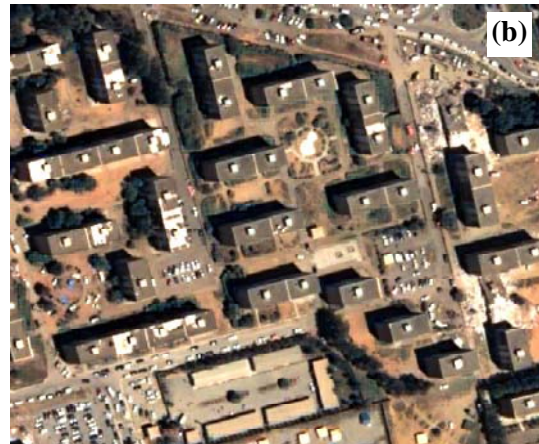
Figure 7. Views from post-event image of Boumerdes City: (a) Densely built-up area where the constructions are mostly low-storied, (b) Area of modern middle to high rise constructions.

In general, In case of total collapse, the damage is easily detectable. However, for low-rise construction located in densely urban environment, sometimes there are difficulties for detecting damage even by using pre- and post-event images. Figure 7(a) shows an example of view, from post-earthquake, of densely built-up area. This image corresponds to the south-eastern part of the city, where almost all the existing constructions were single, non-engineered, 1-3 story private houses, and damage was incurred by only some houses.

Figure 7(b) shows an example of view, from post-earthquake, corresponding south-western part of the city where there are many modern mid-rise buildings. In this zone the damage was extensively concentrated which explains why the damage ratio is more important in the case of mid-rise buildings.

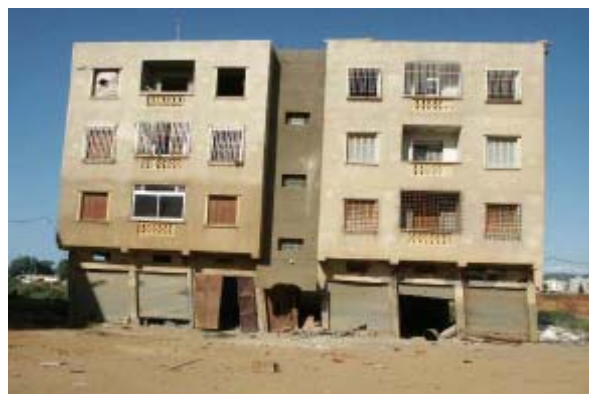
Figure 9. Example of 4-story building (shown by red circle in Fig. 8-a and -b) suffered from soft story damage corresponding to Grade 4, was incorrectly judged as Grade 1-2 through visual detection from QuickBird images.

In addition, Figure 8 clearly shows that some of mid-rise buildings suffering from damage Grades 3 and 4 were incorrectly judged from visual detection through QuickBird images. This can be understood if we take a look to the Figure 9 showing 4-storied buildings suffering from soft storey damage (Grade 4) and incorrectly judged as Grade 1-2 in visual detection. This type of damage is difficult to be detected from vertical image, including the case of buildings suffering sever damage from inside. This observation explains why the percentage of incorrectly judged damage for buildings with Grades 3 and 4 is remarkable.

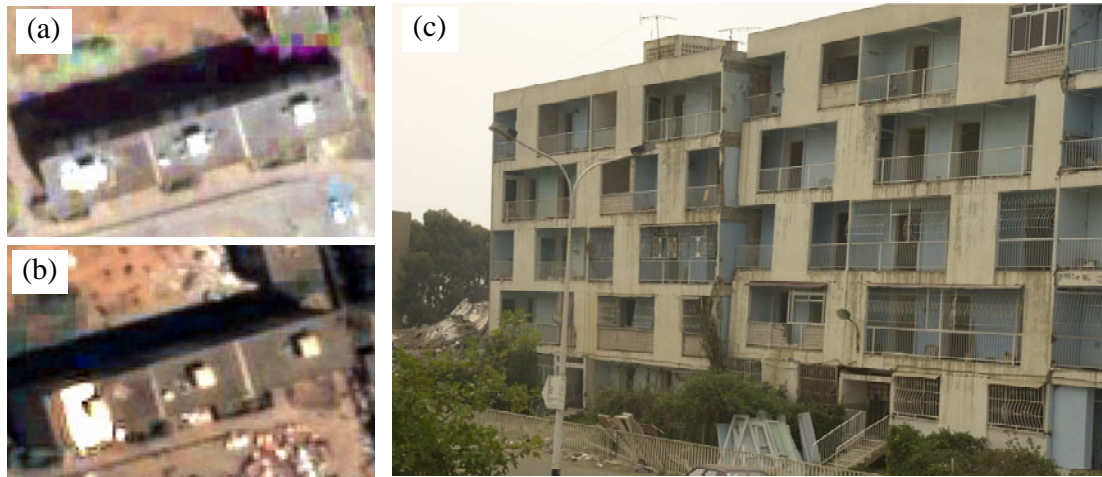
Figure 10. Damage detection accuracy for building slightly tilted, with no debris surrounded. (a) Pre-event QuickBird image, (b) Post-event QuickBird image, (c) Photograph of damaged building.

Figure 10 shows another example for 5-storied building slightly tilted (Grade 4) due to the earthquake, with no debris surrounded, and incorrectly judged as Grade 1-2 in visual detection. Table 2 presents a summary of results regarding the relationship between the observed buildings damage patterns from field survey to the visual detection accuracy for Grades 3, 4, and 5. Figure 11 shows the classification of damage patterns and comparison with results from visual detection for Grades 3, 4, and 5. It is well seen that for low-rise buildings as well as for mid- and high-rise ones the debris plays a predominant role in the accuracy of visual detection and also the nature of observed damage patterns.
