# **BUILDING DAMAGE DETECTION OF THE 2003 BAM, IRAN EARTHQUAKE USING QUICKBIRD IMAGES BASED ON OBJECT-BASED CLASSIFICATION**

**KEY WORDS:** QuickBird, the 2003 Bam earthquake, building, damage detection, object-based classification

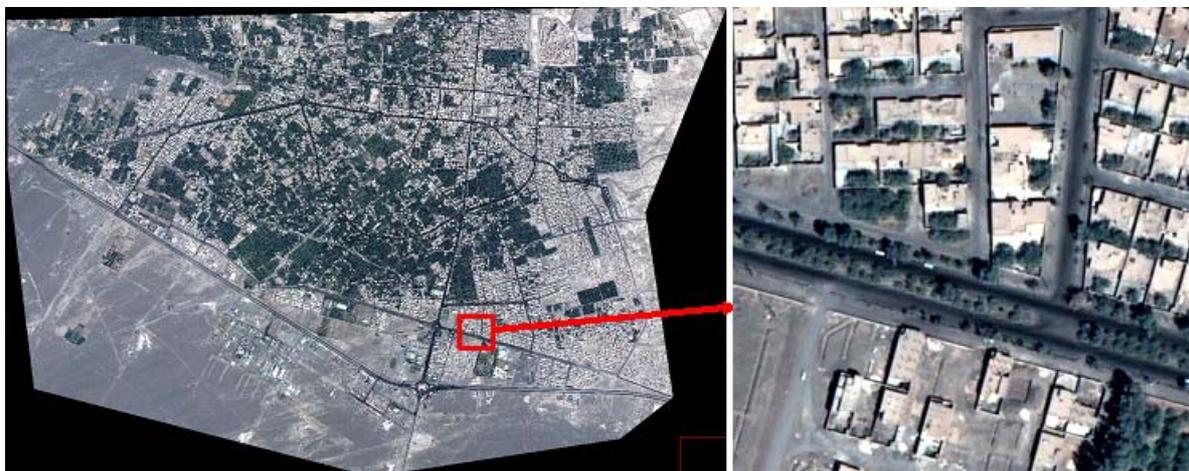
Figure 1. Pan-sharpened natural color QuickBird image of Bam captured on September 30, 2003 and a study area in this paper, located in the southeast of the city

Figure 1 shows a pre-event QuickBird image and a study area in this paper, located in the southeast of the Bam city. This area was selected because the buildings of various damage levels exist in the small area.

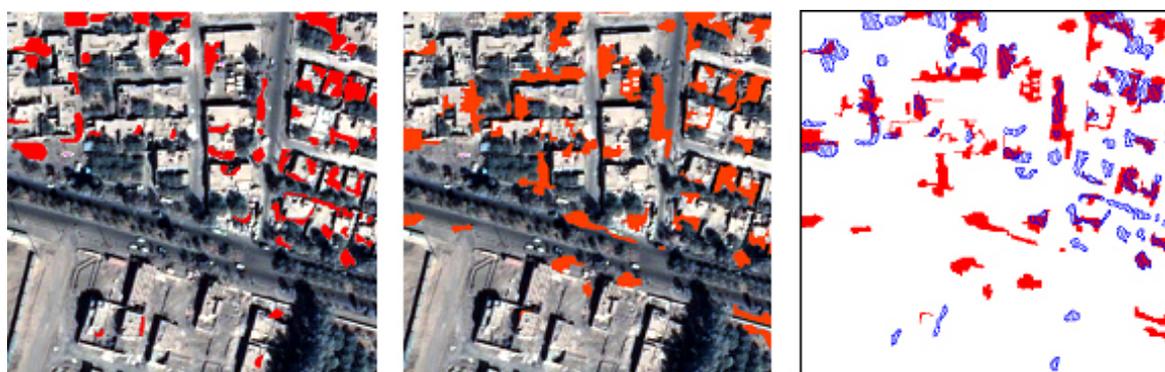
Figure 7. The visually detected (correct) area of debris (left), the classified area of debris (center), and the comparison of the two areas (right). (Red color is the true debris area and blue color is the classified area.)

More detailed comparison is shown in Figure 7 where the correct area of debris (left), the classified area of debris (center), and the comparison of the two areas (right) are plotted. The rate that the classification area corresponds to the correct one (user accuracy) is 44%. In this comparison, overall agreement of debris locations looks an acceptable level. But apparent omission and commission errors are seen. In a future study, spatial relations e.g., “debris is located near buildings”, should be taken into consideration. Change detection between a pre-event image and a post-event image is also a possible alternative approach.
