# EXTRACTION OF BUILDING DAMAGES IN THE 2007 NIIGATA-KEN CHUETSU-OKI EARTHQUAKE USING DIGITAL AERIAL IMAGES

**KEY WORDS:** Digital aerial image, the 2007 Niigata-ken Chuetsu-oki earthquake, Pixel-based classification, Object-based classification, Building damage extraction.

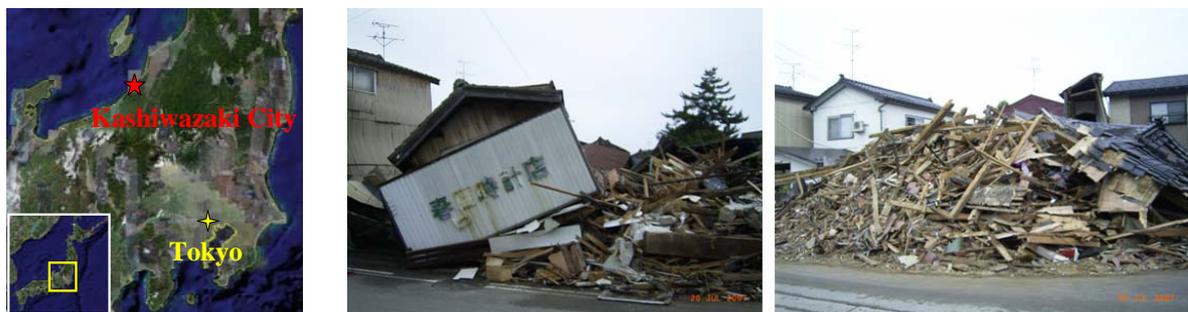
Figure 1 Location of Kashiwazaki City and the photos from the authors' field survey

The central part of Niigata Prefecture, Japan was hit by a strong  $M_{JMA} = 6.8$  earthquake on July 16, 2007. A total 15 people were killed and 1,319 houses were collapsed in Niigata Prefecture. Kashiwazaki City was most severely affected in the prefecture with 14 people killed and 1,109 houses collapsed. Higashi-honcho block is located in the central part of Kashiwazaki City, with a shopping street and a surrounding residential area. We selected Higashi-honcho as an area to study because many old wooden houses in this block were collapsed or severely damaged, as shown in Figure 1.

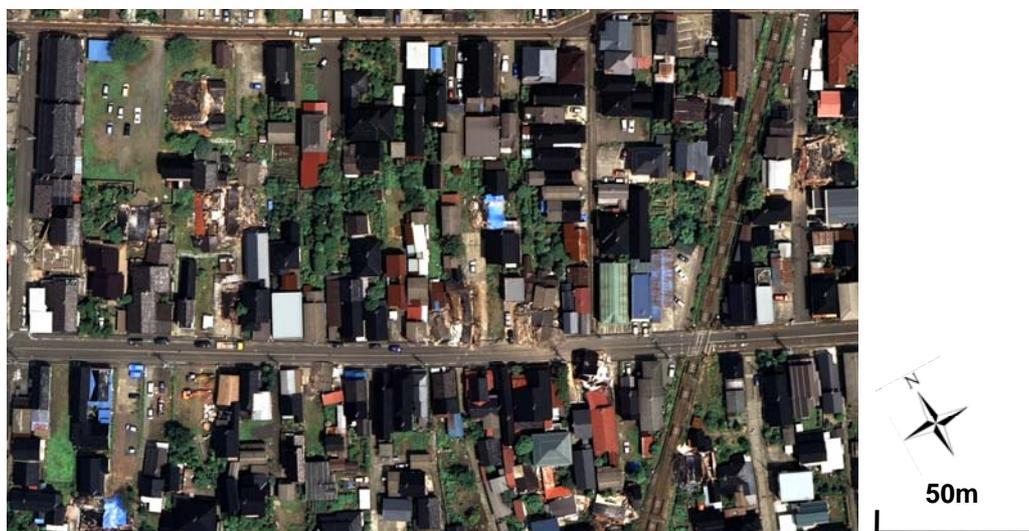
Figure 2 shows a digital aerial image of Higashi-honcho, taken by Asia Air Survey Co., Ltd. on July 19, 2007 (three days after the earthquake). A DMC (Digital Mapping Camera) was used and it is one of the most popular digital aerial cameras in the world. DMC has a wide dynamic range with four (R, G, B, NIR) multi-spectral bands and one panchromatic band (Intergraph Corporation). The ground resolution of the image after pan-sharpening is 12.2 cm. The size of the image is 2,158 pixels in width and 1,350 pixels in height.

Figure 2 Digital aerial image (DMC) of Higashi-honcho in Kashiwazaki (July 19, 2007)

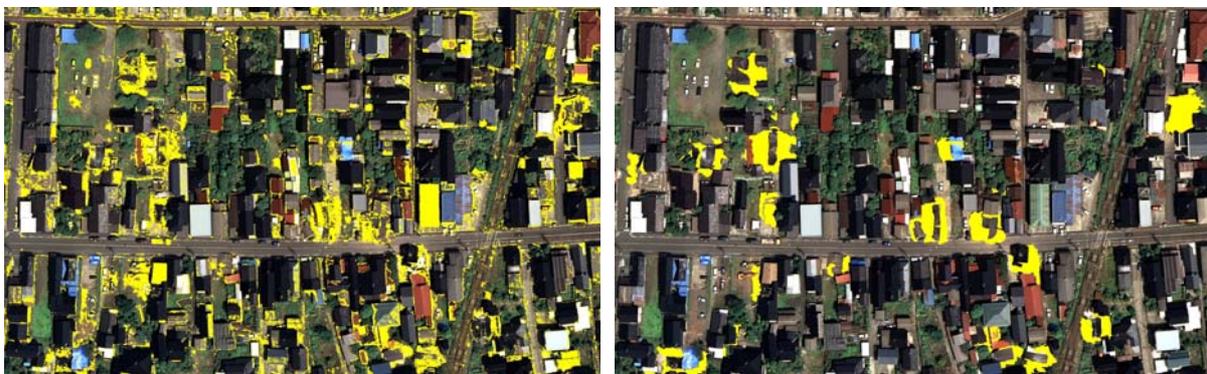
Figure 4 The results of automated damage extraction based on pixel-based classification (left) and visual inspection (right)

Figure 4 shows the result of automated damage extraction based on pixel-based classification and visual damage extraction for the post-event image. The pixels classified as the debris class in the automated damage extraction were more than actual debris. Debris does not have unique spectral characteristics because it consists of the mixture of woods, mud and roof-tiles. Therefore, a lot of misclassifications as debris were seen in the ground and non-damaged roofs, which do not belong to
