## **AUTOMATED DAMAGE DETECTION AND VISUALIZATION OF THE 2003 BAM, IRAN EARTHQUAKE USING HIGH-RESOLUTION SATELLITE IMAGES**

**KEY WORDS:** damage detection, high-resolution image, the 2003 Bam earthquake, visualization

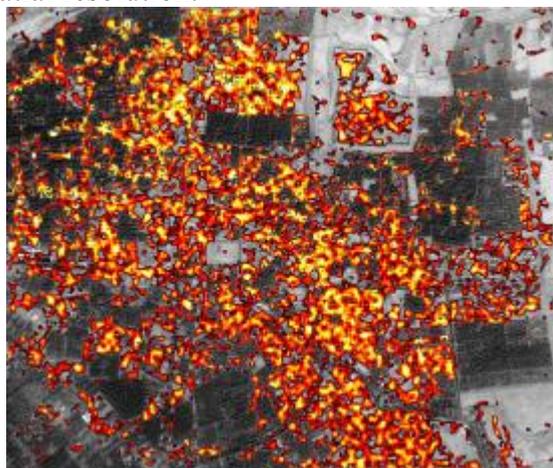
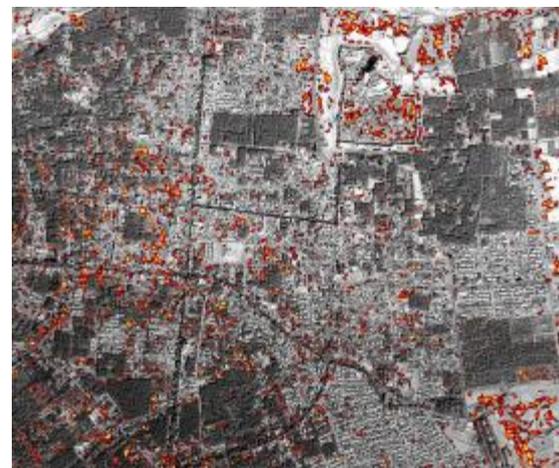
(a) IKONOS image taken on 12/27/2003

(b) QuickBird image taken on 1/3/2004

Figure 1. Result of detected areas with building damage

Figures 1 (a) and (b) show the results of the damage detection method applied to the IKONOS and QuickBird images of a central part of Bam city, respectively. Vegetated areas were removed by thresholding the NDVI. According to the reports of visual damage inspection from QuickBird images (Yano et al., 2004) and reconnaissance field survey (Hisada et al., 2004), more than 80% of buildings in an area, which is located in the south of Arg-e-Bam, were classified into Grade 4 (very heavy damage) or 5 (destruction) in the European Macroseismic Scale (EMS, 1998). The distribution of detected damage areas from IKONOS showed relatively good agreements with these results. However, less damage information could be detected from the QuickBird image

(Figure 1b). Spatial resolution and color distribution might be the factors affecting the results. First, we examined the influence of spatial resolution. However, a re-sampled, one-meter resolution, QuickBird image provided similar result as the original Quickbird image. Hence, spatial resolution did not affect the extraction results. Next, we calculated the rates of DN's of green and blue to that of red in pan-sharpened IKONOS and QuickBird images to examine the color contribution. The average values of green and blue were 0.97 and 0.95 for IKONOS, 1.03 and 1.14 for QuickBird. We found that the QuickBird image contains cyan color in the predominance. In fact, the QuickBird image looked not natural but bluish. Therefore, color modification of QuickBird image by histogram matching with the IKONOS image was carried out. Figure 2 shows the results of extracted areas using the color-modified QuickBird image. Damage areas could be detected more abundantly than the original image use, and their distribution showed good correspondence with the results of the aerial and field investigations as well. The result applied to whole image of Bam city as shown in Figure 3 can support us to identify the locations of the severely damaged spots. In summary, even in use of brightness image, the color distribution of RGB channels is the key factor, which depends on the characteristic of each sensor. Thus, it is necessary to carefully investigate this factor prior to apply our detection technique on any high-resolution satellite imagery.

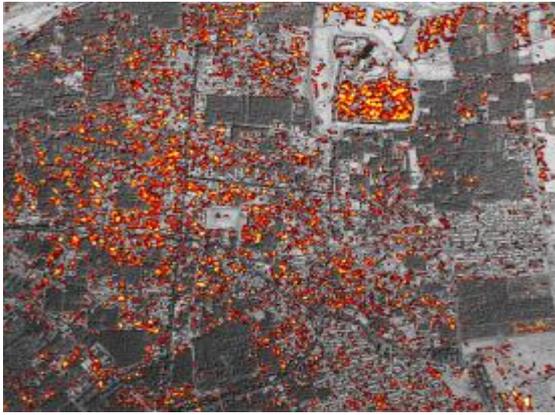
Figure 2. Detected areas with building damage using color-modified QuickBird image

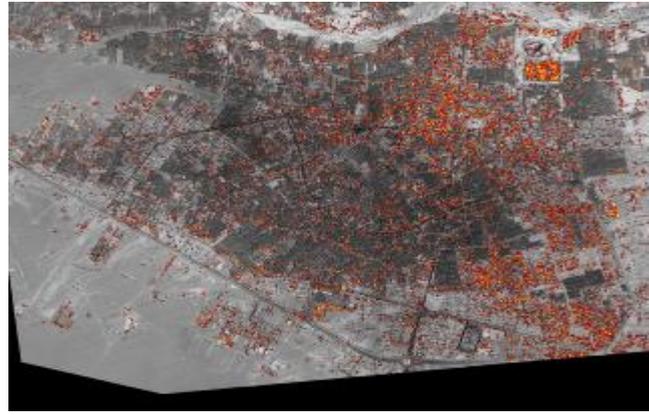
Figure 3. Distribution of detected damage areas using whole QuickBird image with color-modification

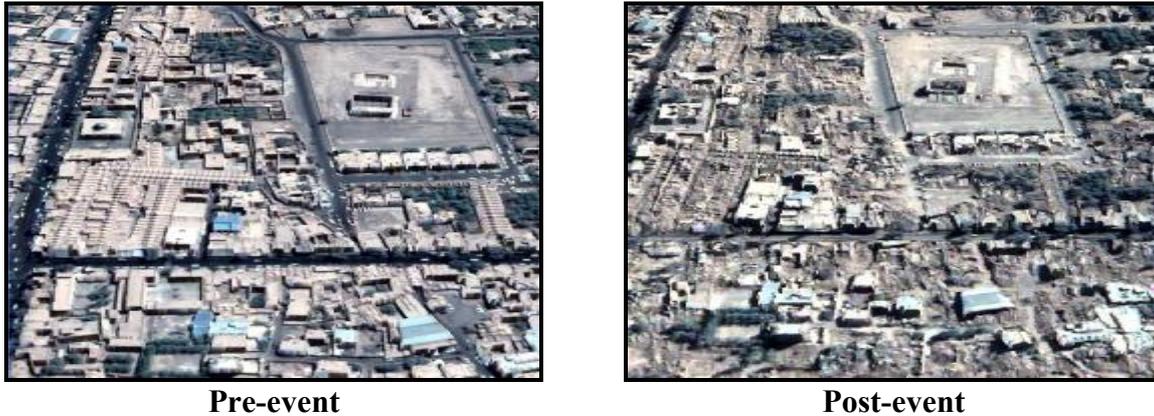
Figure 4. The capture scenes from fly-over animation for pre- and post-event QuickBird images. Horizontal, vertical look angles and flight altitude were 5 degree, -45 degree and 500 meter, respectively. We also varied these parameters to generate different footages.

The captured scenes from pre-event and post-event fly-over animation are shown in Figure 4. Viewed in oblique geometry, damage buildings can be clearly seen from these visualized scenes. Fly-over animation can project two cameras on the same surveying flight. While the left camera shoot the movie over pre-event scene, the right camera shoot the movie over post-event scene with overlaid damaged detection results (Figure 5). It is unreality but amazing and allow the watcher easily catch what happened when earthquake occurred. Due to the lack of DTM and the building inventory database in the case of Bam data as aforementioned, many manual tasks were carried out such as digitization of building footprints. If the database is available, the procedure to make this fly-over animation becomes much faster and easy to be carried out. Another key parameter is the height or number of story of the buildings. It is not only used for extrusion of the buildings but also might be necessary to assist ortho-rectification of the buildings.

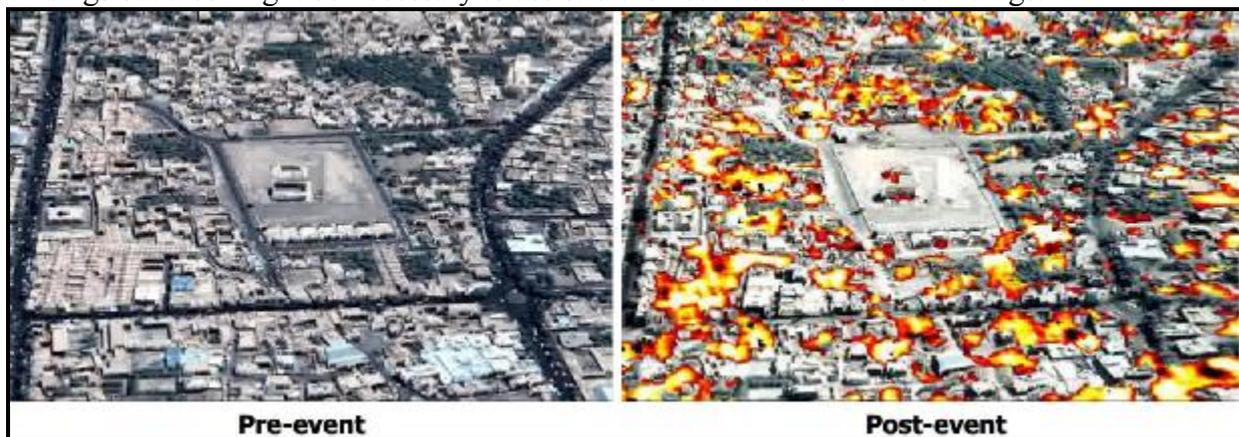
Figure 5. A captured scene of simultaneous fly-over animation for pre- (left) and post-event (right) QuickBird Images. (Red-to-yellow colored regions are detected damaged areas as shown in Figures 4 and 5.)
