## **AUTOMATED DAMAGE DETECTION OF BUILDINGS FROM HIGH-RESOLUTION SATELLITE IMAGES**

### **SUMMARY**

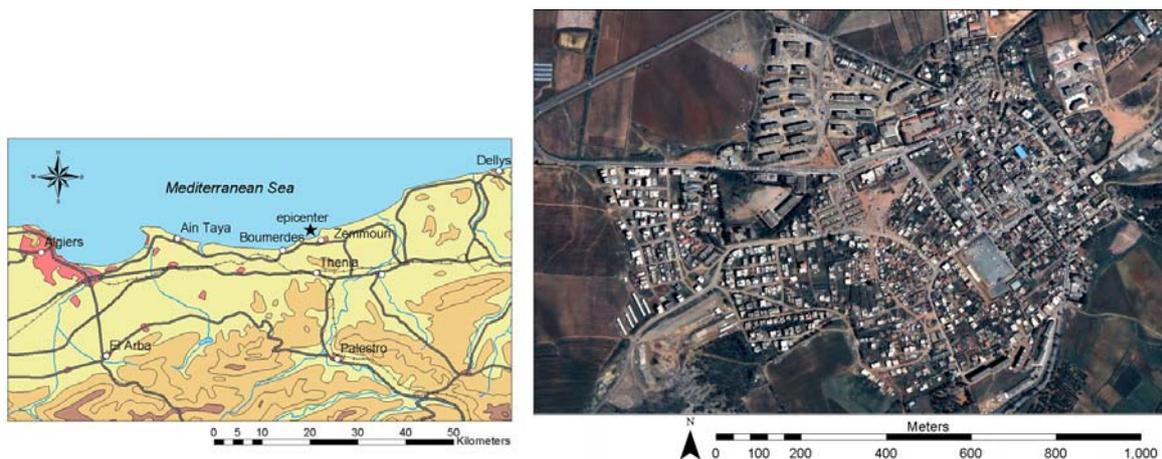
**Figure 1: (a) Epicenter and damaged cities in the north of Algeria and (b) pan-sharpened natural colour QuickBird image of Zemmouri City acquired on 23 May 2003**

A strong earthquake of magnitude 6.8 struck the Mediterranean coast of Algeria on 21 May 2003. The epicenter was located at 36.90N, 3.71E (USGS), offshore of the wilaya of Boumerdes, about 50 km east of the capital city, Algiers (Fig. 1(a)). According to the last official report from National Earthquake Engineering Center of Algeria, 2,278 people were killed, more than 10,000 were injured and about 180,000 people were made homeless.

QuickBird satellite observed the areas of Zemmouri City in the wilaya of Boumerdes. The images of Zemmouri City were obtained 8 days before (13 May 2003) and two days after (23 May 2003) the event. In order to observe target areas in a short time interval, QuickBird can change the view angle of its sensors. Thus these two images have different off nadir view angles: 8.7 and 24.4 degrees. Hence it is by no means easy to superpose these images exactly, especially in the areas where tall buildings are located, and to perform automated change detection. This is the reason why not change detection but detection from one post-event image has been used in this study.

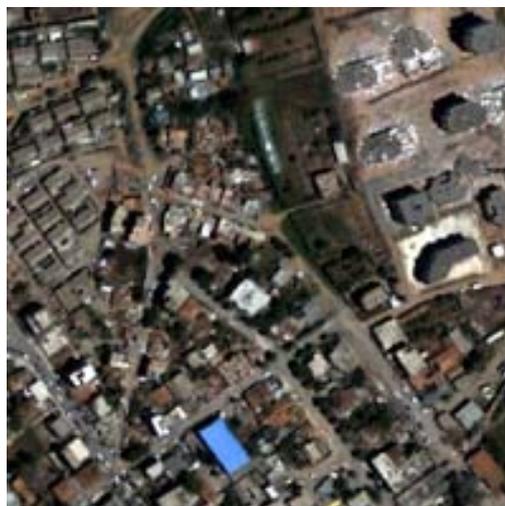
Figure 3: QuickBird image of the study area in Zemmouri City

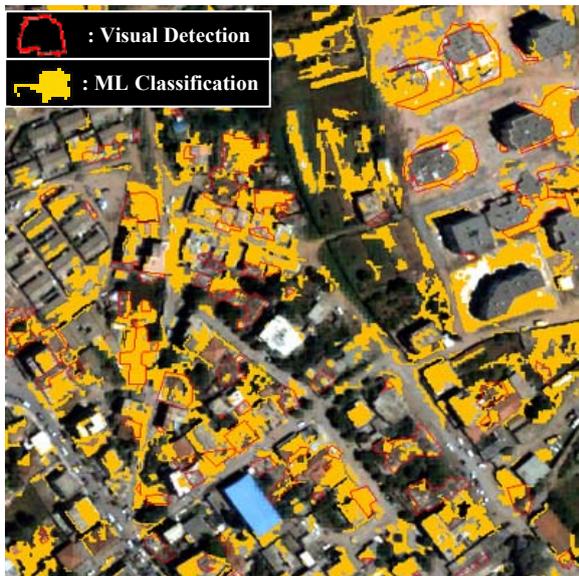
**Figure 5: (a) Debris detected by pixel-based approach and (b) debris detected by object-based approach**

Before performing ML classification, classes were set as follows: gray-roof building, white-roof building, red-roof building, blue-roof building, car, shadow, road, soil, vegetation, and debris. Then, samples for all classes were selected from the post-event image. Finally, the image was classified into the classes mentioned above and only the class of debris was extracted. Fig. 5(a) shows debris areas classified by the pixel-based approach and those visually detected.

As a result, it seems that debris that has been detected is scattered about in the whole image. Additionally, this result indicates that the area classified as debris in the visual detection is not so large and that some errors are seen on the roofs of buildings. The accuracy is discussed and compared with the result of object-based classification in the next section later.

Second, samples of classes that consisted of gray-roof, white-roof, red-roof, and blue-roof buildings, car, shadow, road, soil, vegetation, and debris were selected from the same areas as those used in the pixel-based classification. Using the sample objects' mean values of blue, green, red, and near-infrared band values, and brightness data as indices, the nearest neighbor classification, which is one of the supervised classification techniques, was conducted. After that, the objects classified as the debris class were extracted and shown in Fig.5(b).

Considering the result of the object-based classification, larger areas visually detected as debris have been identified as debris in the object-based damage detection than the pixel-based detection. However, it seems that more errors exist in the areas of white buildings and vegetation. Since merging pixels has removed the variance of spectral data among neighbouring pixels, it can be seen that dotted errors and voids have disappeared. In other words, this approach could realize that an object that spreads to some extent is certainly identified as one homogenous area despite the minute fluctuations of pixel data within the object.
