## DETECTION OF COLLAPSED BUILDINGS DUE TO EARTHQUAKES USING A DIGITAL SURFACE MODEL CONSTRUCTED FROM AERIAL IMAGES

YOSHIHISA MARUYAMA\*, AKIRA TASHIRO  
and FUMIO YAMAZAKI

The buildings that collapsed during the 2007 Niigata Chuetsu-oki earthquake are detected based on aerial photogrammetry using digital aerial images. The digital surface models (DSMs) in the area where severe damage to buildings was observed after the earthquake are constructed using digital aerial camera images. Pre- and post-event aerial images are employed to obtain the DSMs in this study. The differences in building heights between the pre- and post-event models are considered to detect collapsed buildings and the accuracy of the method is discussed in this paper. The results indicate that the collapsed buildings can be detected and undamaged buildings can also be correctly recognized by the proposed method.

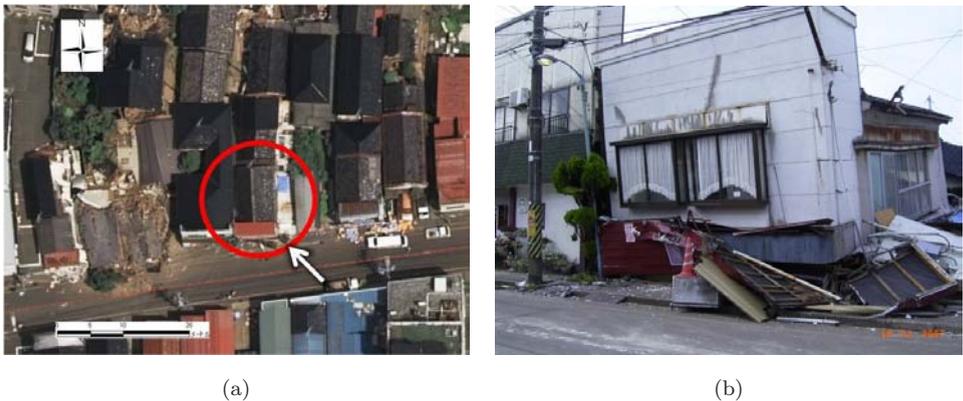
Fig. 1. Comparison between (a) the aerial image and (b) the field photo of the two-story building with the collapsed first story after the 2007 Niigata Chuetsu-oki earthquake.

Thus far, remotely sensed images have been effective in detecting earthquake-induced damages. Because we can only obtain the top view of the affected area, some of the damaged buildings are difficult to reveal. Figure 1 depicts an example of the aerial image captured after the 2007 Niigata Chuetsu-oki earthquake. A two-story building with a collapsed first story was identified from the field photo. The building could not be identified from the aerial image because no significant damage was observed on its roof. In this regard, information on building height will play an important role. High-resolution satellite images were employed to update building inventory data by estimating the number of floors with the aid of shadow length [Miura and Midorikawa, 2006]. Pictometric images are built up from aerial images taken in sequence and in different directions from an aircraft. The images not only have a higher resolution but also offer three-dimensional (3D) depth perception; they were used for damage assessment after the 2010 Haiti earthquake [Madabhushi *et al.*, 2011]. Synthetic aperture radar (SAR) satellite data is used for the estimation of building height [Gamba *et al.*, 2000]. The use of building height estimated using SAR images to detect earthquake damage has been discussed by Balz and Liao [2010].

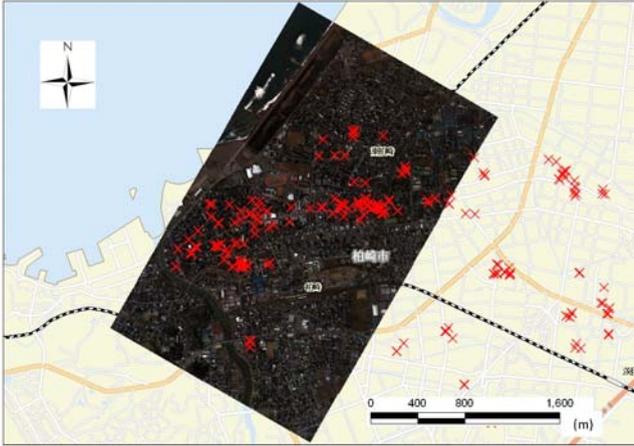
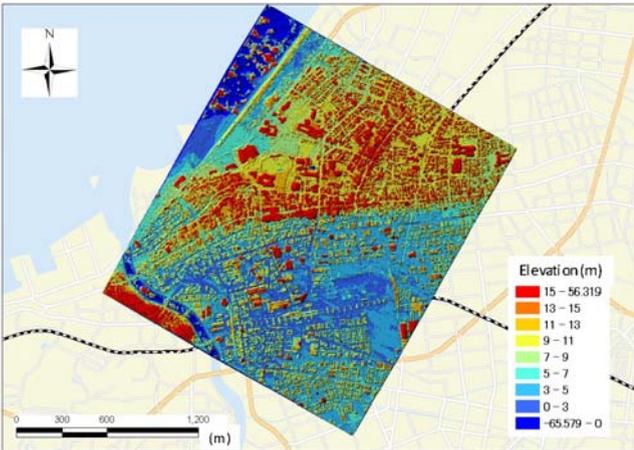
Fig. 2. (Color online) (a) Stereo-pairs of pre-event aerial images and (b) the DSM obtained through aerial photogrammetry. The x-marks in Fig. 2(a) indicate the locations of collapsed buildings due to the earthquake detected by Geospatial Information Authority of Japan.

If the position and the orientation of aircraft are monitored by GPS and IMU during flight, the exterior orientation parameters are directly obtained. For the pre-event images, five sheets of aerial images are established in a map coordinate system and stereo-pairs of digital aerial images are created (Fig. 2(a)). DSMs are

standard products in aerial photography that employ analytical and digital photogrammetric techniques. Analytical photogrammetry is a well-established mapping technique that can provide reliable and accurate measurements [Smith *et al.*, 2004]. Figure 2(b) shows the DSM estimated from the pre-event images through aerial photogrammetry.

The DSM illustrated in Fig. 2(b) was computed on the basis of aerial photogrammetry. It is difficult to construct a 3D model of buildings solely from the computed DSM. Hence, the breaklines [Briese, 2004], which describe the discontinuities of the elevations and are basically extracted manually, were considered in the pre-event

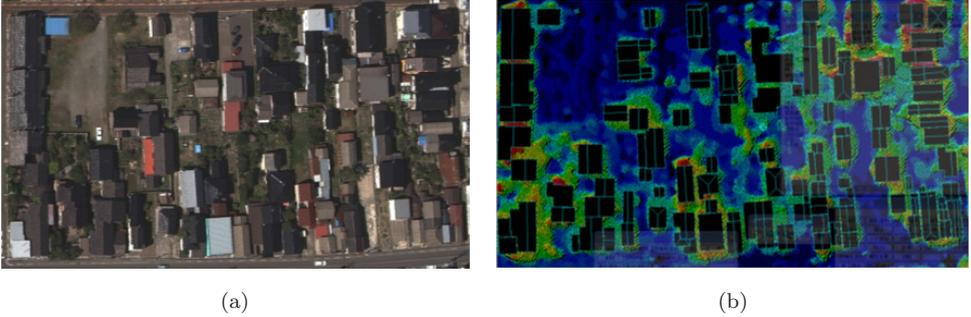
Fig. 3. (Color online) Consideration of breaklines extracted from (a) the digital aerial image in (b) the computed DSM.

DSM (Fig. 3). After the elevations were assigned to both ends of the breaklines, the 3D model of the buildings was eventually created based on the stereo-pairs of pre-event aerial images (Fig. 4). One hundred and nine buildings are realized in the 3D model, which took approximately 2 h to generate.

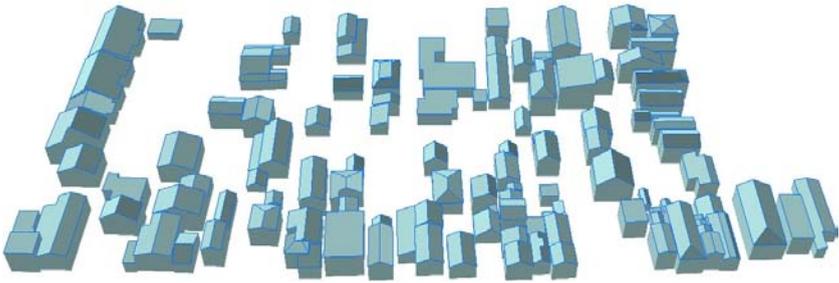
Fig. 4. The 3D model for buildings constructed from the pre-event images.

The differences in building height are employed to detect collapsed buildings due to the earthquake. The triangulated irregular network (TIN) generated from the 3D model for the buildings shown in Fig. 4 is used to determine the heights of the buildings before the event. It takes more time to construct the 3D model of the buildings than to compute the DSM because the breaklines that can be extracted manually are required to develop the 3D model. However, we have a preparation period to make the 3D model of buildings before the event and some of the 3D GIS datasets [Zhou *et al.*, 2004] with building height have recently been well developed. Considering these situations, the authors assume that detailed information on building height can be prepared before an earthquake and the 3D model of buildings in Fig. 4 is used to reveal the building height before the event.

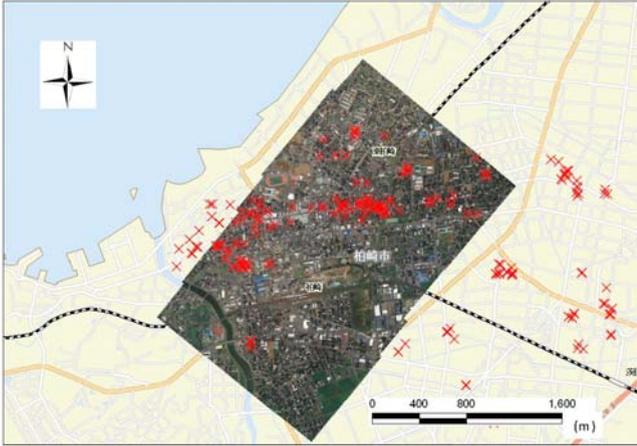
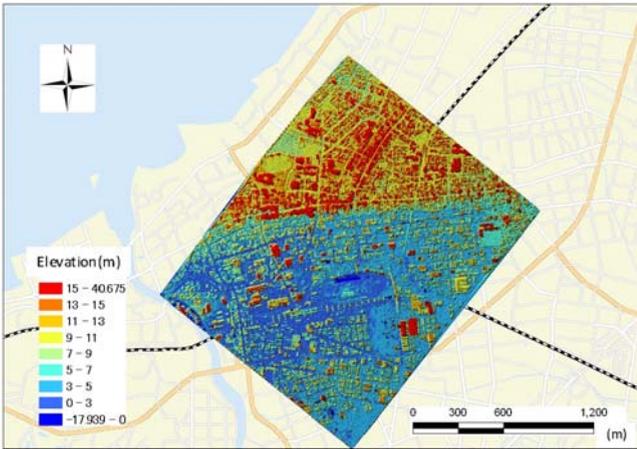
Fig. 5. (Color online) (a) Stereo-pairs of post-event aerial images and (b) the DSM. The x-marks in Fig. 5(a) indicate the locations of collapsed buildings due to the earthquake detected by Geospatial Information Authority of Japan. The exterior orientations were determined by the locations of ground control points extracted from pre-event images to construct the post-event DSM (see Fig. 6).

The post-event digital aerial images were captured by Asia Air Survey Co. Ltd. on July 19, 2007 (three days after the earthquake). A digital mapping camera system (DMC) was employed to obtain the aerial images in the affected areas. The GPS/IMU system was also operated during the flight. Following the same procedure as the previous chapter, six sheets of aerial images were established in terms of map projection using the record of the GPS/IMU system and stereo-pairs of images were developed (Fig. 5(a)). Next, aerial photogrammetry was performed to compute the DSM from the post-event aerial images.

In this study, the stereo-pairs of post-event aerial images were re-established in terms of map coordinates by introducing ground control points. The ground control points were extracted from the stereo-pairs of pre-event images because they could be georeferenced correctly with the record of the GPS/IMU system. Figure 6 shows examples of the control points extracted from the stereo-pair of the pre-event images. A total of 12 control points were extracted from the pre-event images. Assuming a collinearity condition [Habib *et al.*, 2000], the exterior orientations of the post-event images were calculated based on the locations of the 12 control points. Then, the computational DSM was developed from the post-event images (Fig. 5(b)).

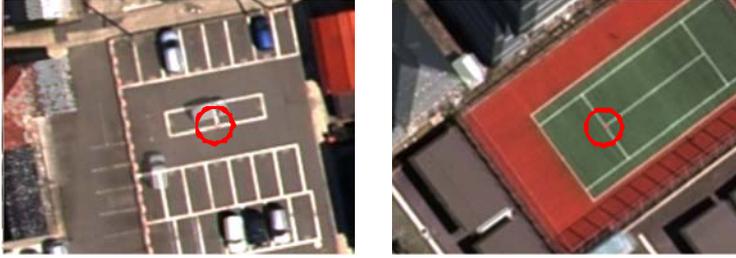
Fig. 6. Extraction of control points from the stereo-pairs of pre-event images to revise those of post-event images.

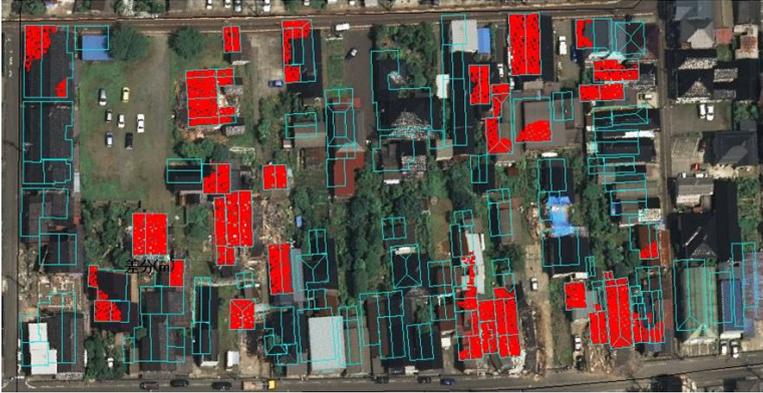
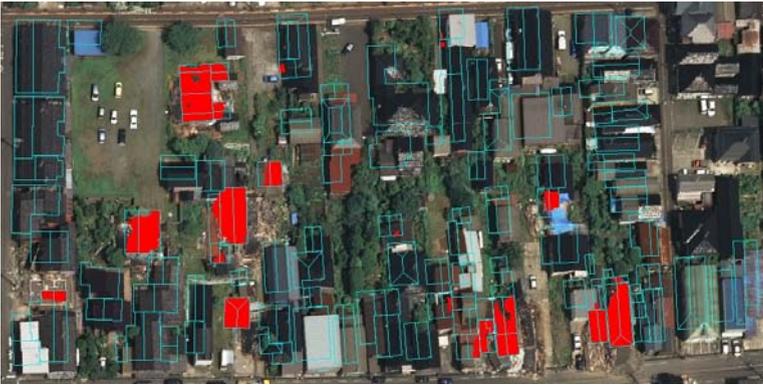
Fig. 7. (Color online) Results of detection of collapsed buildings considering the differences in building height between the pre- and post-event models. The height of buildings after the earthquake was estimated from (a) the computed DSM and (b) the 3D model constructed using breaklines. Red pixels indicate those with height differences of more than 2.5 m.

Subtracting the height of the building estimated from the post-event images from that of the pre-event model, the collapsed buildings were extracted. According to Hobi and Ginzler [2012], the vertical median error of the DSM constructed from images captured by a digital aerial imaging system is less than 4.8 times of spatial resolution, which corresponds to approximately 0.8 m in this study. Hence, the DSMs developed from the aerial images can be used for accurate height modeling. Since this study tries to detect buildings with a collapsed first story, the threshold value to detect this failure mode is set to be 2.5 m. In this regard, the authors assume that the average height of each story is approximately 3 m. Figure 7 shows the results of the detection of collapsed buildings, taking into consideration the differences in heights between the pre- and post-event models. Since the detailed damage information of buildings was difficult to access, the accuracy of the estimation was examined through comparison with the result of the visual damage inspection of the aerial image and field photos shown in Fig. 8. Table 1 summarizes the comparisons. Here, partial collapse refers to buildings whose less than half of areas are covered with red pixels in Fig. 7. An inclined building was found through the visual damage inspection of field photos in the lower part of Fig. 8 and it was also labeled as partially collapsed in Table 1.

According to the visual inspection, 18 collapsed, 1 partially collapsed, and 90 undamaged buildings were observed. When the height of buildings was estimated from the computed DSM, 16 of the 18 collapsed buildings could be pointed out. Although the 13 undamaged buildings were misrecognized as collapsed ones, these are located in the upper-right area of Fig. 7(a), where the computed DSM contained much noise. Because of the less accurate DSM, some of the buildings were mistakenly recognized as being collapsed. Except for this area, many of the undamaged buildings were correctly detected using the computed post-event DSM. Using the height of buildings estimated by the 3D model that considered breaklines, only 5 of the 109 buildings were incorrectly detected. This result suggests that better estimations could be obtained if detailed information regarding building height is available after an earthquake.

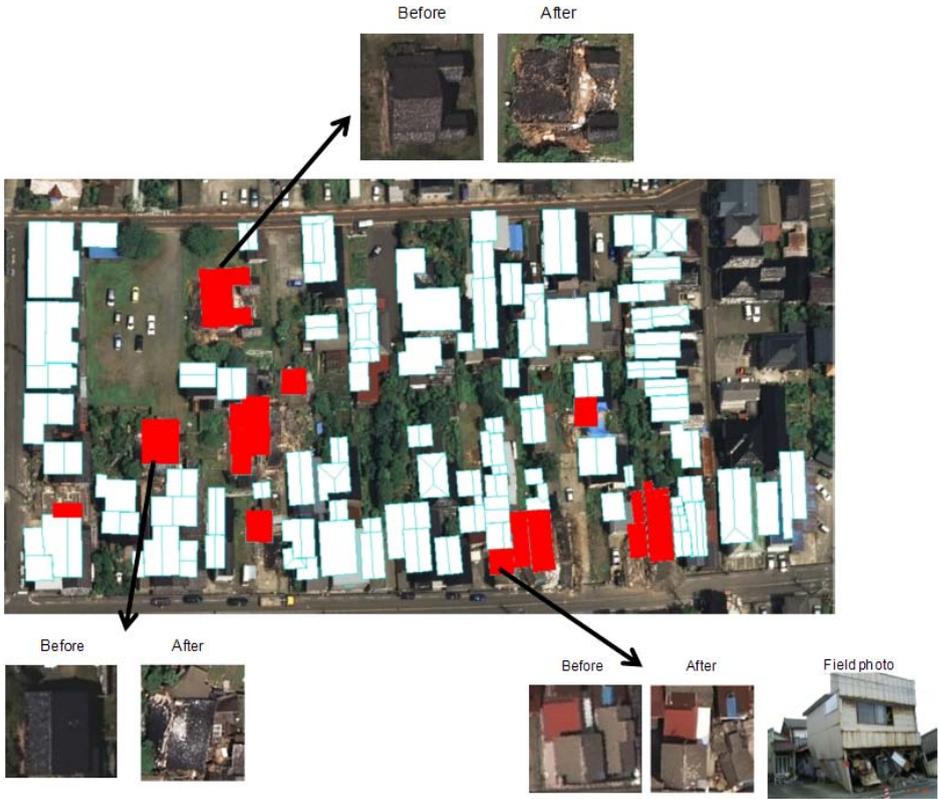
Fig. 8. (Color online) Examples of visual damage inspection using aerial images and field photos and detected collapsed buildings by this study.
