REMOTE SENSING TECHNOLOGIES IN POST-DISASTER DAMAGE ASSESSMENT

FUMIO YAMAZAKI

This paper highlights the recent applications of remote sensing technologies in post-disaster damage assessment, especially in the 2004 Indian Ocean tsunami and the 2006 Central Java earthquake. After the 2004 Indian Ocean tsunami, satellite images which captured the affected areas before and after the event were fully employed in field investigations and in tsunami damage mapping. Since the affected areas are vast, moderate resolution satellite images were quite effective in change detection due to the tsunami. Using high-resolution optical satellite images acquired before and after the 2006 Central Java earthquake, the areas of building damage were extracted based on pixel-based and object-based land cover classifications and their accuracy was compared with visual inspection results. In the Central Java earthquake, ALOS/PALSAR captured a SAR image of the affected area one day after the event as well as pre-event times. Taking the difference of the pre-event correlation and the pre-and-post event correlation, the areas affected by the earthquake were also identified. From these examples, the use of pr

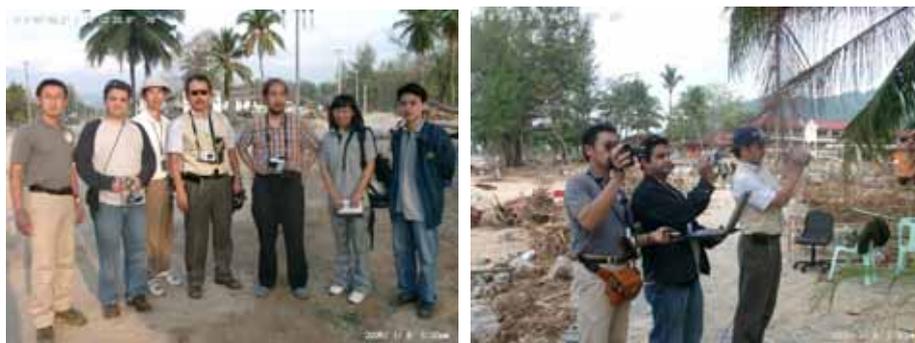
Figure 1. (a) Members of the field survey team and (b) video shooting with three videos synchronized with GPS

adopted (Figure 1(b)) by deploying three video cameras that simultaneously captured footage for three directions (front, left, and right) in some heavily affected areas. This streamlined the video collection process and provided a wider view of the area. We named this new system as “Panoramic-VIEWS”.

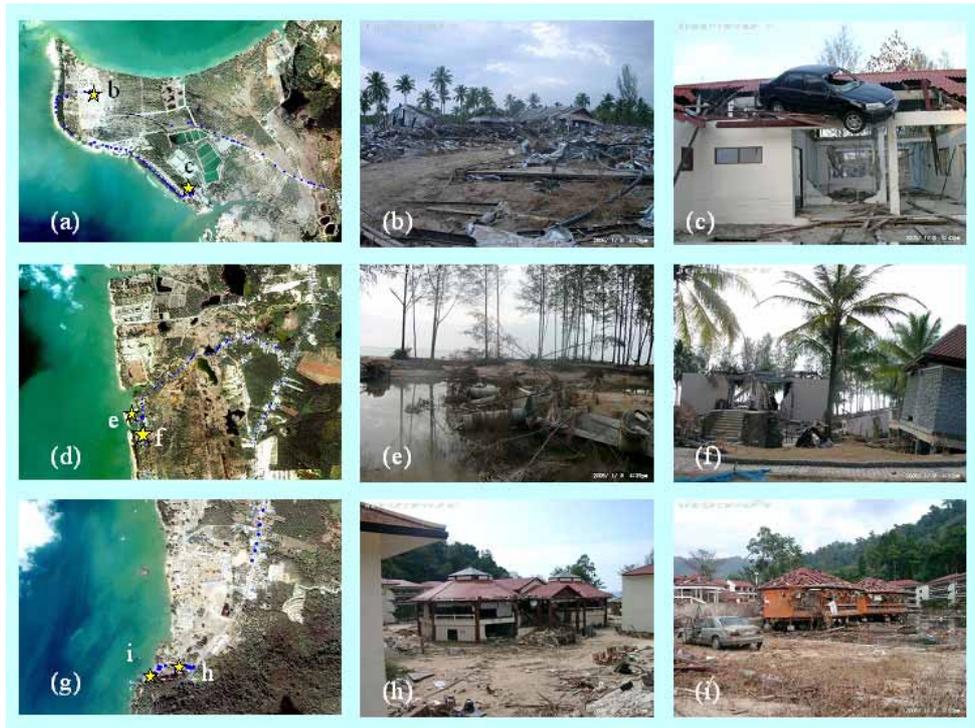
Figure 2: Post-tsunami IKONOS image of Khao Lak and photos taken during the field survey. (a) Phakarang cape area, (b) devastated Bamboo Orchid Resort, (c) a car on the roof, (d) mid Khao Lak area near Weather station, (e) a collapsed bridge by tsunami, (f) destroyed cottages in a resort, (g) Nang Thong beach area in lower Khao Lak, (h) & (i) Similana Resort devastated by tsunami

Figure 2 shows the post-tsunami Ikonos images of Khao Lak and the photos taken during the field survey. Blue dots in Ikonos images are the location of geo-referenced photo shooting. Figure 2(a) is Ikonos image of Phakarang cape area with 1 m resolution, (b) is the photo of devastated Bamboo Orchid Resort on Phakarang cape, (c) shows a car thrown on the roof by tsunami. If we enlarge the Ikonos image, several black pixels corresponding to this car can be identified. Figure 2(d) is Ikonos image of mid Khao Lak area near a weather station, (e) is a collapsed bridge by the tsunami near the weather station, and (f) shows destroyed cottages in a resort. Figure 2(g) shows Nang Thong Beach area in lower Khao Lak, and Figures 2(h) and (i) are photos taken in Similana Resort, which was devastated by the tsunami of about 5 m high.

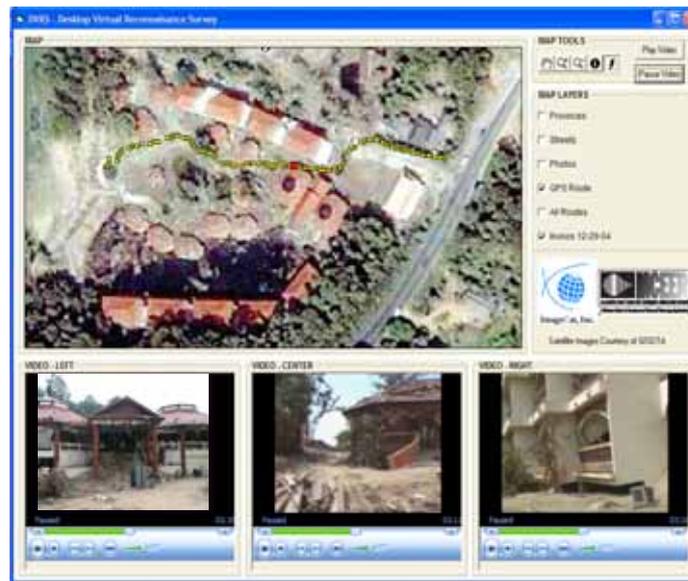
Figure 3. Screen shot from the virtual reconnaissance system, showing satellite imagery, GPS readings, video footage from three video cameras collected in Khao Lak, Thailand (Ghosh et al. 2005)

In order to integrate, share, visualize, and ultimately analyze post-disaster reconnaissance field data collected using VIEWS, MCEER funded the development of tandem internet- and desktop-based “virtual reconnaissance systems” (Ghosh et al. 2005). Figure 3 shows a screen shot from the virtual reconnaissance system, showing satellite imagery (Ikonos on 2004/12/29) with GPS readings and video footage from three video cameras collected in Khao Lak. By selecting a GPS point, users can view corresponding video footage and scroll the photographic archive in the adjacent windows.

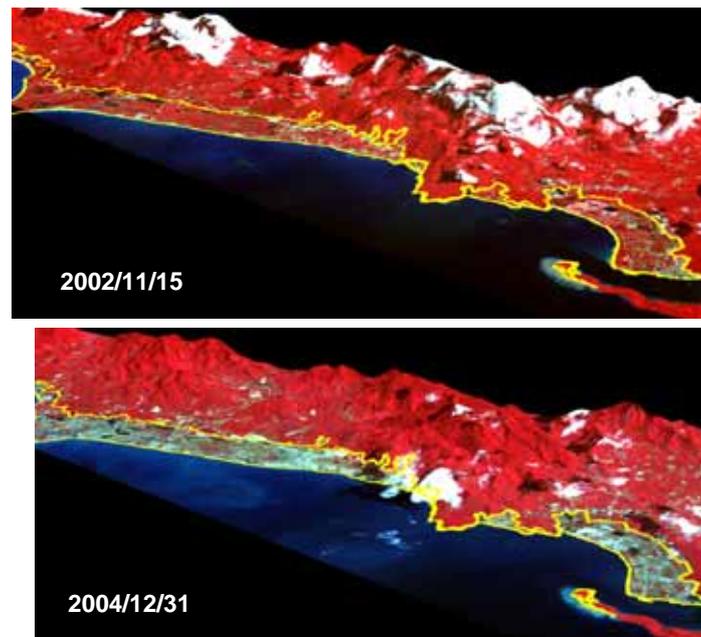
Figure 4. ASTER false color composite images of Khao Lak before (Nov. 15, 2002) and after (Dec. 31, 2004) the tsunami plotted on SRTM 90 m DEM. Yellow lines drawn over ASTER images show tsunami inundation boundary visually extracted by GISTDA.

Terra-ASTER observed the hard-hit area including Khao Lak two years before and 5 days after the tsunami, as shown in Figure 4 in a false color composite: which means the

reflectance of the near-infrared (NIR) band is assigned to the red component, that of the red (R) band to the green component, and that of the green (G) band to the blue component, respectively. The false color images are shown overlying a digital elevation model (DEM) of 90 m grid from SRTM (Shuttle Radar Topography Mission, Jet Propulsion Laboratory 2005).

Comparing these images, it could be observed that the reflectance of the near-infrared band in the affected areas became weak after the tsunami, which roughly means that, due to the tsunami, vegetation there might be removed/killed and that the land cover class might be changed to soil. This observation has also been confirmed in the field survey.

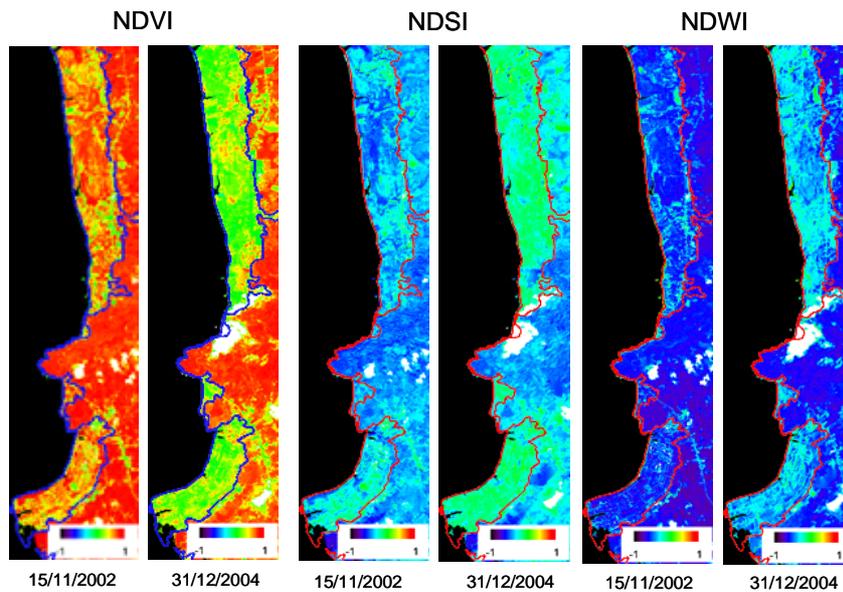
Figure 5. Computed NDVI, NDSI, and NDWI for the pre-event and post-event ASTER images.

The thematic maps of NDVI, NDSI, and NDWI are shown in Figure 5. The greater NDVI becomes, the more probable the area is covered with vegetation. It is also the case with NDSI for soil and NDWI for water. The first analysis is to compare the characteristics of the three indices in the affected areas and non-affected areas using only a single post-event image, and consequently, to determine the thresholds for detection of tsunami-affected areas. This approach is applicable in the case no pre-event image exists.

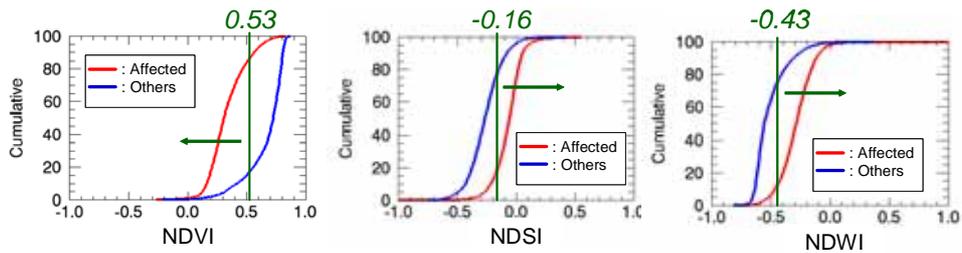
Figure 6. Cumulative frequency distributions of NDVI, NDSI, and NDWI from the data one week after the tsunami.

The cumulative frequency distributions of NDVI, NDSI and NDWI in the affected areas and non-affected areas are plotted in Figure 6. As a result, it is observed that there are clear differences in the distributions between the two plots for each index. It is possible to determine a value where the difference between their cumulative frequency distributions is maximized as a threshold to distinguish two classes. Using this method, the thresholds to identify affected areas are 0.53 for NDVI, -0.16 for NDSI, and -0.43 for NDWI in this example. To summarize, the pixels which have NDVI value less than the threshold, and NDSI and NDWI values more than the thresholds are identified to belong to tsunami-affected areas using only the post-event image.

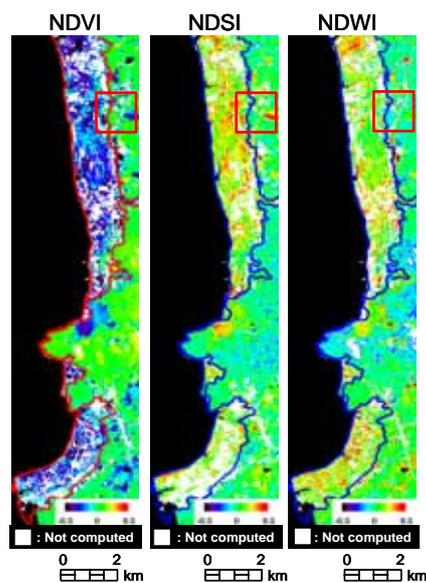
Figure 7. Differences of the three indices obtained from the pre- and post-event ASTER images.

After eliminating the seasonal effect, the indices' differences are illustrated in Figure 7, where white pixels were excluded from the following process.

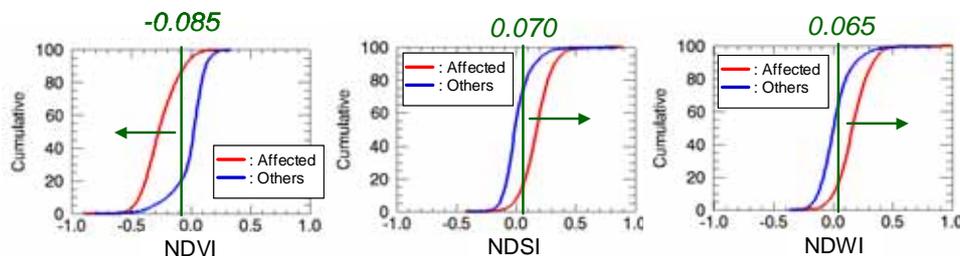
Figure 8. Cumulative frequency distributions of the differences of NDVI, NDSI, and NDWI obtained from the pre- and post-tsunami images.

The cumulative frequency distributions of the time differences of NDVI, NDSI, and NDWI in the affected and non-affected areas are plotted in Figure 8. Similarly to the result using only the post-event image, the thresholds for detecting tsunami-affected areas were determined. In this example, the visually extracted tsunami run-up boundary was used as the truth data. But for the case with no truth data, digital elevation models, topographic condition, and the distance from the coast line should be employed to obtain an accurate tsunami inundation map.

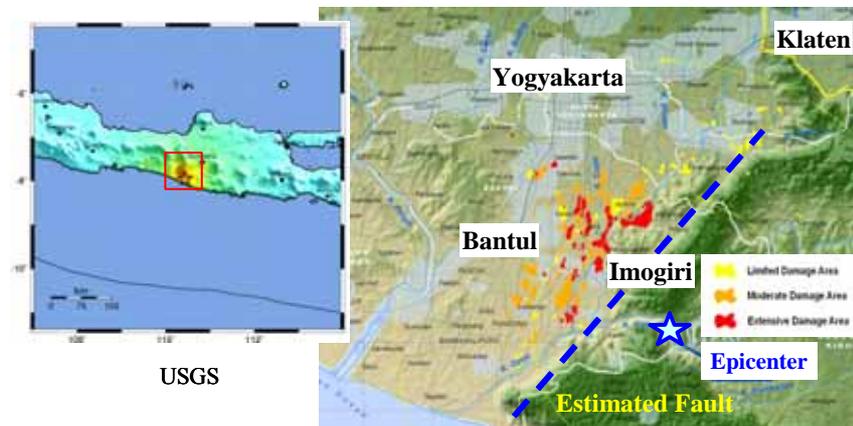
Figure 9. Epicenter of the 2006 Central Java earthquake (USGS 2006) and preliminary damage assessment map produced by UNOSAT (2006) on May 31, 2006.

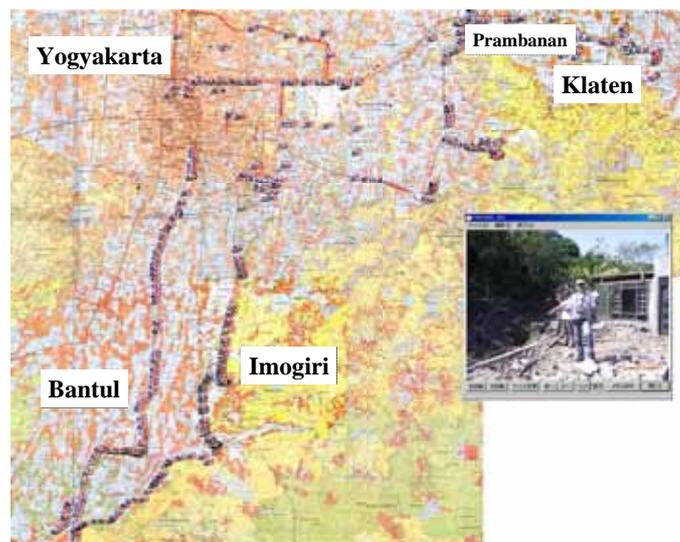
Figure 10. Field survey route by the authors. Camera icons show the locations of GPS synchronized photo shooting.

After the earthquake, various international teams conducted damage surveys of the affected area. As one of sub-teams of the research group supported by the Ministry of Education, Science, Sports and Culture (MEXT), Japanese Government, Grant-in-Aid for Special Purposes (No.1890001, 2006), the present authors visited the affected area from 26 to 30 June, 2006. The main objective of our sub-team was to gather geo-referenced ground truth data, which can be used to validate the damage detection results from satellite images. Figure 10 shows the route of the field survey. The camera icons on the map show the locations where we took geo-referenced digital photos.

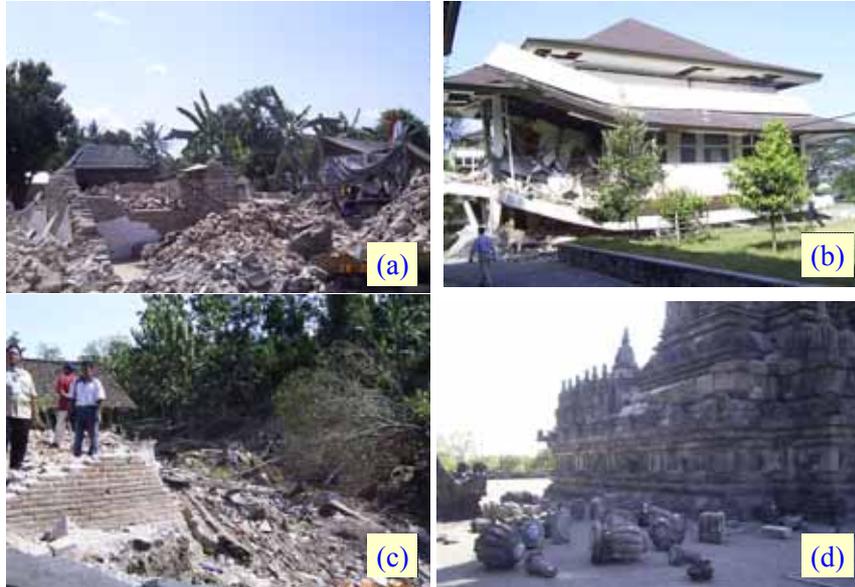
Figure 11. Typical damages seen in the field survey: (a) collapsed brick-masonry houses in a rural area, (b) a collapsed reinforced-concrete school building, (c) a large-scale landslide observed in a mountainous area, (d) stones fallen down from the towers in Prambanan temple compound.

Figure 11 shows typical damages observed in the field. Figure 11(a) is collapsed brick-masonry houses in a rural area. This type of total collapses of walls and roofs were seen everywhere and considered to be responsible for many casualties in this earthquake in spite of

its small magnitude. Figure 11(b) shows a collapsed reinforced-concrete school building. Such severe damages to engineered buildings were seen only at limited locations. Figure 11(c) shows a large-scale landslide observed in a mountainous area. In Prambanan World Heritage, the largest Hindu temple compound in Indonesia, many big stones were fallen down from the towers as shown in Figure 11(d). The site has been closed to tourists since the earthquake and it was reported that the restoration may take a few years.

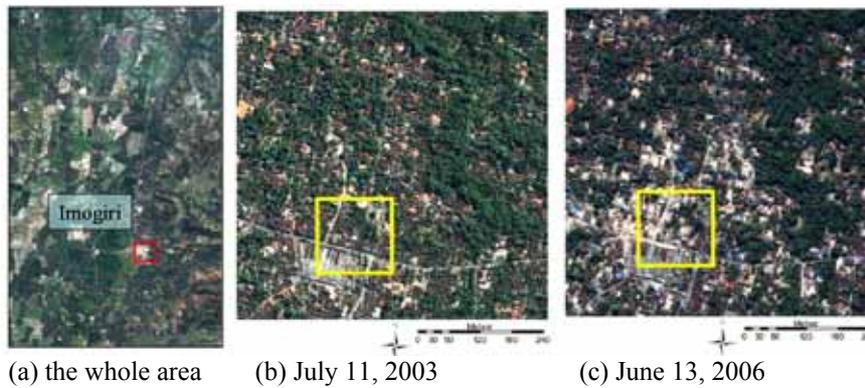
Figure 12. (a) Pan-sharpened natural color QuickBird images of Imogiri area, (b) is the pre-event image and (c) is the post-event image used in this study.

QuickBird has 0.6 m resolution in panchromatic mode and 2.4 m resolution in multispectral mode with 4 bands: blue, green, red, and near-infrared. A pan-sharpened image of 0.6 m resolution can be produced through combining a panchromatic image and a corresponding multispectral image. After the Java Earthquake, QuickBird captured a clear image of the affected areas on June 13, 2006. The image includes Imogiri, one of the most severely affected areas in this earthquake. For the area, a pre-event image captured on July 11, 2003 also exists. Thus a part of these images, shown in Figure 12, were used in this study.

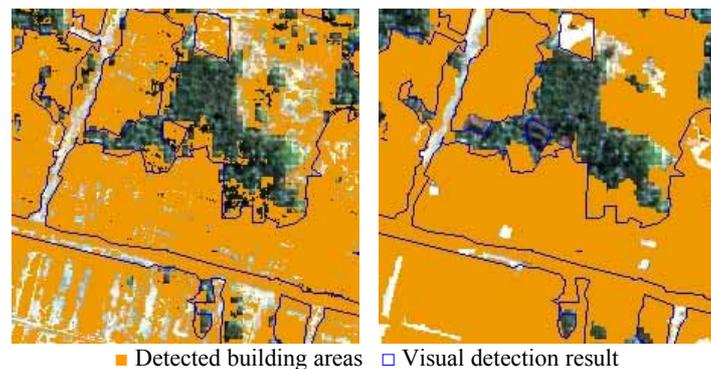
(a) Pixel-based classification (b) Object-based classification

Figure 13. Part of the pre-event image (yellow square in Figure 12 (b)) and the result of land cover classifications.

First, a pixel-based classification was carried out based on the maximum likelihood method, the most common supervised classification method, using 8-bit four bands data. The following 8 classes: black-roof, gray-roof, red-roof, white-roof buildings, road, soil, vegetation, and shadow, were assigned for the pre-event image as the training data. For the post-event image, 7 classes: black-roof, gray-roof, red-roof buildings, debris, road, vegetation, and shadow, were assigned. White-roof building and soil classes were not used for the post-event image because they look close to the debris class and it was difficult to select their training data. The building areas obtained by the pixel-based classification are shown in Figure 13 (a) and Figure 14 (a). In these figures, the buildings with different roof-color are shown in the same color for easier understanding.

The results from the object-based classification for the pre-event and post-event images are shown in Figures 13 (b) and 14 (b), respectively. Comparing the results from the pixel-based and object-based classifications with that by visual inspection, salt-and-paper noises are seen in the pixel-based classification. Hence, it may be concluded that in this high resolution and the sizes of the target objects, the better result can be acquired by object-based classification. But in object-based classification, some road and shadow areas were misclassified to building classes because their spectral values of the sample area are similar to those of building classes. Hence even object-based classification, some classes like these are needed to remove in advance using object feature indices, e.g. length, or spatial relationships.

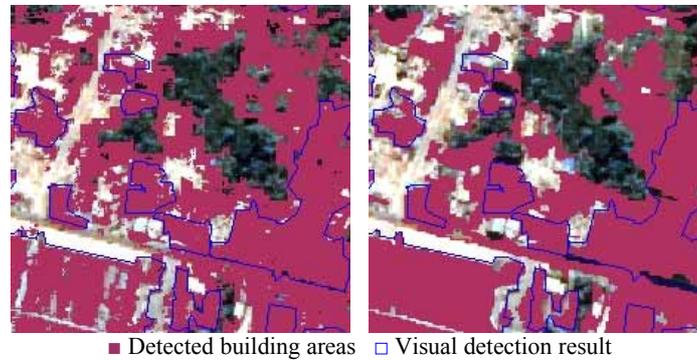
(a) Pixel-based classification (b) Object-based classification

Figure 14. Part of the post-event image (yellow square in Figure 12 (c)) and the result of land cover classifications.

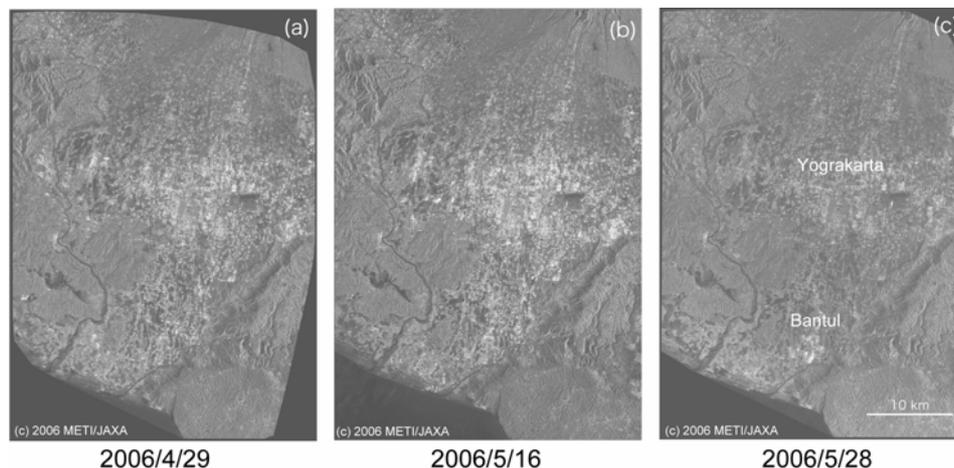
Figure 15. Backscattering intensity images of Yogyakarta area from ALOS/PALSAR before and after the 27 May 2006 Central Java earthquake.

By activating the disaster charter (International Charter 1999), L-band SAR system, PALSAR (HH polarization with 9 m resolution) onboard ALOS, was operated for capturing the information on the areas damaged due to the earthquake. Figure 15 shows the backscattering intensity images of time-series PALSAR covering Yogyakarta and central Java provinces. On the next day of the earthquake, PALSAR observed the area successfully in 36.9 degree off-nadir angle (microwave transmission angle). Two pre-event images had also been obtained on April 29 and May 16, 2006 with 34.3 and 30.8 degree off-nadir angles, respectively. Using these images, the variation of the correlation coefficient was calculated and the effects of signal noise and stationary temporal changes were evaluated. The

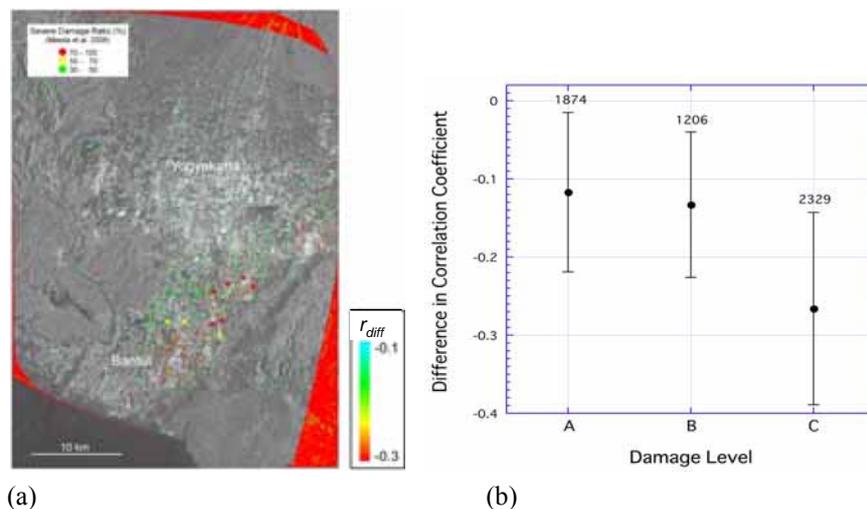
Figure 16. (a) Distribution of the difference, r_{diff} , between correlation coefficients derived from ALOS/PALSAR imagery, plotted on the post-earthquake backscattering intensity image. Areas with extremely negative r_{diff} values at the edge of the image are errors due to image co-registration. The colored circles indicate the building damage ratio surveyed by Maeda et al. (2006). (b) Relationship between the building damage level and the difference between correlation coefficients, r_{diff} . The damage levels were classified as A, B or C, corresponding to damage ratios of 30-50%, 50-70% and 70-100%, respectively.

distribution of the difference, r_{diff} , between the r_{bb} value of the two pre-event images and the r_{ab} of the pre- and post-event images plotted on PALSAR intensity image is shown in Figure 16 (a). To focus on built-up areas, the decorrelated areas (correlation coefficient less than 0.8) from the pre-event pair were excluded from the analysis in advance. In Bantul, the lower r_{diff} areas distribute from southwest to northeast, showing good agreement to the estimated damaged areas (see Figure 9) by visual interpretation from high-resolution satellite images (UNOSAT 2006).

A Japanese field survey team carried out an intensive building damage investigation around schools and obtained the ratio of severely damaged buildings in a 500 m radius from a school (Maeda et al. 2006). In Figure 16 (a), twelve investigated areas (colored-circles classified by the severely damaged ratio) are also plotted on the r_{diff} distribution.

For a quantitative analysis, we selected pixels within the investigated circles in the field survey and calculated the average and standard deviation of r_{diff} value in each damage level. The damage levels classified into A, B, and C, correspond to the severely damaged ratio of 30-50, 50-70, and 70-100 %, respectively. The comparison between the building damage level and the difference in correlation coefficient, r_{diff} , is shown in Figure 16 (b). The numbers on the top of the error bars represent the counts of pixels. In the figure, as the damage level increases, the difference in the correlation coefficient is seen to decrease although the standard
