## DAMAGE DUE TO LIQUEFACTION DURING THE 2011 TOHOKU EARTHQUAKE

Shoichi Nakai<sup>1</sup> and Toru Sekiguchi<sup>2</sup>

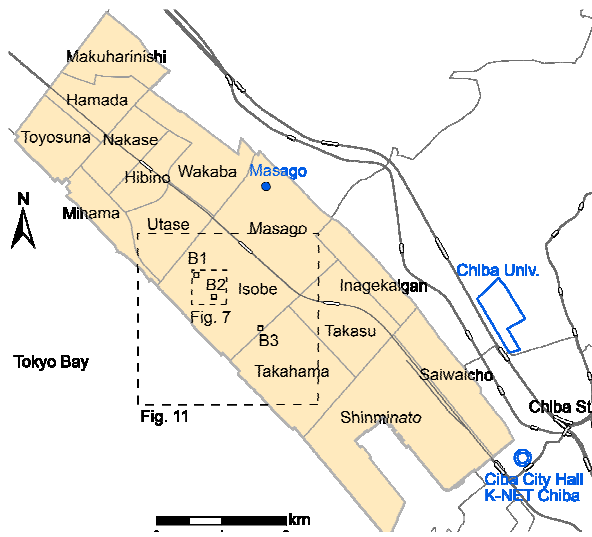
Figure 2 Map of Mihama ward

Figure 2 shows the map of Mihama ward with the constitution of districts. Mihama ward is located in the western part of Chiba city along the coast of Tokyo Bay and consists entirely of the reclaimed ground. It was reclaimed by dredge soil consisting of sand or sandy silt taken from the sea bed of Tokyo Bay. Reclamation was carried out from the southern part of the ward toward north from 1960s until mid-1980s.

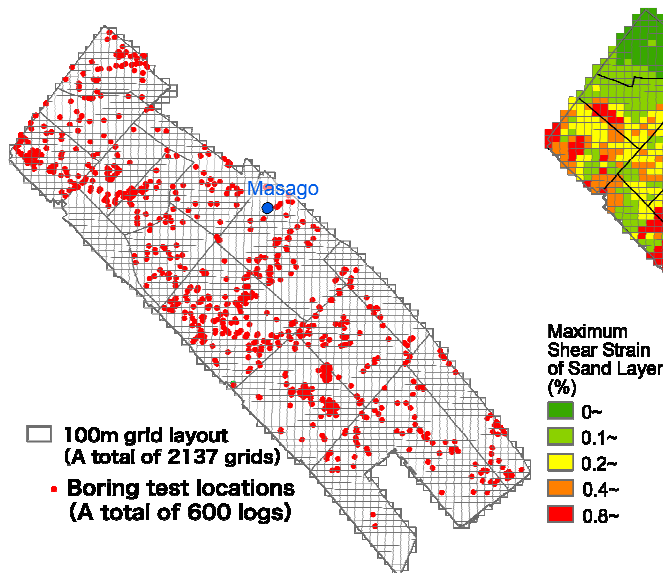
Figure 9 Boring test locations

We have collected a total of about 600 boring logs in this area, as shown by the dots in Figure 9. Based on these data, three-dimensional soil model of this area has been constructed in the following way:

- The target area is partitioned into a number of small areas, each of which has the size of 100 m by 100 m.
- The soil profile for each subdivided area is determined by the weighted average of surrounding eight boring logs nearest to the area.
