After the 2011 Great East Japan Earthquake, an investigation team consisted by the members from NILIM (National Institute of Land, Infrastructure and Management) and BRI (Building Research Institute) was dispatched to the disaster areas on July 1<sup>st</sup> and 2<sup>nd</sup> to examine performance of SI buildings. The seismically isolated buildings showed excellent performance without any severe damage even to nonstructural elements in superstructure. However, some damage to isolation dampers and expansion joints were observed. This paper introduces some cases to explain seismic performance of seismically isolated buildings.

## PERFORMANCE OF HIGH-RISE BUILDINGS

## PERFORMANCE OF SEISMICALLY ISOLATED BUILDINGS

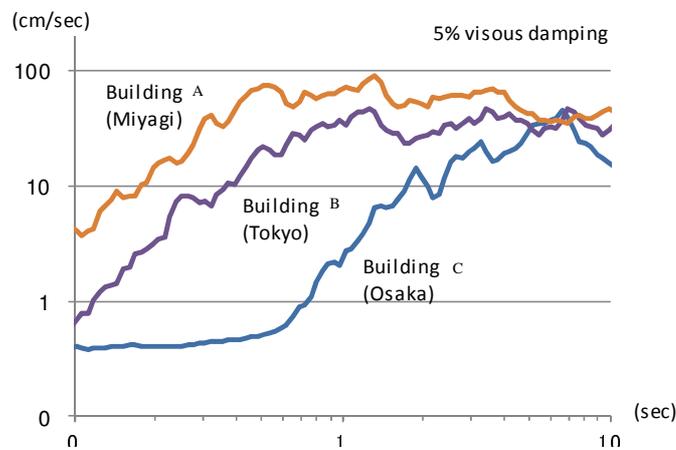
**Figure 2.** Velocity response spectra

Table 1 shows the list of high-rise buildings under observation located in Sendai, Tokyo and Osaka and the maximum acceleration values observed in the buildings. Figure 2 shows the velocity response spectra of the horizontal records at the lowest levels of the high-rise buildings in Miyagi, Tokyo and Osaka. The velocity spectra of Miyagi and Tokyo have strong component in the wide band period from 0.5 seconds to 10 seconds; therefore, it is considered not only high-rise buildings but also low-rise buildings were strongly shaken by the earthquake ground motions. On the other hand, the response spectrum of Osaka has a peak period of 6-7 seconds, and it was a typical long-period ground motion which shakes high-rise buildings.

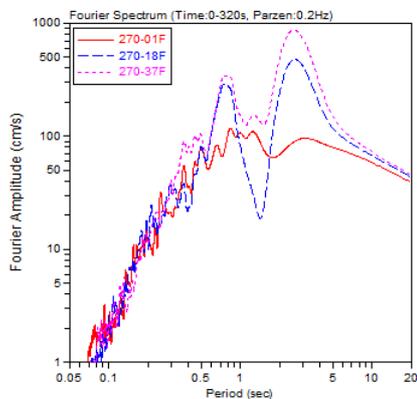
**Figure 4.** Fourier spectrum (Building B)

Figure 4 shows the Fourier spectra of acceleration records observed at 1<sup>st</sup>, 18<sup>th</sup> and 37<sup>th</sup> floor of the high-rise building B in Tokyo. The spectra of the records at 18<sup>th</sup> and 37<sup>th</sup> floors have two peaks which correspond to the first and second mode vibrations. Minor damage around the entrance of each residential unit was observed as shown in Figure 5. The number of units which suffered damage was counted in each floor and it is seen that the damage distributes in the medium floors. This fact suggests the effect of second mode vibration.
