Development of Building Damage and Tsunami Inundation GIS Dataset following the 2010 Chile Earthquake

Summary

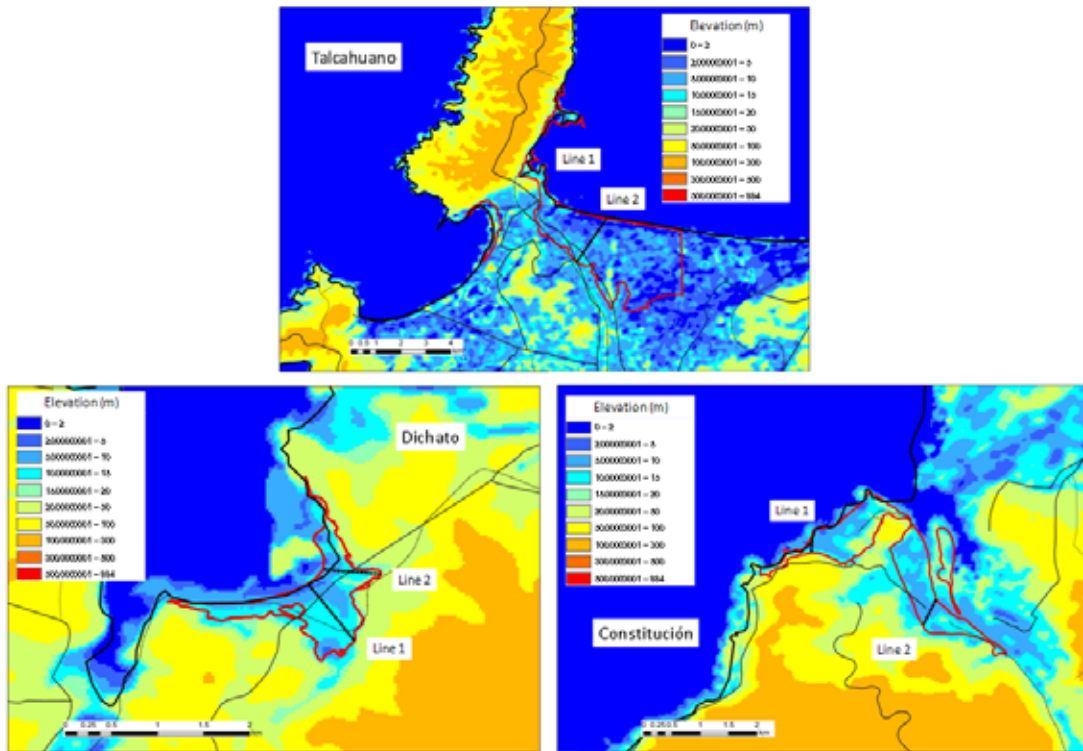
Fig. 8: Tsunami-inundated areas in Talcahuano, Dichato, and Constitución

Figure 8 shows the tsunami-inundated areas in Talcahuano, Dichato, and Constitución and the distributions of the elevation derived from the ASTER GDEM. The elevations in the inundated areas are lower than 20 m on the whole except for a certain area in Constitución. As shown in the figure, we set the two traverse lines in each inundated area. The elevations were extracted along the two lines. The extracted elevations are illustrated in terms of the distance from the coastline in Fig. 9. As for Line 2 in Constitución, the elevations are presented with respect to the distance from the Maule River. The relatively low elevations and slow grades result in long travel distances of the tsunami wave. According to Line 2 in Talcahuano, the tsunami wave could travel approximately 2000 m from the coastline. Line 1 in Constitución was assigned to identify the surveyed site by Imamura *et al.* [13]. According to their report, the tsunami runup height was 28.3 m at the site. Since the DEM used in this study is a global dataset that consists of 30-m grid cells, the elevation at the site is estimated to be approximately 23 m. The slope is estimated to be approximately 67% and is almost equivalent to that reported by Imamura *et al.*, which is 63.5% [13].

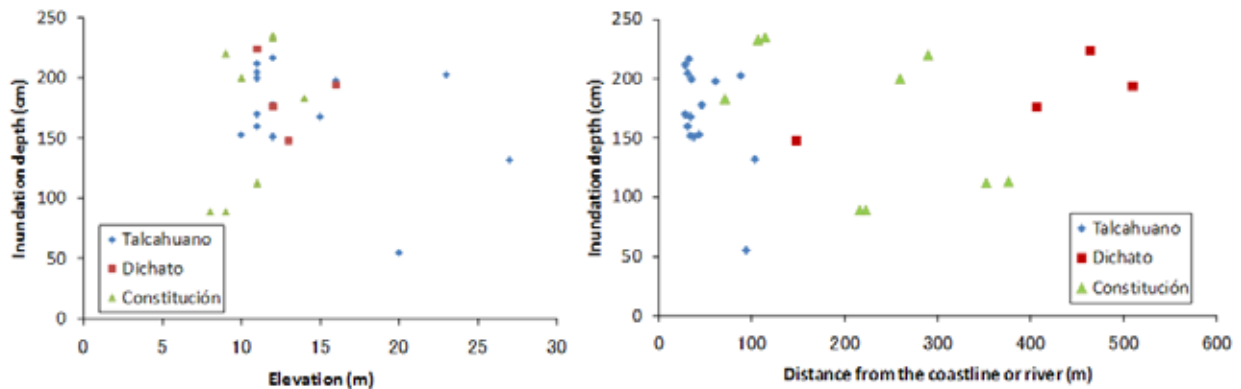
Fig. 11: Summary of the measurement of tsunami inundation depth

As shown in Fig. 10, the inundation depth was measured at several sites in the three cities. The inundation depth along the beachfront street in Talcahuano was larger than 150 cm, but a depth of 55 cm was observed in its bystreet (site 4). Figure 11 summarizes the measurements in the three cities. The inundation depth is presented with respect to the elevation and the distance from the coastline. As for the results in Constitución, the records are shown with respect to the distance from the Maule River. A clear tendency is not seen in the relationship between the tsunami inundation depth and the elevation. The recorded depth in Talcahuano and Constitución decreased with an
