# Field survey of the 2010 tsunami in Chile

We conducted the field survey of the tsunami generated by the M8.8 great earthquake in Chile triggered on 27 February 2010 (UTC). The survey focused on the measurements of tsunami inundation/run-up height, flow depth, extent of inundation zone, structural damage inspection, and collecting eyewitness accounts. In total, tsunami heights and flow depths at approximately 155 points were measured along the coast of Biobío region, Chile, to understand the tsunami features during this event.

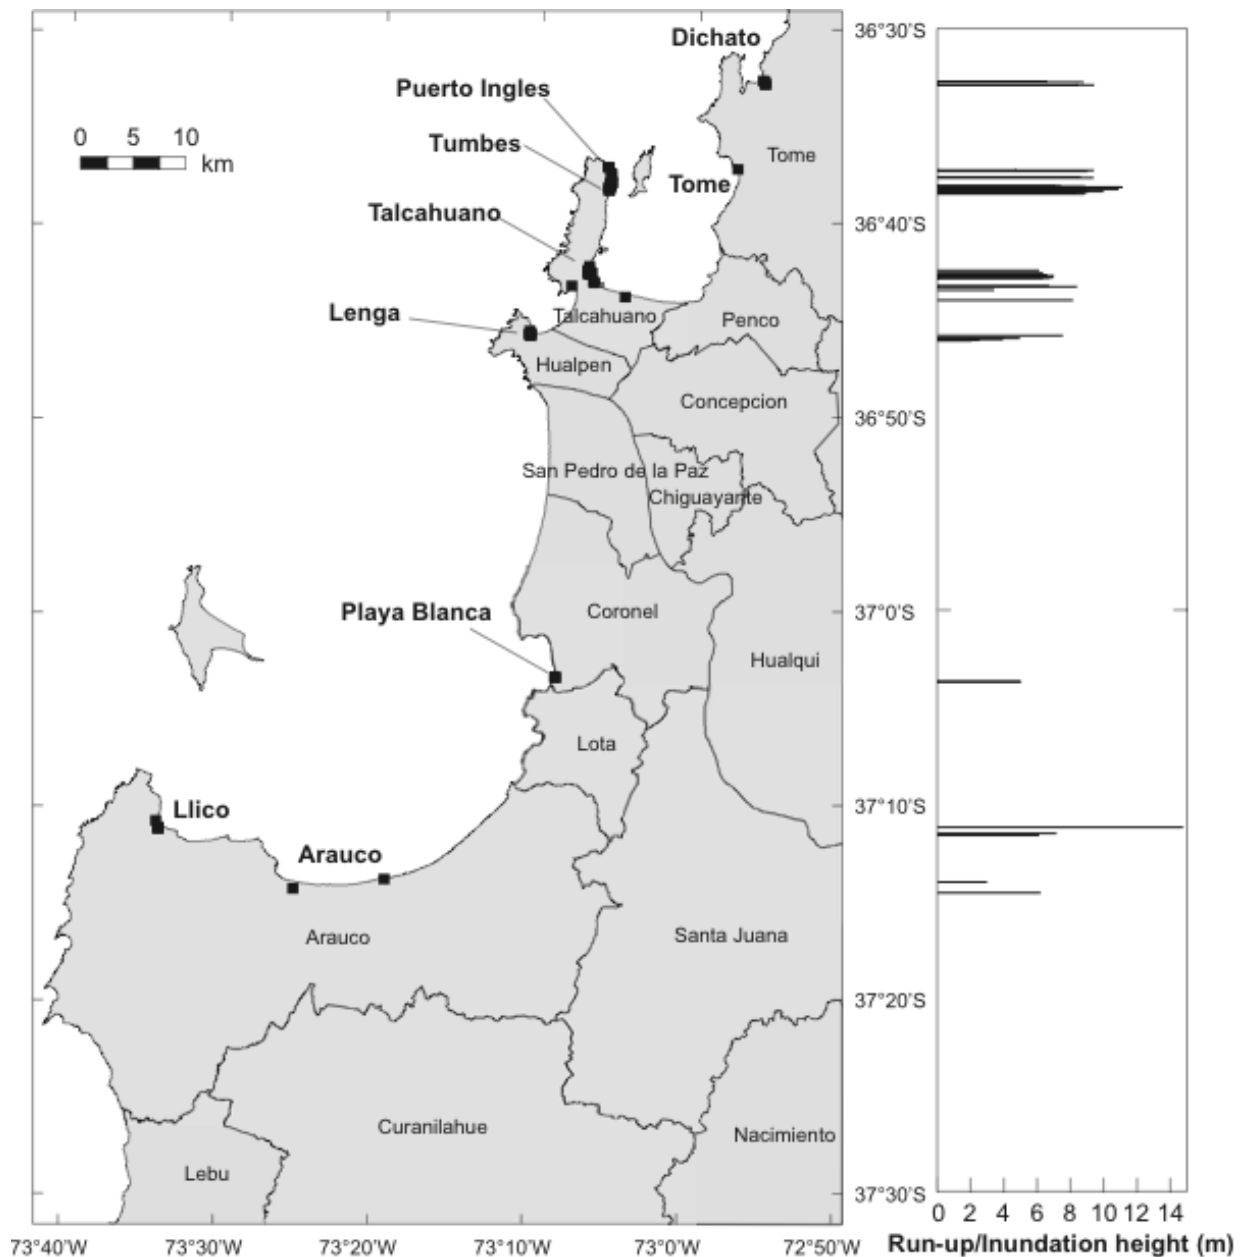
**Fig.3** Longshore distribution of inundation and run-up height above the astronomical tide level when the tsunami arrived. Tide correction was made by using tide table in Talcahuano.

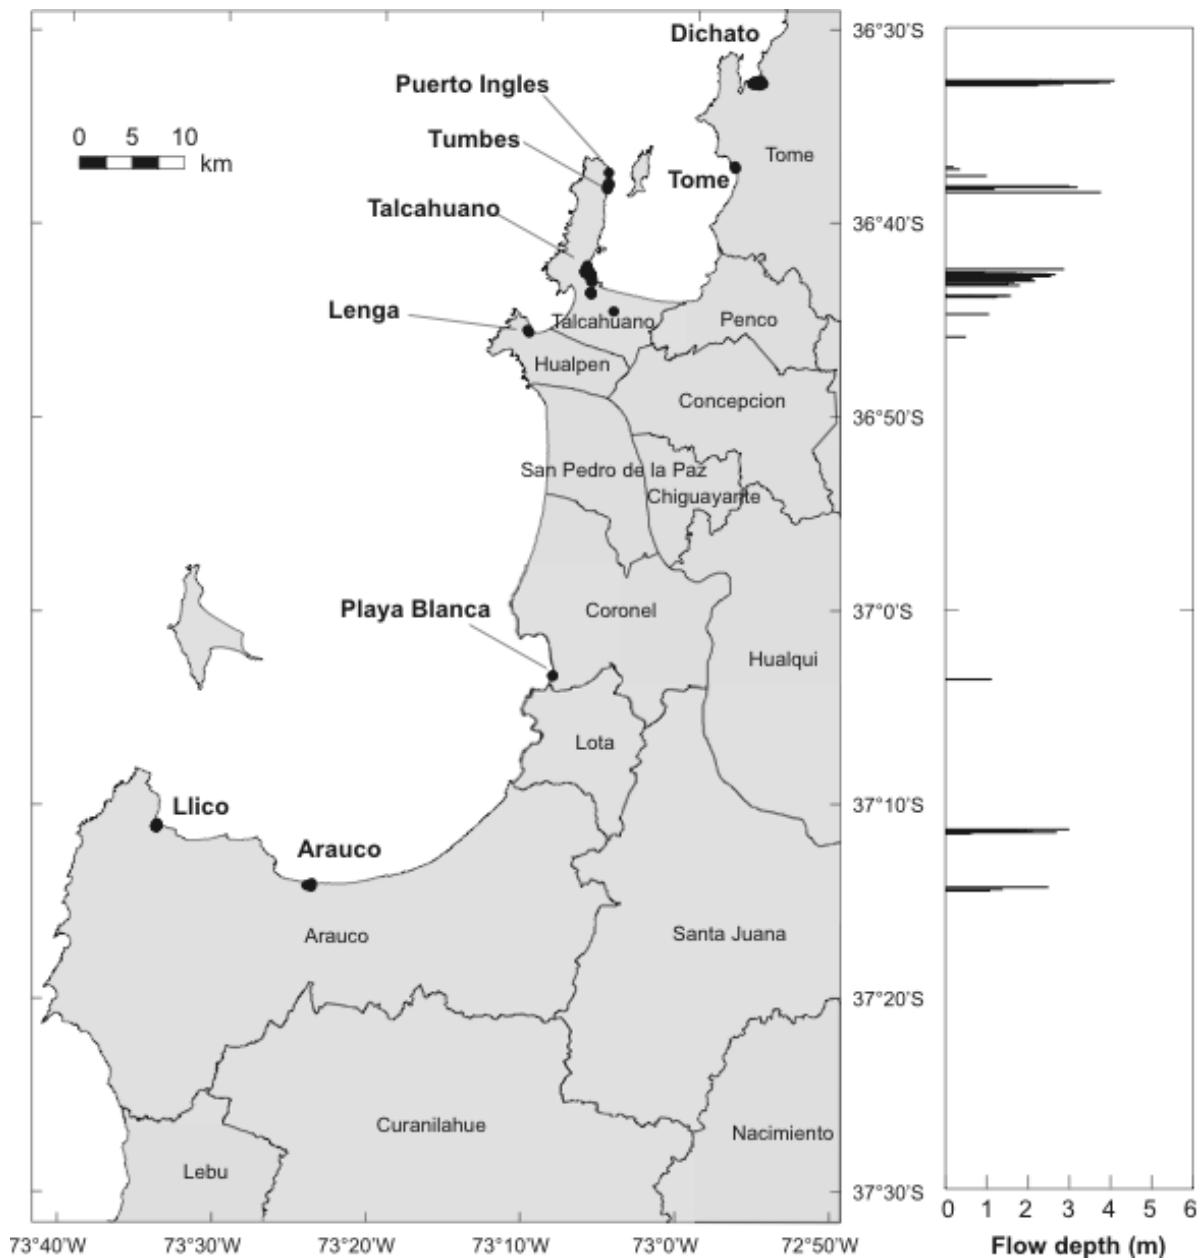
**Fig.4** Longshore distribution of measured flow depths, which were measured as a height of watermark of tsunami penetration above the ground level.
