**2010 CHILE EARTHQUAKE AND TSUNAMI
TECHNICAL REPORT**

**JST-JICA SATREPS PERU PROJECT
CHILE EARTHQUAKE FIELD INVESTIGATION TEAM**

DECEMBER 2010

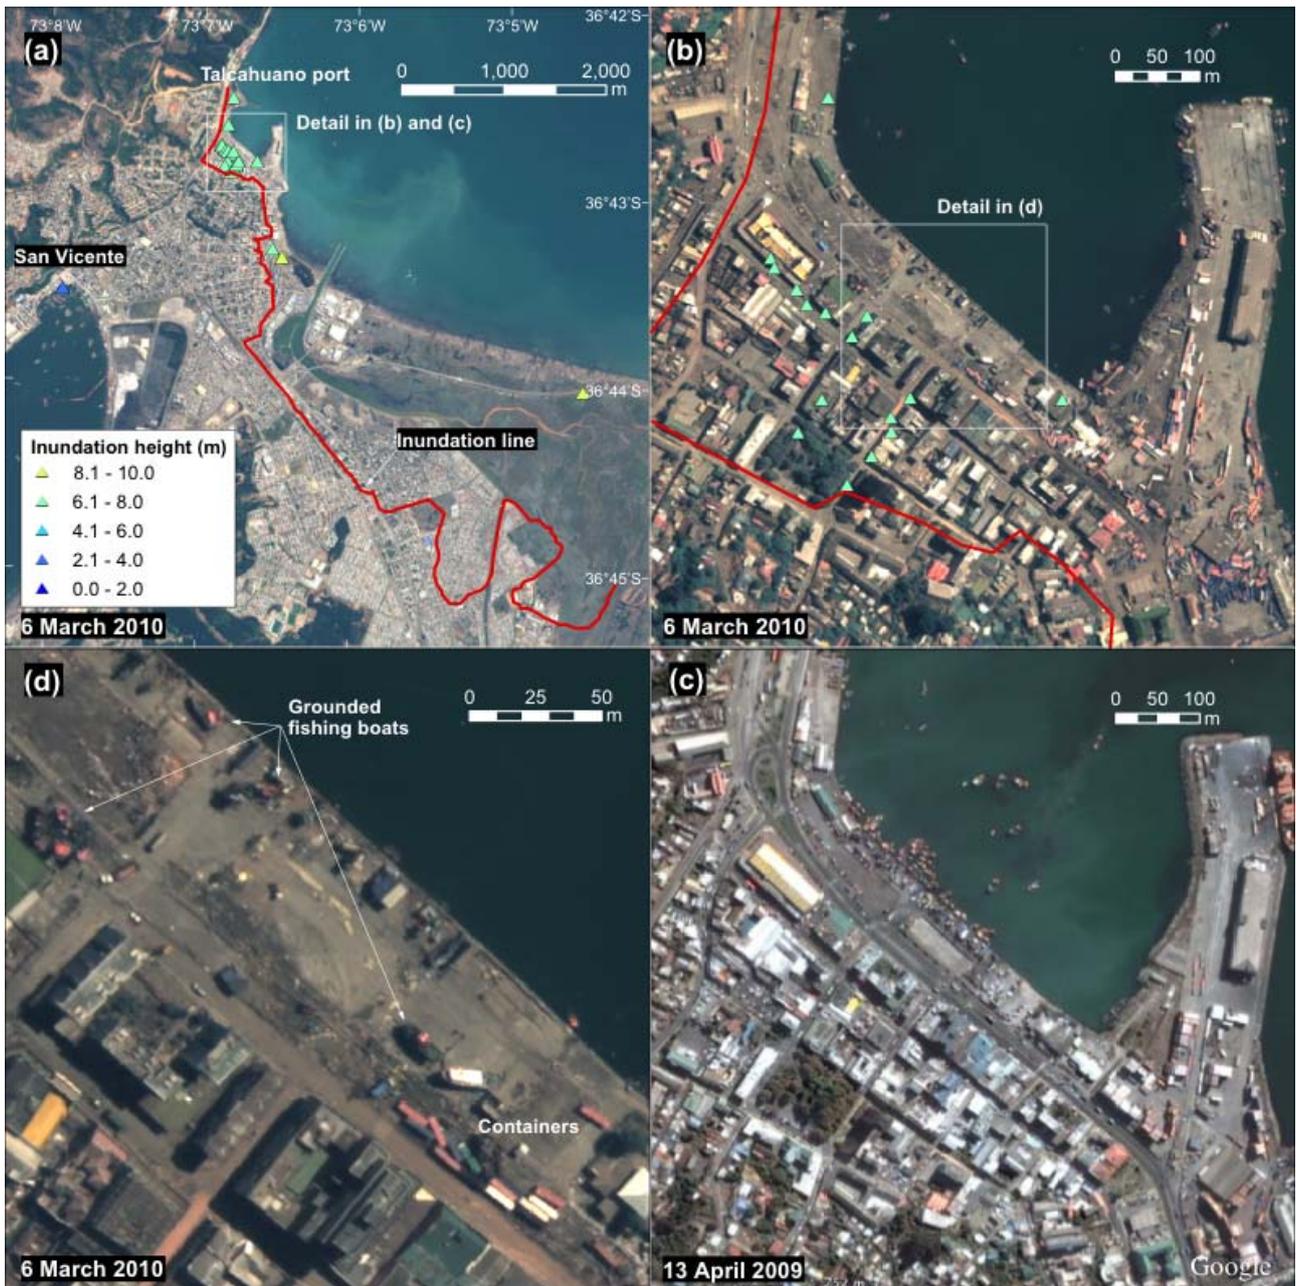
Fig. 5 represents the result of tsunami inundation height measurement in Talcahuano. The tsunami penetrated approximately 300 m inland in the port-town area and more than 1 km in the southern coastal marsh. Tsunami inundation reached to 6-8 m in port-town area and 10 m in the coastal marsh. This figure also shows the comparison of pre and post event satellite images in Talcahuano port (**Figs. 5(b), (c)**). Significant amount of containers and fishing boats were left as tsunami debris, which caused long duration of failure of port and harbor facilities. While the tsunami left considerable damage to the town of Talcahuano (eastern bottom of the bay), no damage was found in the western port area (San Vicente). The measured tsunami run-up height in San Vicente was 3.4 m (**Fig. 5(a)**).

Fig. 5 (a) Result of tsunami height measurement in Talcahuano. The red line indicates the extent of inundation zone which was obtained by the interview with CATOE (Centro de Alertamiento Temprano y Oficina de Emergencia). (b) Damage in Talcahuano found in the post-event satellite image (WorldView-2). (c) Satellite image of Talcahuano before the tsunami attack (13 April 2009, from Google) (d) Close-up view of port of Talcahuano. Grounded fishing boats and drifted containers were seen.

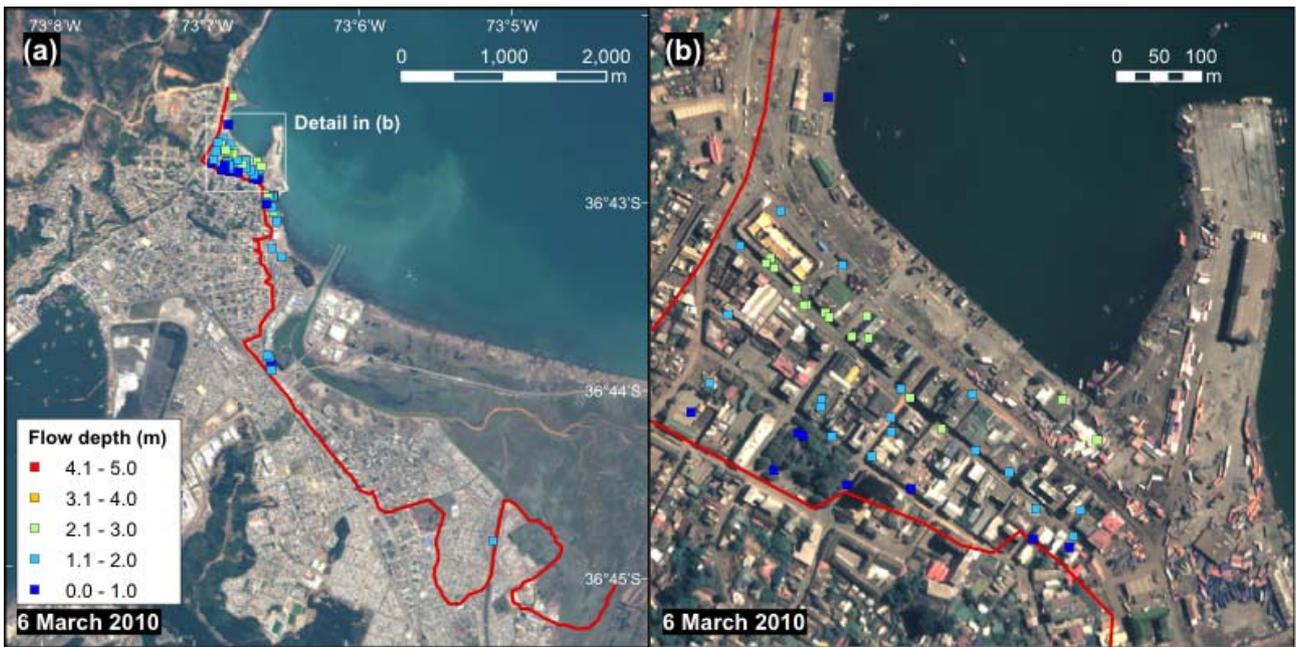
Fig. 6 Result of tsunami flow depth measurement in the town of Talcahuano. The tsunami penetrated approximately 100 m inland with the flow depth of up to 2-3 m.

In the town of Talcahuano, the tsunami penetrated with up to 2-3 m of flow depth (**Fig. 6**). After inspecting the structural damage in the town, some washed-away structures were found, but it was limited within the port facilities (north-west) and industrial area (south-west). Most of the structural damage in the town was likely to be caused by ground shaking, but minor damage, e.g. bending shutters of commercial buildings and broken windows.

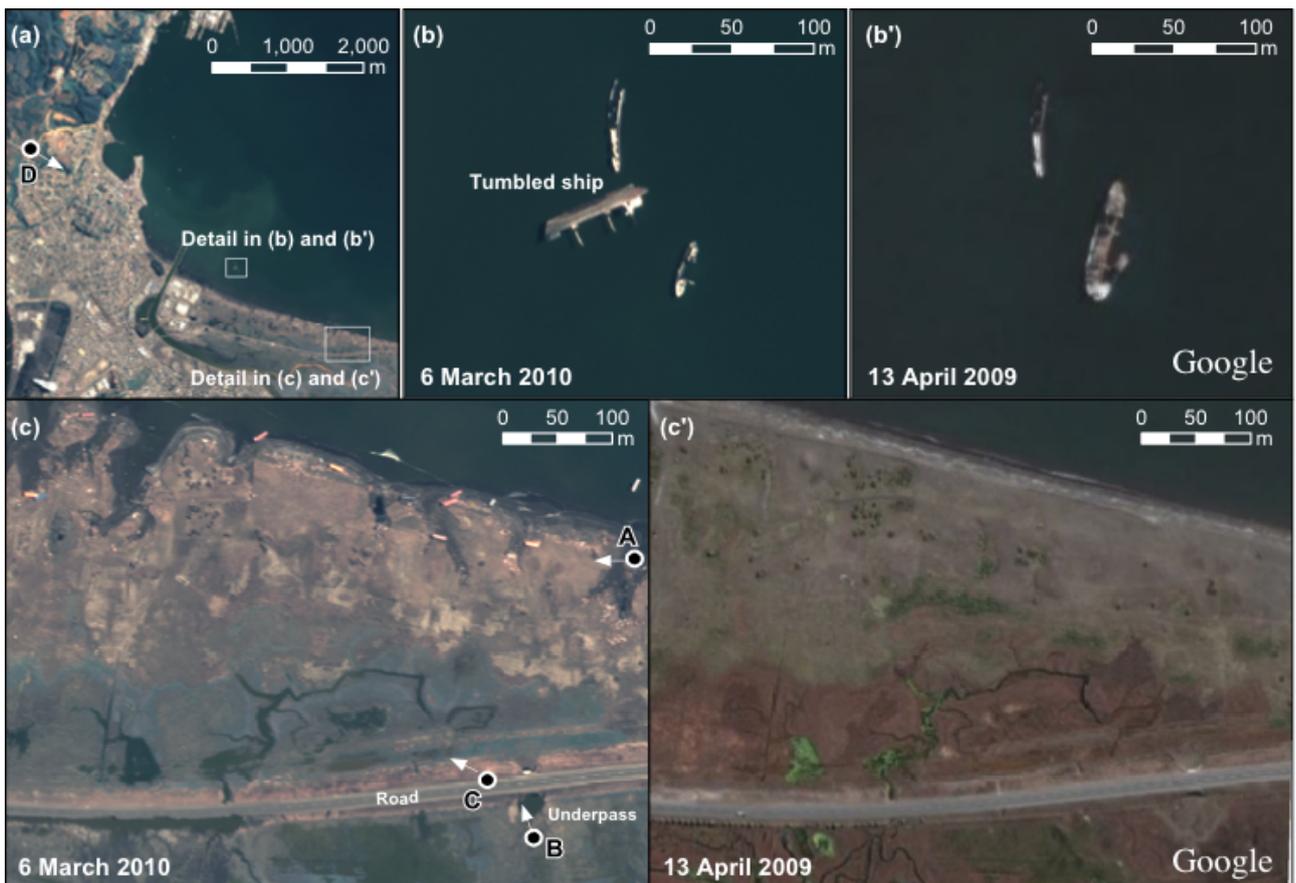
Fig. 7 Pre and post event satellite images in Talcahuano. Points A to D represent the position of ground photos taken by the authors (**Fig. 8**). White arrow is approximate direction of the camera focus. (a) Overview of Talcahuano port. (b) and (b') A 70m-long tumbled ship found the east of waterway. (c) and (c') Considerable change of coastline and drifted containers in the coastal marsh.

Inspecting pre and post event satellite images and ground photos helps to understand multi aspects of tsunami disaster. **Fig. 7** is the comparison of pre and post event satellite images in Talcahuano. We acquired the pre-tsunami image from GoogleEarth (QuickBird image taken on 13 April, 2009), and used WorldView-2 pan-sharpened composite image as post-tsunami image. From post-tsunami image and field survey, we found the tumbled ship at the west of waterway in Tulcahuano bay that has been stably stood in the bay (even though it was not in use). In the coastal marsh, considerable changes of shoreline and tsunami debris are seen in the satellite images, and it was found from the ground photos (**Fig. 8**) that the coastal sand were eroded by inland penetration of tsunami.

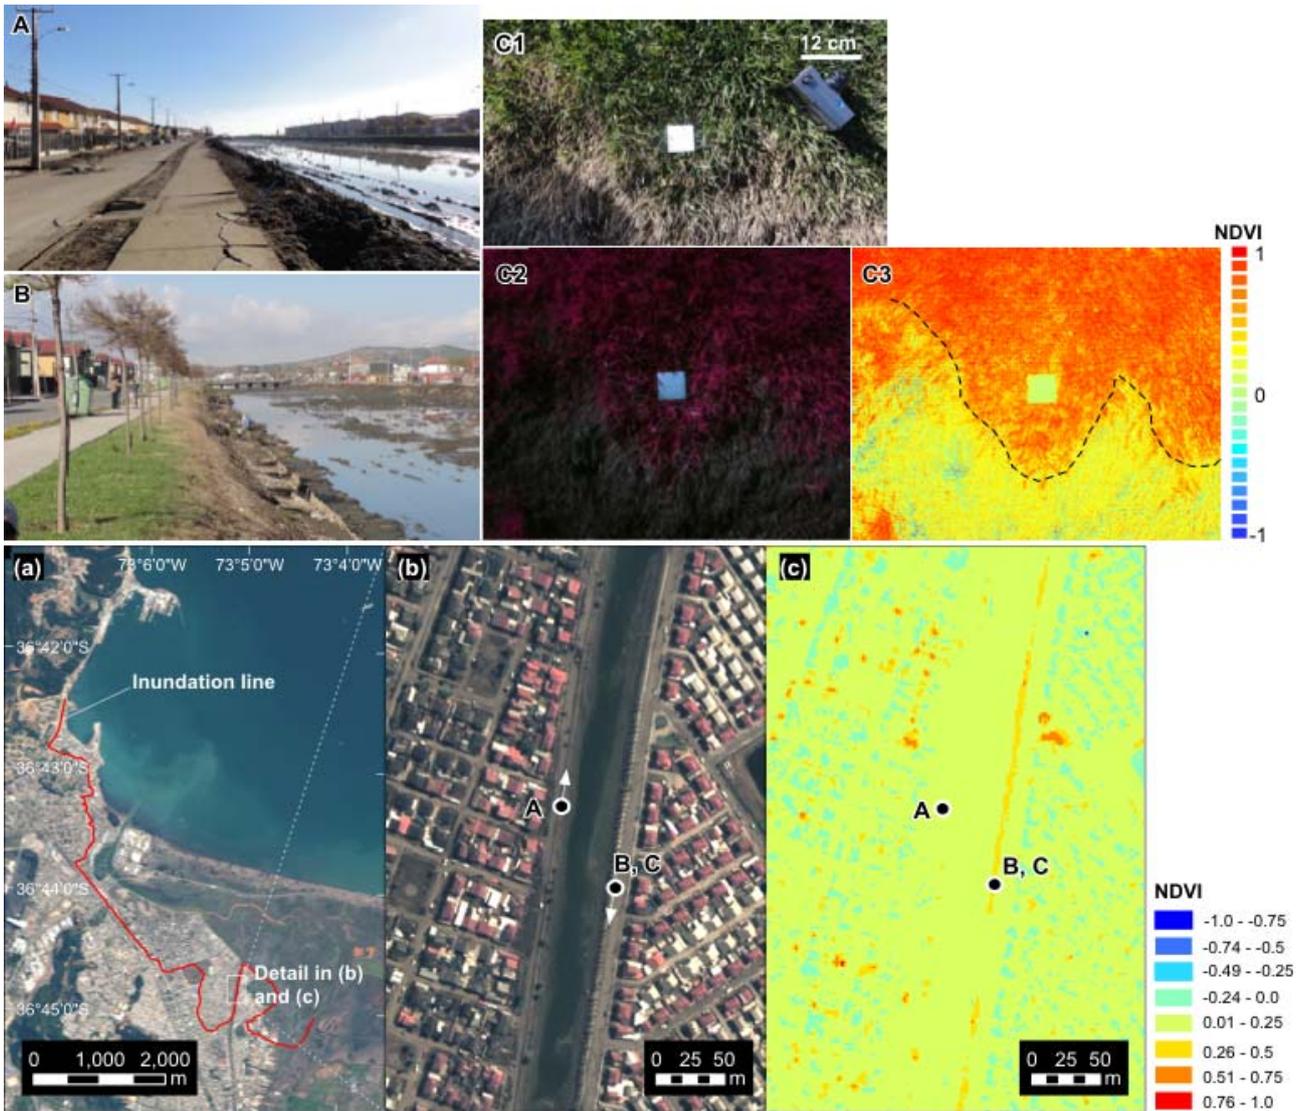
Fig. 9 (a) Inspection area of salt-water penetration, (b) Pan-sharpened multi-spectral image of WorldView-2 acquired on 6 March 2010. A, B and C is the point of ground photos, White arrow is approximate direction of camera focus. (c) Spatial distribution of NDVI Western. A and B : Ground photos taken on the western and eastern bank of the canal respectively. C1 is the ground photo for inspecting vegetation activity (Same position as B). C2 and C3 : False color composite image and NDVI taken by the multi spectral camera (Tetracam ADC3). White plate is the reflector used for calibration.

Here, we focused on the eastern bank of the canal in Talcahuano. **Fig. 9** indicates the area of investigation and illustrates the result of detecting tsunami penetration by the analysis of WorldView-2 pan-sharpened multi-spectral image and the multi spectral camera (Tetracam ADC3). As shown in the ground photos (**Figs. 9 A and B**), considerable inundation was found on the western bank of the canal while the eyewitness testified that the tsunami slightly overtopped the eastern bank (no inundation in houses). Using the multi spectral camera that takes visible red, green and near infrared bands, we first calculated NDVI at the top of the bank where the tsunami did not overtop (**Fig. 9B**). As a result, we found that NDVI of the dead vegetation becomes less than 0.3. Using the threshold value determined by the spectral camera, we discuss the salt-water penetration on the eastern bank of the canal. **Fig. 9 (c)** shows the distribution of NDVI calculated from the post-tsunami WorldView-2 image (pan-sharpened). NDVI indicates lower value on the western bank (inundated) while relatively higher value on eastern bank (not inundated), and these features are quite consistent with the ground photos A and B.

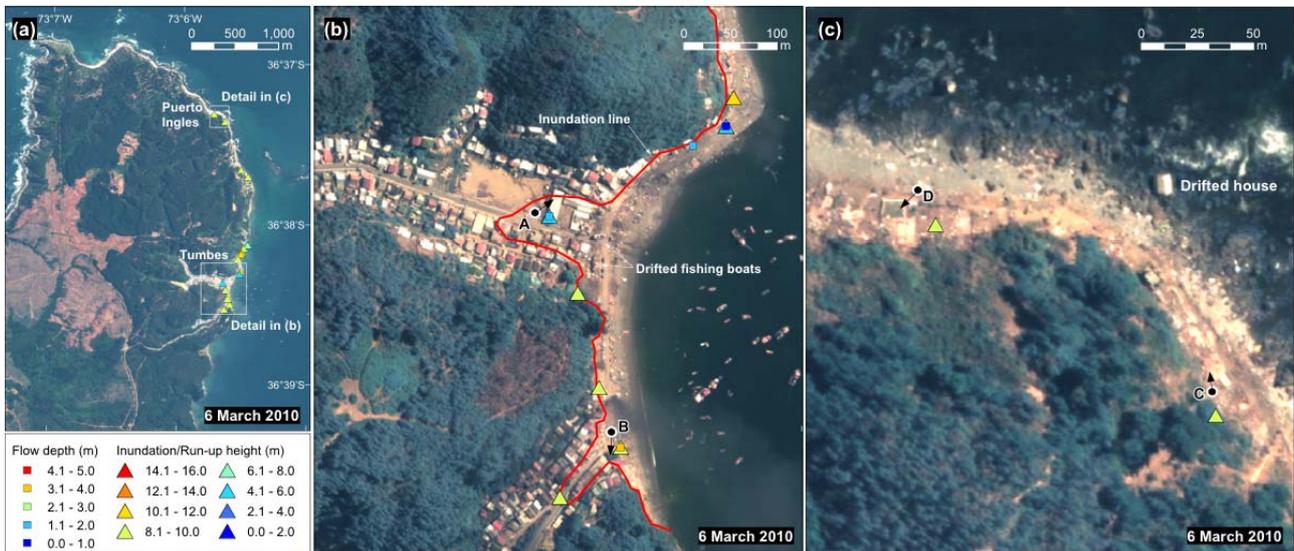
Tumbes locates and Puerto Ingles are the coastal communities, which were isolated by the limited road access. **Fig.10** represents the overview of tsunami height measurements. Tsunami attacked these communities with up to 11 m height and caused significant damage. Along the coast from Tumbes to Puerto Ingles, the tsunami was particularly devastating to demolish the houses of isolated villages (**Fig.11**). Some survivors mentioned that the first wave was withdrawal and the 2nd wave was the largest. Having the experience and lessons from the 1960 Chilean tsunami, most of the village people evacuated to the hill immediately after the ground shaking. They mentioned that the tsunami in 1960 was witnessed only as receded sea and did not cause inundation.

Fig. 10 (a) Overview of tsunami measurements (inundation and run-up heights) in Tumbes and Puerto Ingles. (b) Detailed features of the measurements and the damage in Tumbes. (c) Devastated damage in Puerto Ingles. Point A to D is the position of ground photos in **Fig. 11** respectively with the arrow of focus direction.

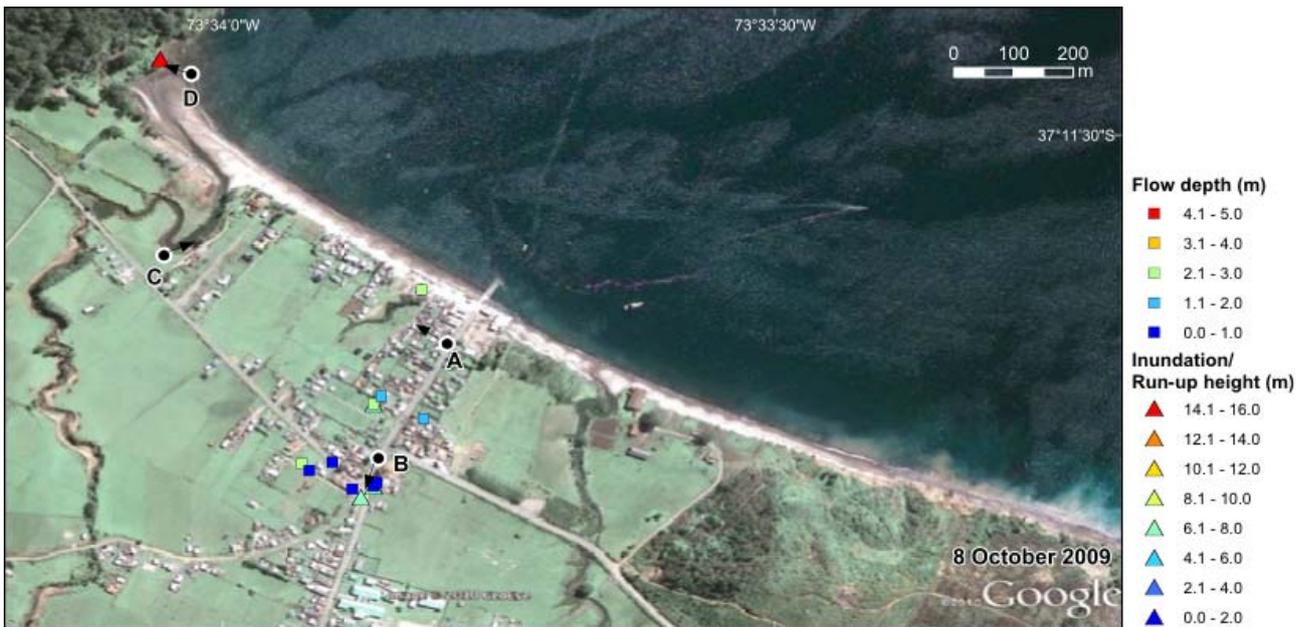
Fig 12. Result of tsunami height measurement in Llico. Point A to D are the position of ground photos with the arrow of focus direction shown in Fig. 13.

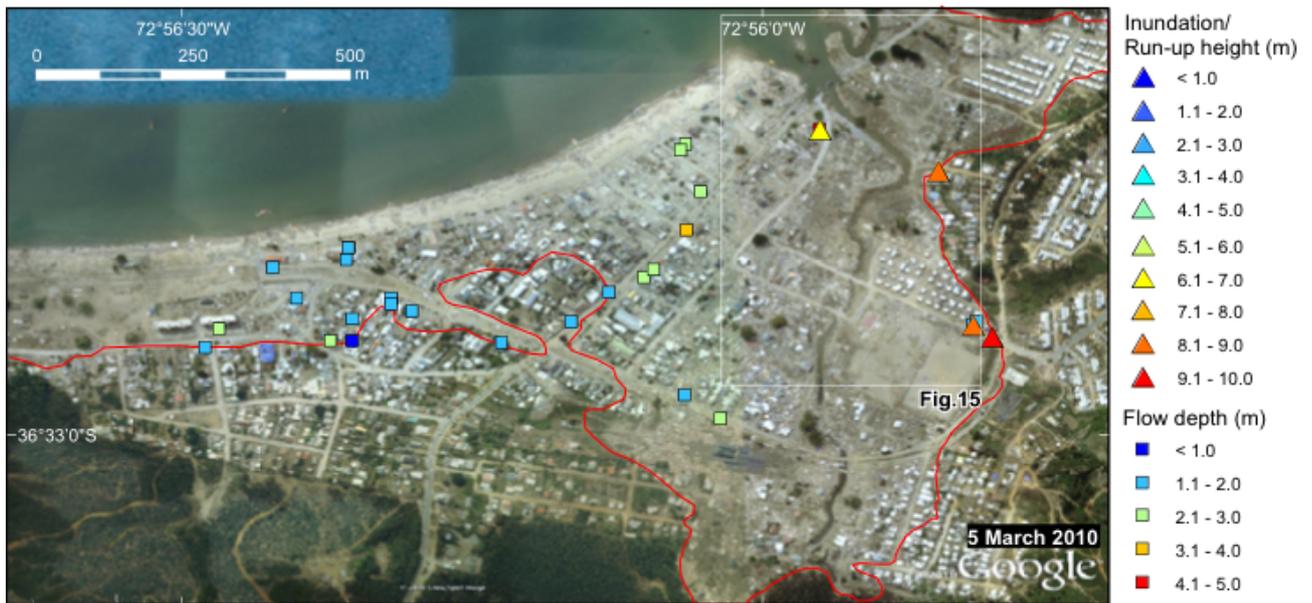
Fig. 14 Tsunami height, flow depth and extent of inundation in Dichato.

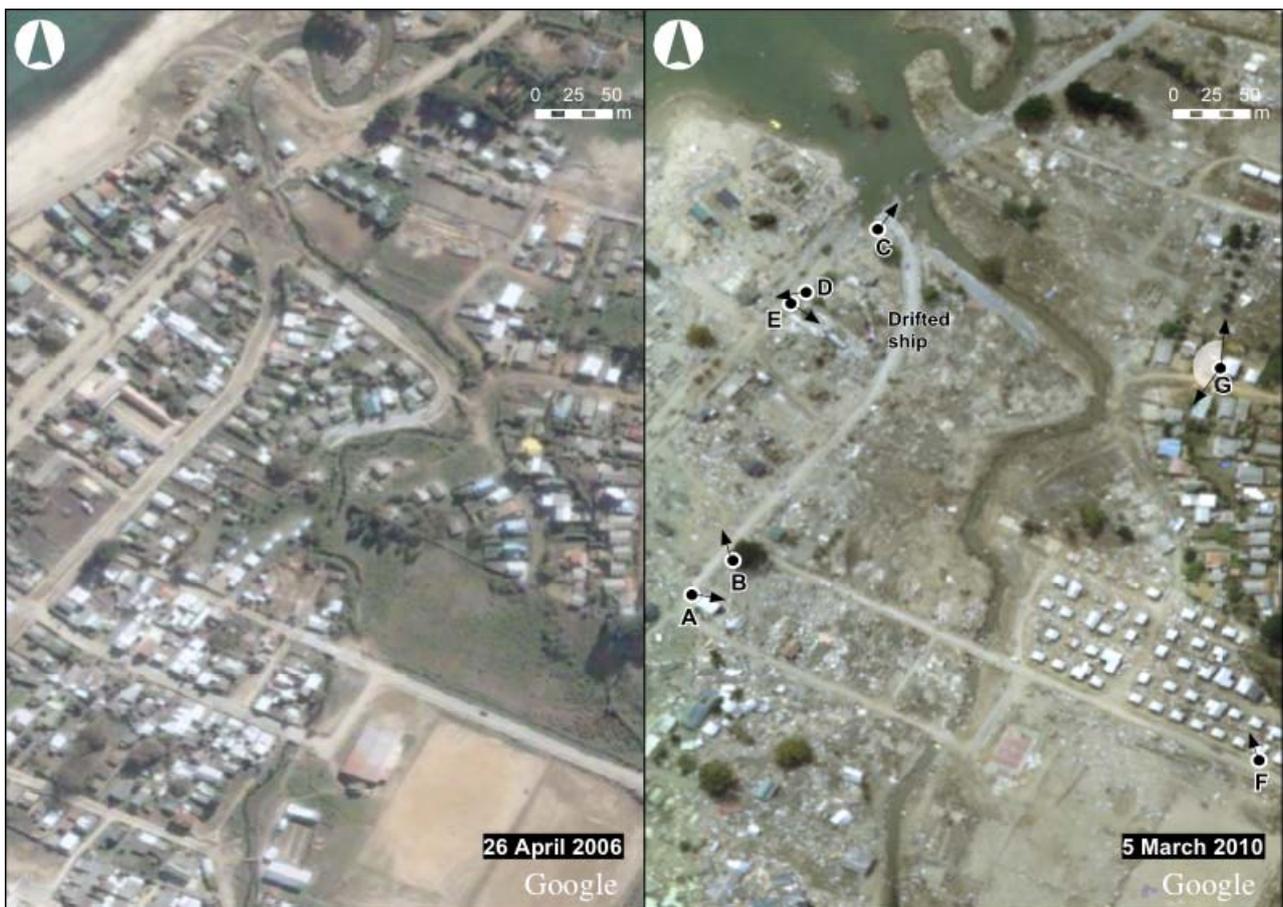
Fig. 15 Pre and post event satellite images of the most devastated area in Dichato. Points A to G represent the position of ground photos taken by the authors (**Fig. 16**). White arrow is approximate direction of the camera focus.

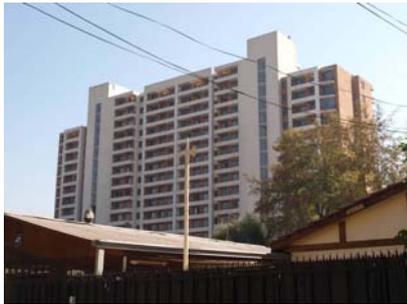
ground (2 stories underground) (Photo 1). The building was damaged particularly on the first basement level of the underground self parking lot (Photos 2, 3). The structural features and the summary of damage are follows:

Photo 1
Appearance of the building

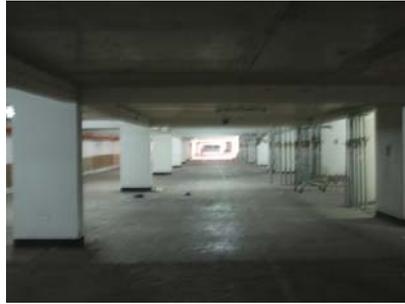
- Multi-story shear wall structure connected by flat slabs.
- Flexural tension failure occurred in three structure planes out of five 4-span ones on the first basement. An end main reinforcement ruptured.
- The height of the north side multi-story shear wall on the basement is shorter by 1200 mm than on higher floors. In addition, only the northern end of the north side multi-story shear wall lacks an orthogonal wall (Figures 2, 3). Accordingly, the flexural strength of the north side multi-story shear wall is low on the first basement, likely resulting in the flexural tension failure in the south direction on the north side multi-story shear wall.

Photo 2
Underground parking lot

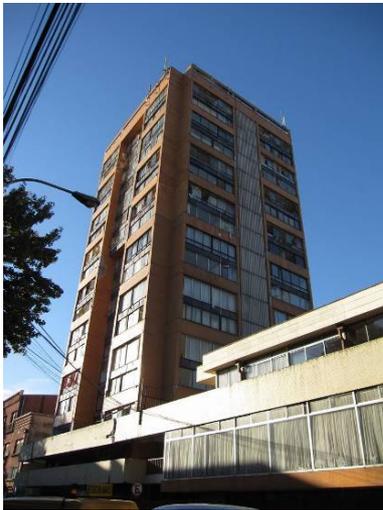
Photo 4
Appearance of the building

It is an RC wall flat slab structure constructed in 1973. The building has 17 stories above ground and one basement (with no underground car park), of which the three lower floors are occupied by commercial tenants and the fourth and above floors are used for housing (Photo 4). The machine room on the first basement was hardly damaged. The non-structural brick wall collapsed more seriously on upper floors. The walls on the first

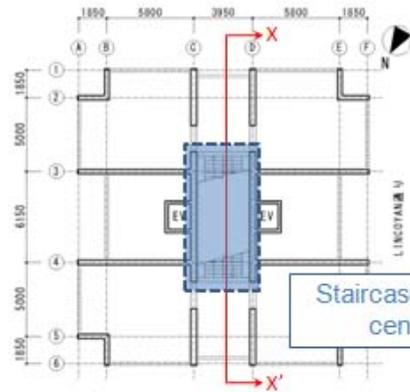
and second floors failed in flexural tension with the wall-end main reinforcement fractured or buckled (Photo 5). While the building was damaged particularly on the walls in the northeast and southwest directions, little damage was observed on the walls in the orthogonal direction. The damage concentrated on the wall footing is likely attributable to the lack of flexural strength of the T section web resulting from the respective bending deformation of two multi-story shear walls arranged in parallel due to the limited floor slab area in the staircase (Figures 4, 5, 6).

Figure 4
Building plan view

Figure 5
X-X' section view

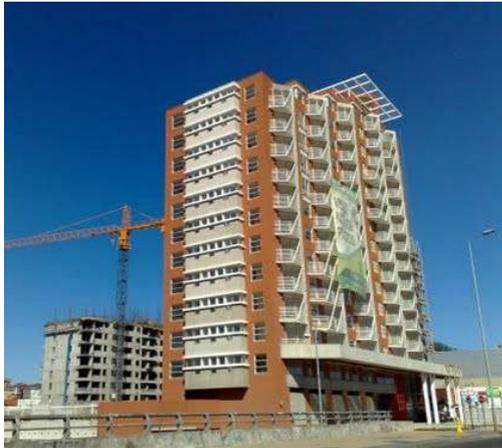
Photo 6
Photo of the building before collapsed
(excerpted from the Web Page)

It is a reinforced concrete apartment complex constructed in 2008 with 15 stories above ground and two stories underground (parking lot). The building completely fell down from the base on the first floor (Photo 6, 7). Photo 7 shows the appearance of all the reinforcing bars on the first floor having been pulled out or cut down from the wall pillars and load-bearing walls on the first floor during the overturning of the building. Conversely, little damage was observed on the underground end plane walls. As shown in the plan view of Figure 7, the walls on the first floor and the basements (parking lot) are smaller than those on the second and above floors in both length and volume. This fact may have resulted in the damage particularly on the wall footing on the basements.

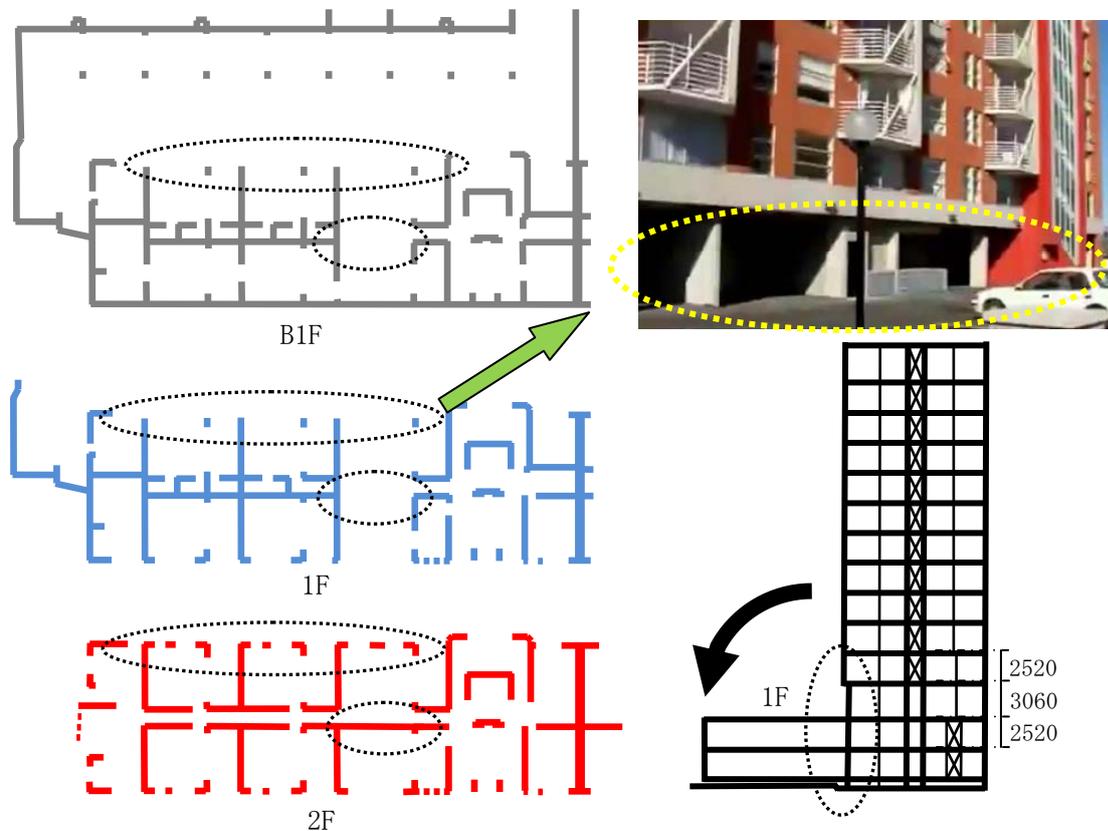
Figure 7 Difference in wall volume and layout among basement, first floor, and second floor

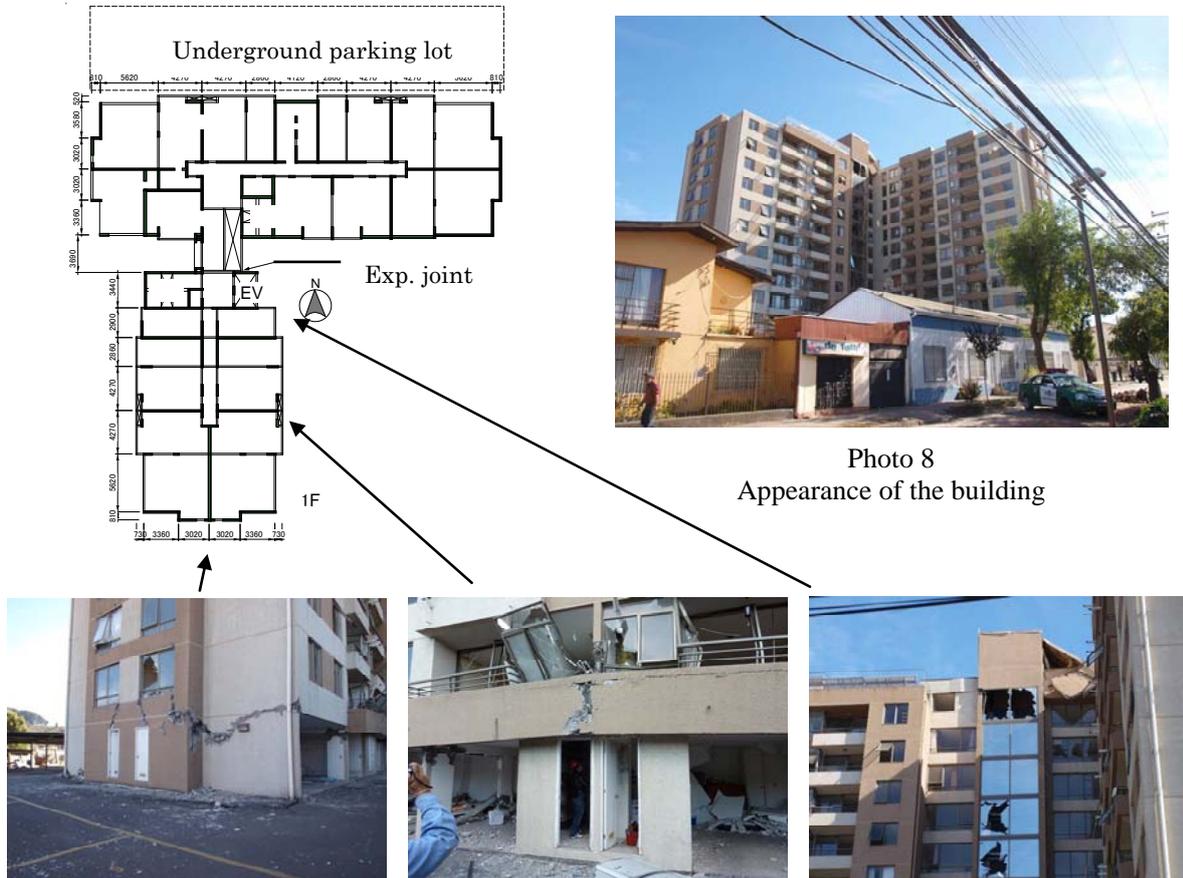
It is an apartment complex constructed in 2007 with 13 stories above ground and an underground car park provided beside the building. It consists of two buildings arranged in L shape and connected with an expansion joint (Photo 8, Figure 8). It is constructed with a middle corridor in planar shape with more wall volume in the ridge direction. While the south side building was seriously damaged, the north side building was slightly damaged. The south side building seems to have suffered torsional vibration caused by stiffness eccentricity resulting from the many walls in the surrounding of elevators and staircases.

Photo 8
Appearance of the building

Figure 8 Plan view and damage

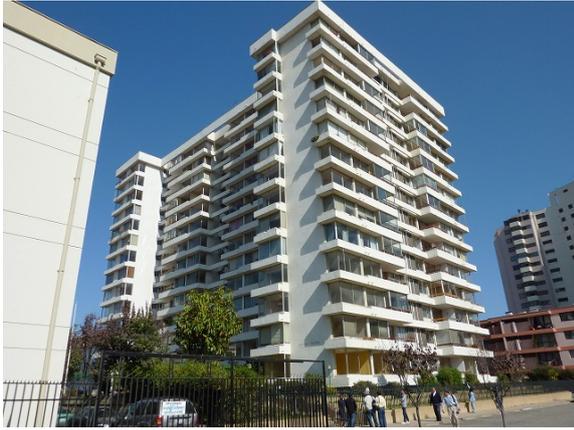
Photo 9
Appearance of the building

It is an apartment complex (wall-type flat slab structure) with 14 stories above ground and one basement. It was severely damaged (Photo 9). The building had undergone seismic retrofitting such as the placement of additional concrete for walls and beams and the additional installation of walls in response to the earthquake in 1985, but suffered damage in the recent earthquake such as flexural tension failure and separation of concrete-added walls in the wall footing (Photo 10, Figure 9).

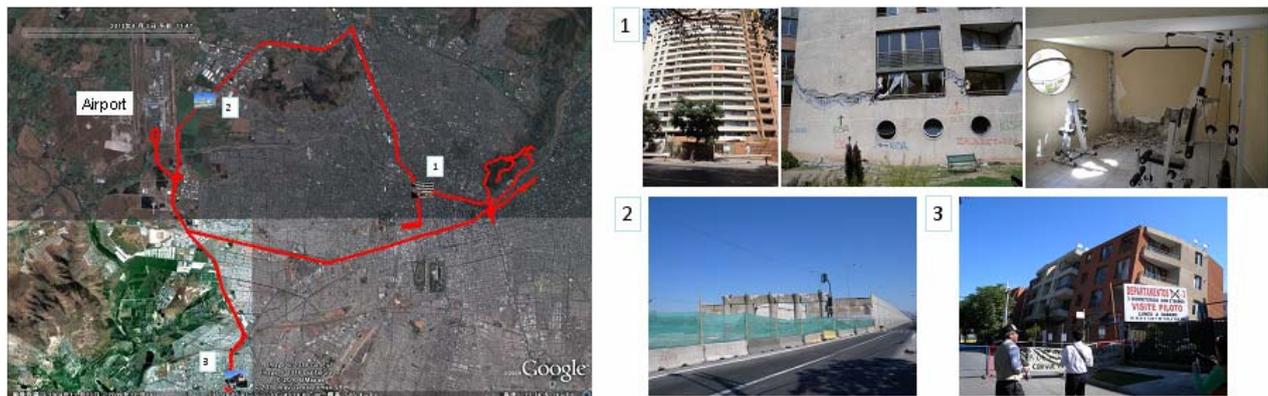
Fig. 2 Survey route and field photos in Santiago—April 2, 2010

Figure 2 shows the route of our field survey in Santiago and some field photographs. The route was recorded by a portable GPS device during the survey and the location of the photo shooting could be identified as the location data were embedded in the Exchangeable Image File Format (EXIF). An RC building with 20 stories constructed in 2003 suffered from shear failures in columns and walls at the first and the second stories. A collapsed highway bridge and an RC building with the collapsed first floor were found. The locations of these sites are also shown in the survey route in **Fig. 2**.

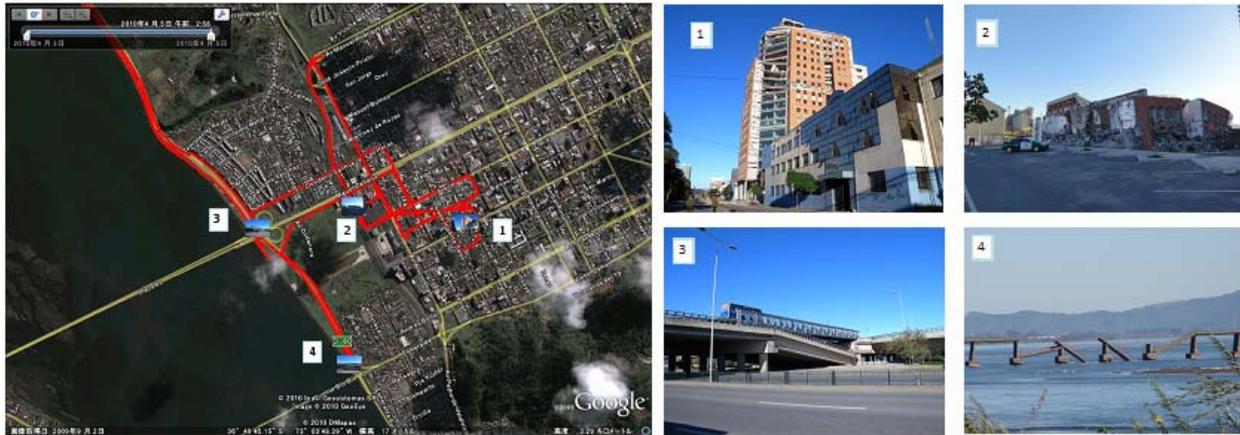
Fig. 3 Survey route and field photos in Concepción—April 4, 2010

Figure 3 shows the survey route in Concepción. An RC building with the damaged middle floor was found at the site numbered 1. An RC building with 15 stories had collapsed completely at the site numbered 2. The road bridges collapsed at sites 3 and 4. The temporary bridge girder was constructed two days after the earthquake at site 3. Although the photos are not shown in this paper, the adobe and unreinforced masonry constructions were severely damaged in the urban area.

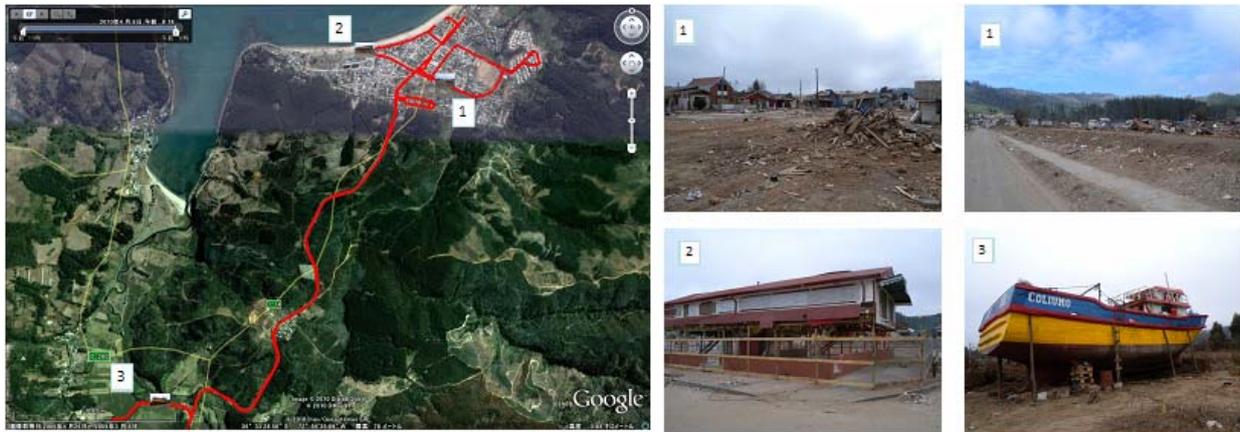
Fig. 4 Survey route and field photos in Dichato—April 5, 2010

Figure 4 shows the survey route in Dichato. It is reported that more than 80% of the built-up area in Dichato suffered from tsunami⁵⁾. As shown in the field photos, the buildings collapsed because of the tsunami waves. A ship was conveyed against the river flow because of the tsunami and eventually found at site 3.

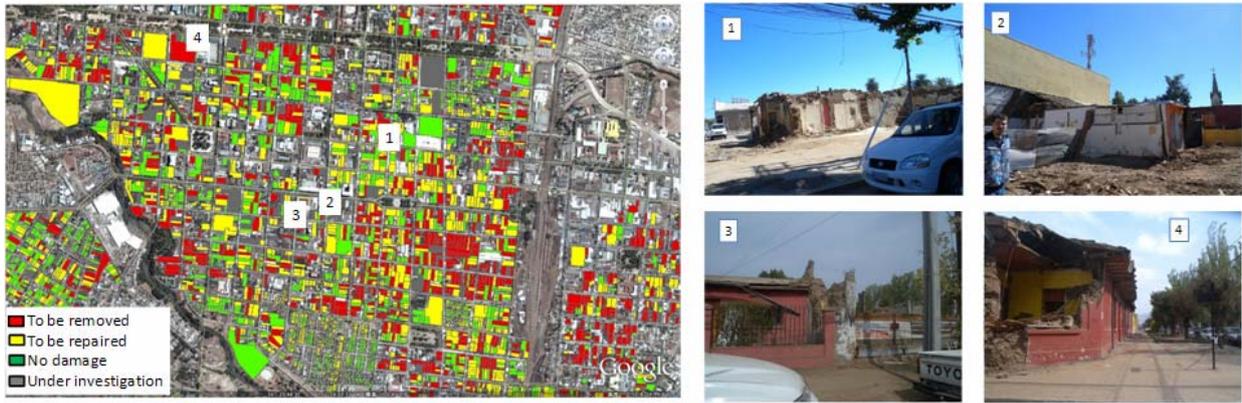
Fig. 5 GIS file to show the damage levels of buildings in Talca and locations of field photos

image file was converted to a GIS file with polygons to identify the damage levels of buildings. **Figure 5** shows the developed GIS file presented by Google Earth and some field photos to show the examples of damaged buildings.

In all, 5617 polygons were projected to the map coordinate system. 1559 (27.8%), 1872 (33.3%), and 1864 (33.2%) buildings were classified as to be removed, to be repaired, and no damage, respectively. The typical construction types in Talca are adobe and unreinforced masonry buildings, which are primarily used for older constructions with 2–4 stories (dating back to before the 1960s–70s). Modern buildings that were designed according to the current codes suffered minor, repairable damage, while a large number of adobe and unreinforced masonry constructions suffered significant damage⁶.

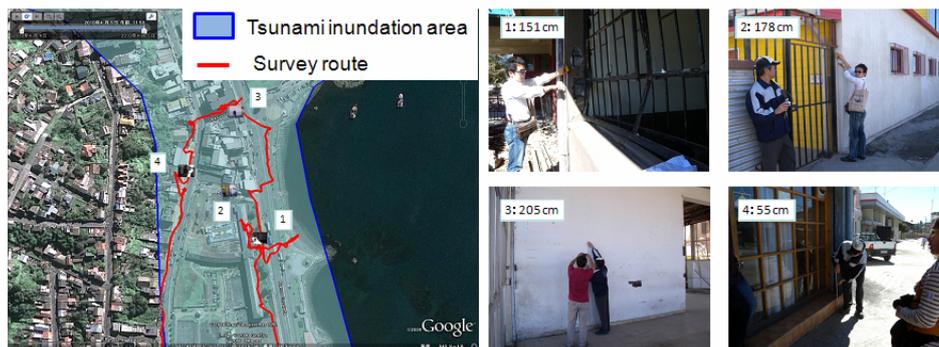
Fig. 10 Measurement of tsunami inundation depth in Talcahuano

As shown in Fig. 10, the inundation depth was measured at several sites in the three cities. The inundation depth along the beachfront street in Talcahuano was larger than 150 cm, but a depth of 55 cm was observed in its bystreet (site 4). Figure 11 summarizes the measurements in the three cities. The inundation depth is presented with respect to the elevation and the distance from the coastline. As for the results in Constitución, the records are shown with respect to the distance from the Maule River. A clear tendency is not seen in the rela-
