Development of Spatial Information Database of Building Damage and Tsunami Inundation Areas following the 2010 Chile Earthquake

Fumio YAMAZAKI¹, Yoshihisa MARUYAMA², Hiroyuki MIURA³, Shizuko MATSUZAKI⁴ and Miguel ESTRADA⁵

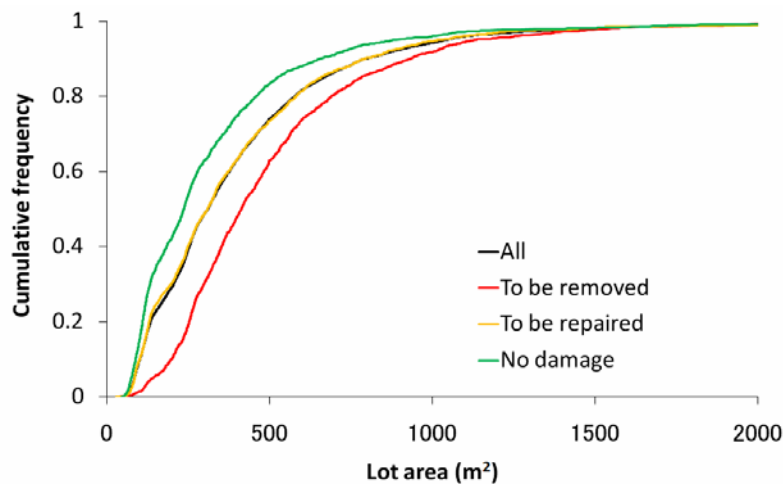
Fig. 6 Cumulative frequencies of the areas of building lots with respect to the damage level

Figure 6 shows the cumulative frequencies of the areas of building lots with respect to the damage level.

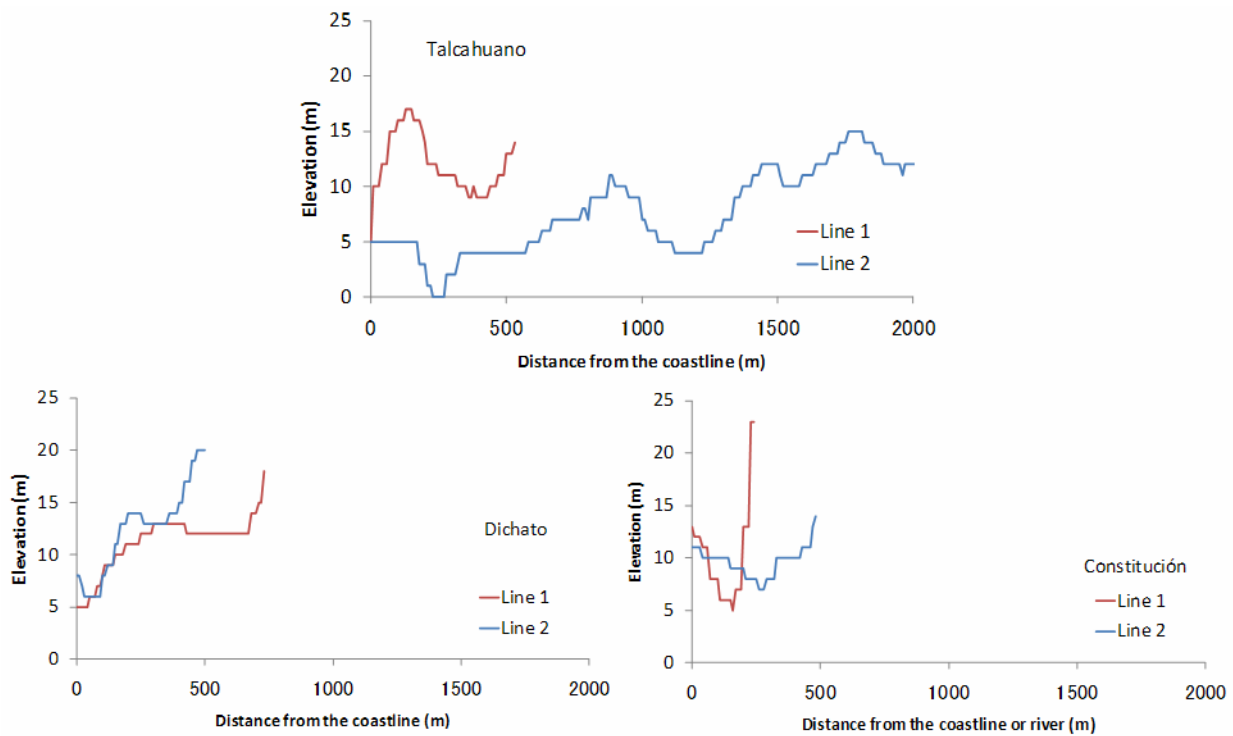
Fig. 9 Elevations along the transverse lines set in Fig. 8

Figure 8 shows the tsunami-inundated areas in Talcahuano, Dichato, and Constitución and the distributions of the elevation derived from the ASTER GDEM. The elevations in the inundated areas are lower than 20 m on the whole except for a certain area in Constitución. As shown in the figure, we set the two traverse lines in each inundated area. The elevations were extracted along the two lines. The extracted elevations are illustrated in terms of the distance from the coastline in Fig. 9. As for Line 2 in Constitución, the elevations are presented with respect to the distance from the Maule River. The relatively low elevations and slow grades result in long travel distances of the tsunami wave. According to Line 2 in Talcahuano, the tsunami wave could travel approximately 2000 m from the coastline. Line 1 in Constitución was assigned to identify the surveyed site by Imamura et al.¹³⁾. According to their report, the tsunami runup height was 28.3 m at the site. Since the DEM used in this study is a global dataset that consists of 30-m grid cells, the elevation at the site is estimated to be approximately 23 m. The slope is estimated to be approximately 67% and is almost equivalent to that reported by Imamura et al., which is 63.5%¹³⁾.
