BUILDING DAMAGE AND TSUNAMI INUNDATION GIS DATASETS AFTER THE 2010 CHILE EARTHQUAKE

Abstract: This paper presents the results of a field survey conducted by the authors after the 2010 Chile earthquake. The authors visited the affected area about a month after the earthquake. The GIS datasets for the damage levels of buildings in Talca and the tsunami-inundated areas in Talcahuano, Dichato, and Constitución are constructed in this study, and a series of fundamental analyses are performed using a digital elevation model (DEM). Further, the usefulness of satellite images captured after the earthquake to detect damaged buildings in Talca is discussed using the GIS datasets constructed in this study.

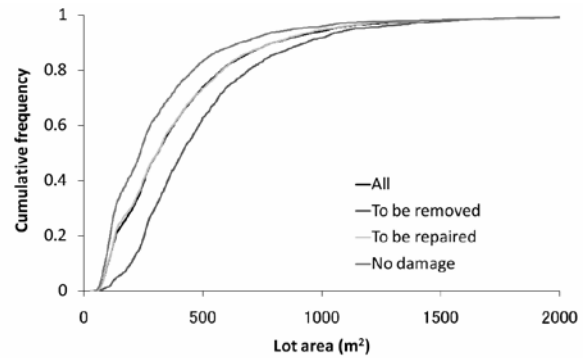
Figure 6 Cumulative frequencies of the areas of building lots with respect to the damage level

Figure 6 shows the cumulative frequencies of the areas of building lots with respect to the damage level. The mean of all the georeferenced areas was approximately 430 m² and was almost equal to that of the areas associated with the buildings to be repaired. The mean of the lot areas of the buildings to be non-damaged was approximately 340 m², which was considerably smaller than that of the buildings to be removed. On the basis of the results, it has been speculated that the newer buildings are constructed in relatively small lots; however, the construction periods are not available at this moment.

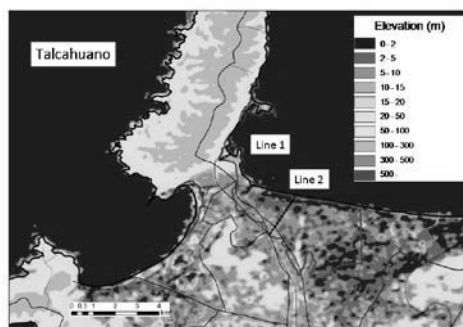
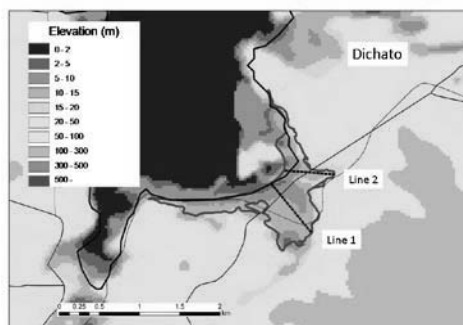
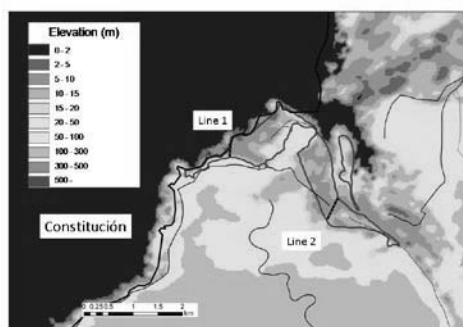
Figure 8 Tsunami-inundated areas in Talcahuano, Dichato, and Constitución

Figure 8 shows the tsunami-inundated areas in Talcahuano, Dichato, and Constitución and the distributions of the elevation derived from the ASTER GDEM. The elevations in the inundated areas are lower than 20 m on the

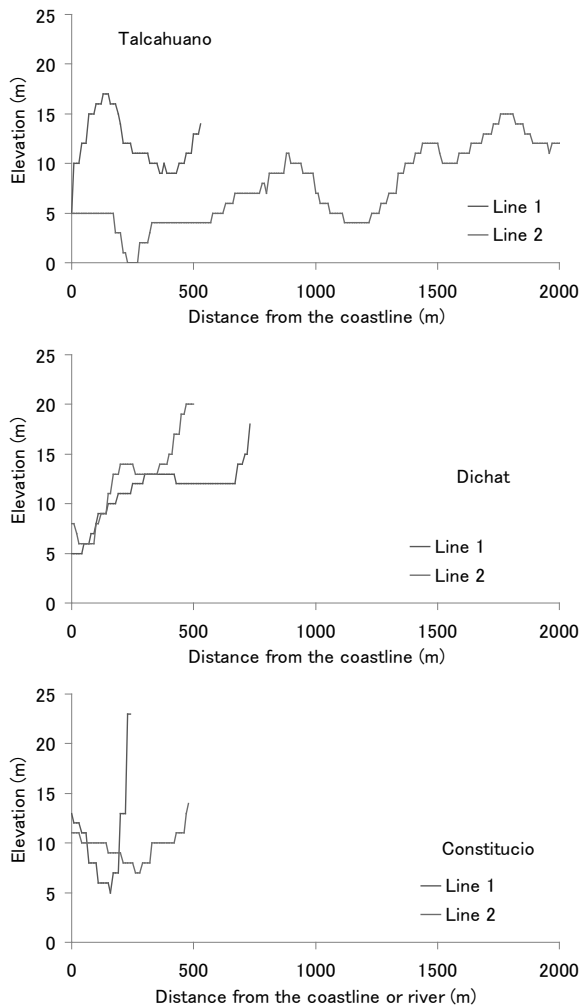
Figure 9 Elevations along the transverse lines set in Fig. 8

whole except for a certain area in Constitución. As shown in the figure, we set the two traverse lines in each inundated area. The elevations were extracted along the two lines. The extracted elevations are illustrated in terms of the distance from the coastline in Fig. 9. As for Line 2 in Constitución, the elevations are presented with respect to the distance from the Maule River. The relatively low elevations and slow grades result in long travel distances of the tsunami wave. According to Line 2 in Talcahuano, the tsunami wave could travel approximately 2000 m from the coastline. Line 1 in Constitución was assigned to identify the surveyed site by Imamura *et al.* (2010). According to their report, the tsunami runup height was 28.3 m at the site. Since the DEM used in this study is a global dataset that consists of 30-m grid cells, the elevation at the site is estimated to be approximately 23 m. The slope is estimated to be approximately 67% and is almost equivalent to that reported by Imamura *et al.* (2010), which is 63.5%.

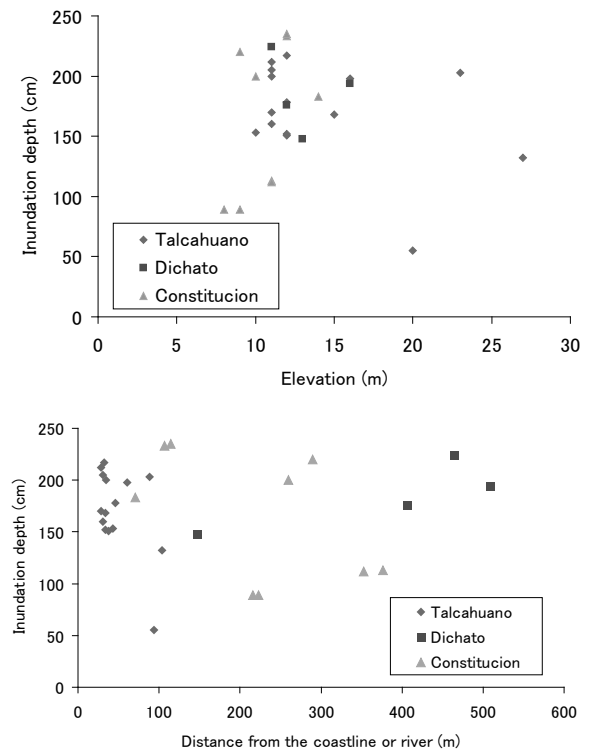
Figure 11 Summary of the measurement of tsunami inundation depth

respect to the elevation and the distance from the coastline. As for the results in Constitución, the records are shown with respect to the distance from the Maule River. A clear tendency is not seen in the relationship between the tsunami inundation depth and the elevation. The recorded depth in
