Evaluation of Tsunami Damage in the Eastern Part of Sri Lanka due to the 2004 Sumatra Earthquake using High-Resolution Satellite Images

Tokyo Institute of Technology

Hiroyuki MIURA, A. Wijeyewickrema and S. Inoue

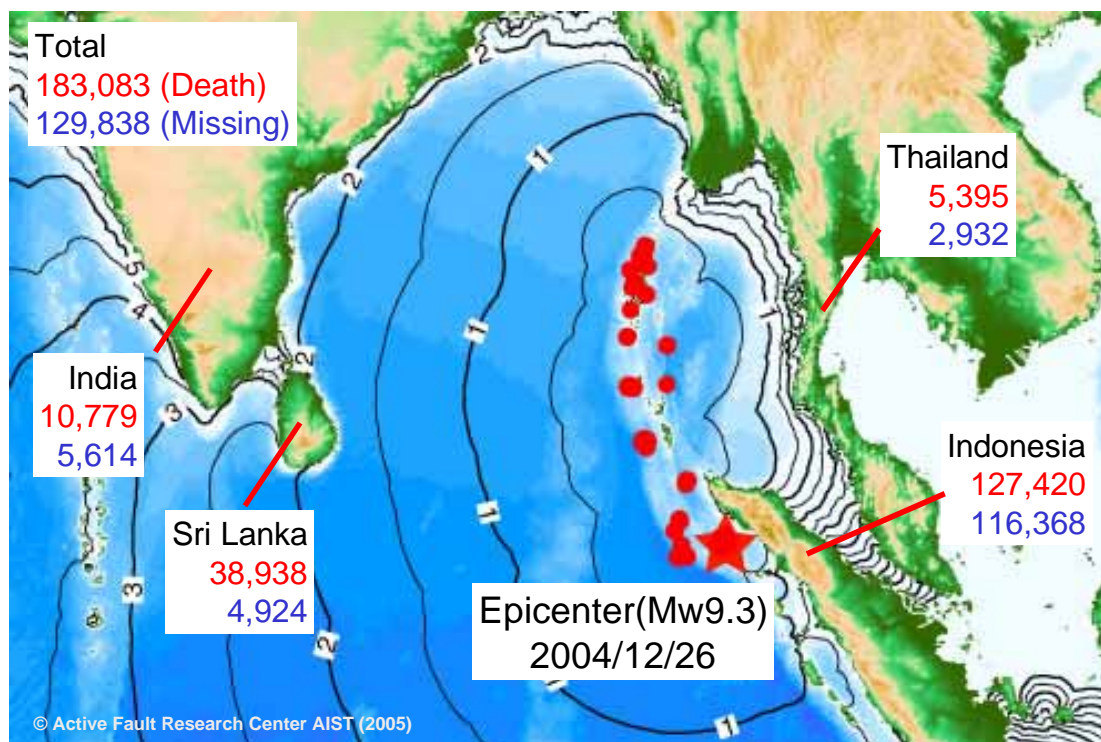
Casualties in the 2004 Sumatra Earthquake

Severe damage is observed also in Sri Lanka

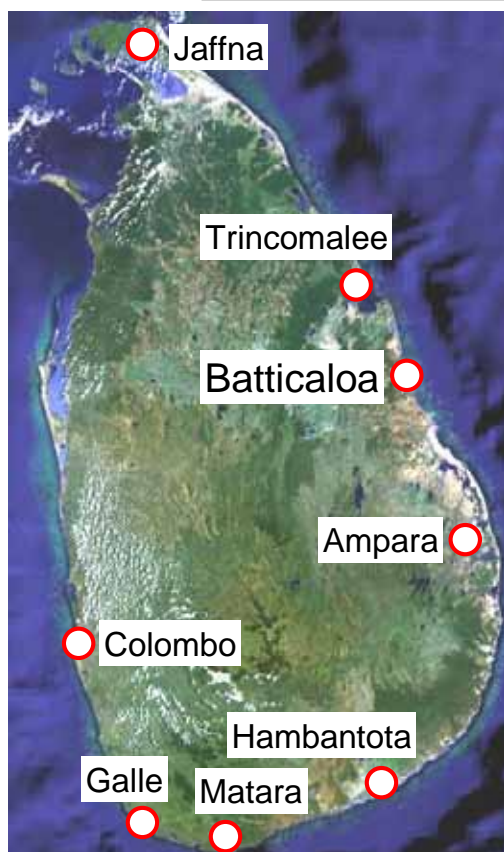
Tsunami Damage in Sri Lanka

Eastern and southern provinces show severer damage than western one. Batticaloa is one of the districts that severe damage is observed.

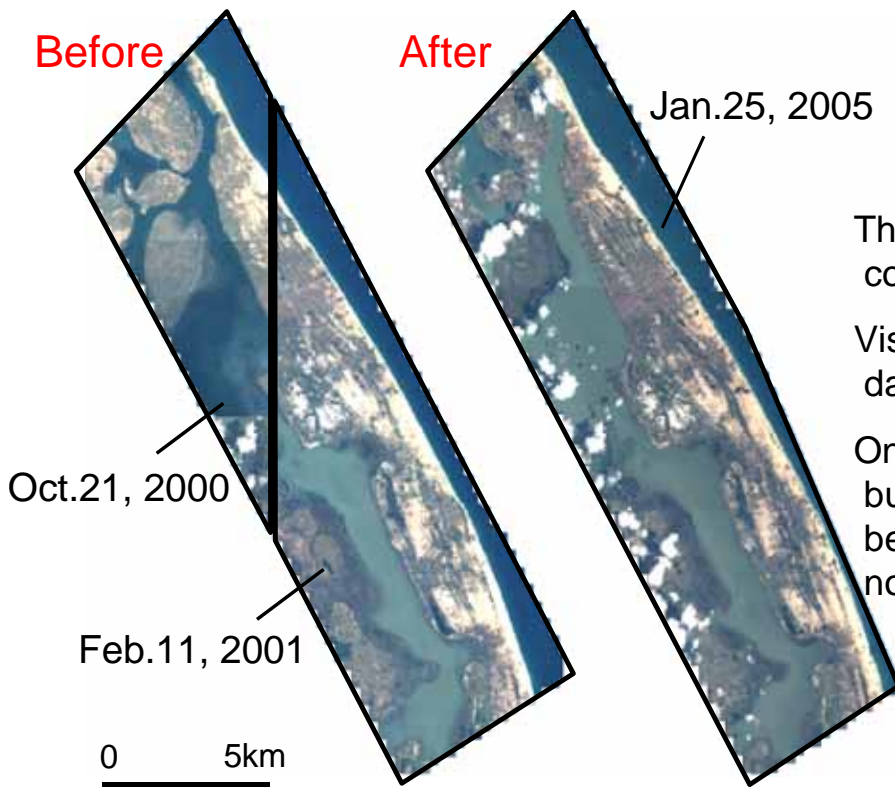
IKONOS Images in Batticaloa

Resolution: 1m
 Area size: 124km²
 Type: Pan Sharpen

The image cover 1/10 of the coastal line in Batticaloa.
