ACCURATE EVALUATION OF BUILDING DAMAGE IN THE 2003 BOUMERDES, ALGERIA EARTHQUAKE FROM QUICKBIRD SATELLITE IMAGES

ABDELGHANI MESLEM*

FUMIO YAMAZAKI and YOSHIHISA MARUYAMA

Accepted 8 October 2010

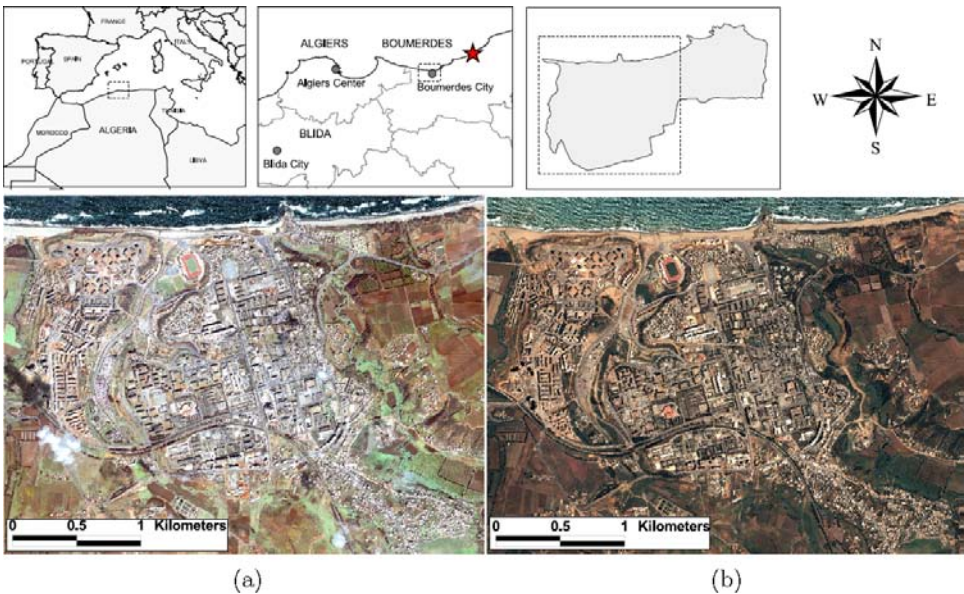
Fig. 1. Pan-sharpened natural color QuickBird satellite images of Boumerdes city captured before and after the 2003 Algeria earthquake: (a) the preevent image captured on June 22, 2002 (before 394 days) and (b) the post-event image captured on May 23, 2003 (after two days). The red star represents the epicenter of the mainshock.

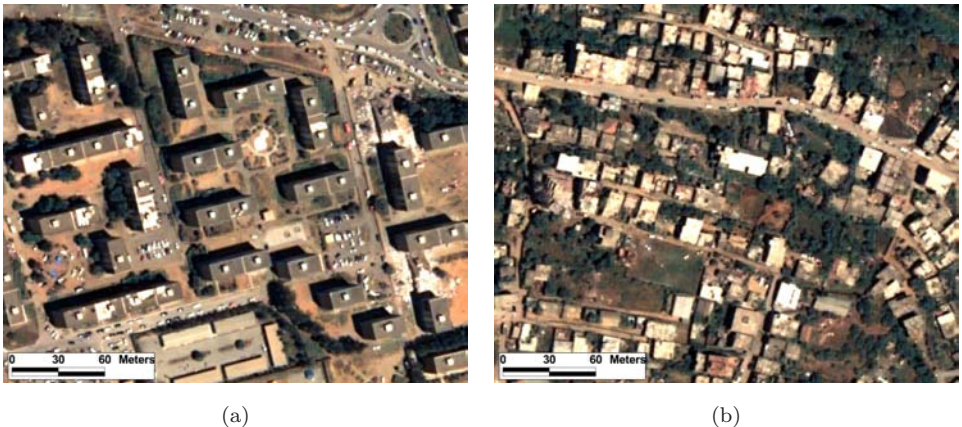
Fig. 2. Post-event images of Boumerdes city: (a) an area of modern medium- to high-rise constructions and (b) a densely built area mostly with low-rise constructions.

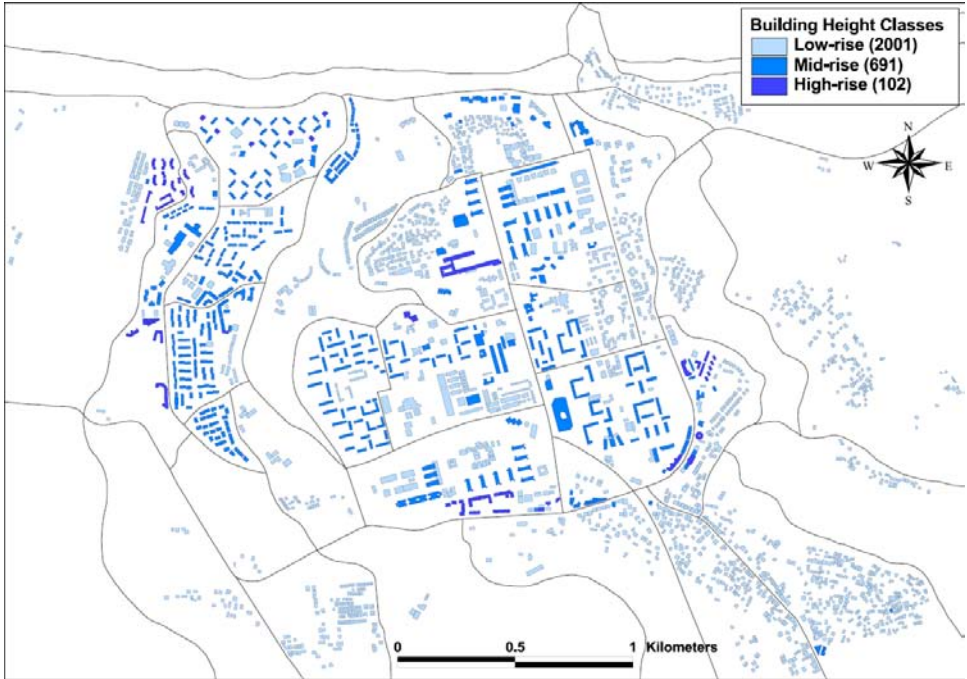
Fig. 3. Construction classification according to building height in Boumerdes city.

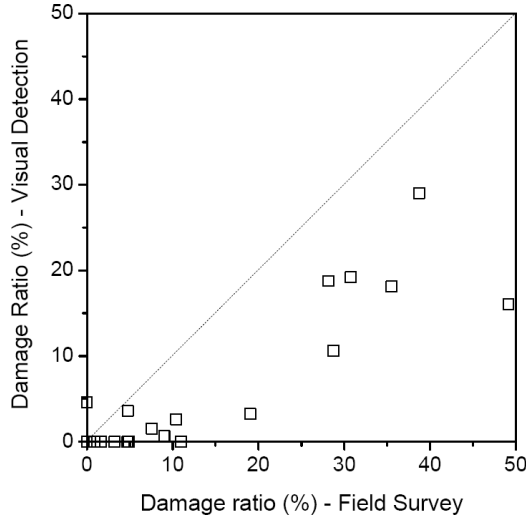
based on visual damage detection were underestimated compared with those based on the field survey. This is because some buildings suffering from Grade 4 damage were incorrectly judged by visual detection; this is in contrast to buildings suffering from Grade 5 damage, which generally corresponds to total or partial collapse.

Fig. 7. Comparison of damage ratios computed using damage data from field survey with that computed using estimated damage data from the QuickBird satellite images by visual detection.

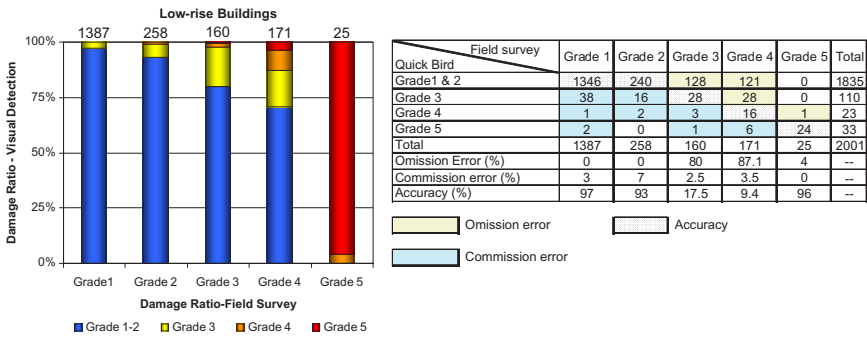
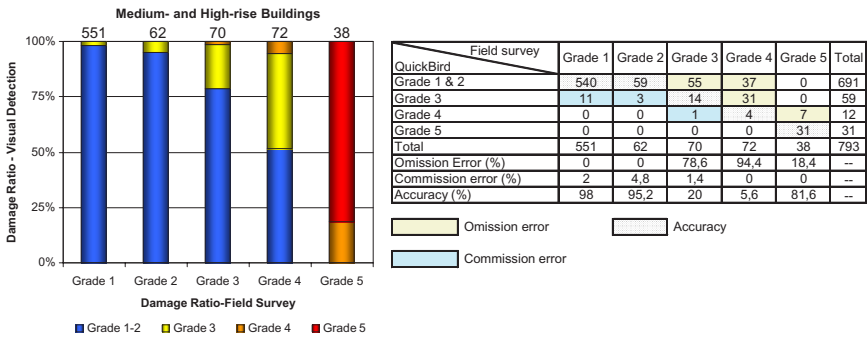
Fig. 8. Accuracy of distinguishing building damage grades from high-resolution satellite imagery by building height class: (a) Damage grade accuracy for low-rise buildings and (b) Damage grade accuracy for medium- and high-rise buildings.

Damage was extensively concentrated in the southwestern part of the city (Fig. 5), where there are many modern medium-rise buildings (Figs. 2(a) and 3); this explains why the damage ratio is more important for medium-rise buildings evaluated as engineered structures. Figure 8 clearly shows that some of these medium-rise buildings that suffered from Grades 3 and 4 damages were incorrectly judged by visual detection through QuickBird images. The omission error was estimated to be 79% and 94% for the detection of Grades 3 and 4, respectively; out of 70 and 72 medium-rise buildings identified by the field survey as Grades 3 and 4, respectively, only 14 (20%) and 4 (5.6%) medium-rise buildings were judged to be so by visual damage detection.

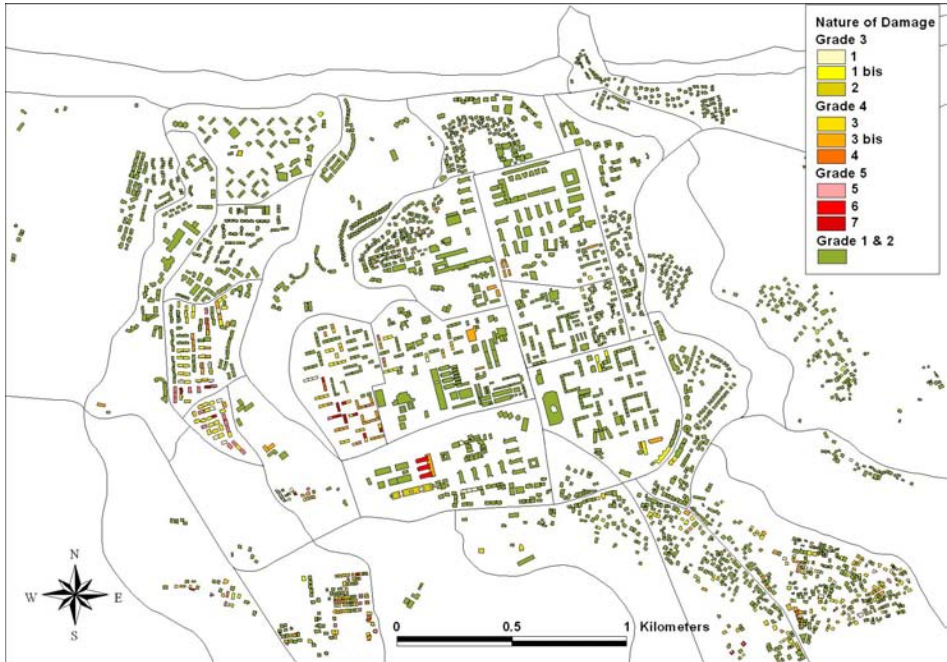
Fig. 13. Damage distribution for buildings in Boumerdes city following the 2003 Algeria earthquake. Details for each class are presented in Table 2 according to the nature of damage.

According to the results of our analysis (Fig. 13), each degree of damage for Grades 3, 4, and 5 is divided into three classes by the nature of damage and visual detection accuracy. Details for each class by the nature of damage is given in Table 2, which presents a summary of results for the relationship between the observed building damage patterns of Grades 3–5 from the field survey and the visual detection accuracy. Figure 14 shows the classification of damage patterns for

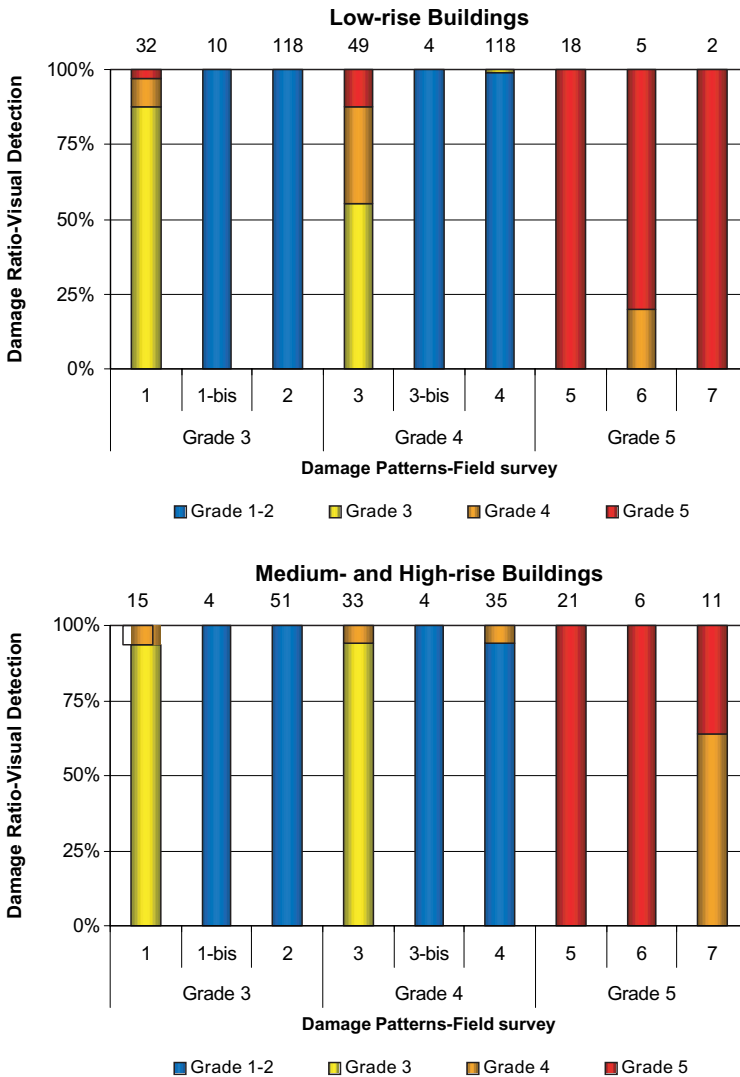
Fig. 14. Accuracy of distinguishing building damage grade from high-resolution satellite imagery, according to damage pattern from field survey.

Grades 3–5 and a comparison with results from the visual detection. For all types of constructions, low-rise as well as medium- and high-rise structures, the nature of observed damage patterns and visualization of debris played a dominant role in damage detection accuracy.
