# The Effects of Building Characteristics and Site Conditions on the Damage Distribution in Boumerdès after the 2003 Algeria Earthquake

Abdelghani Meslem,<sup>a)</sup> Fumio Yamazaki,<sup>a)</sup> Yoshihisa Maruyama,<sup>a)</sup> Djillali Benouar,<sup>b)</sup> Abderrahmane Kibboua,<sup>c)</sup> and Youcef Mehani<sup>c)</sup>

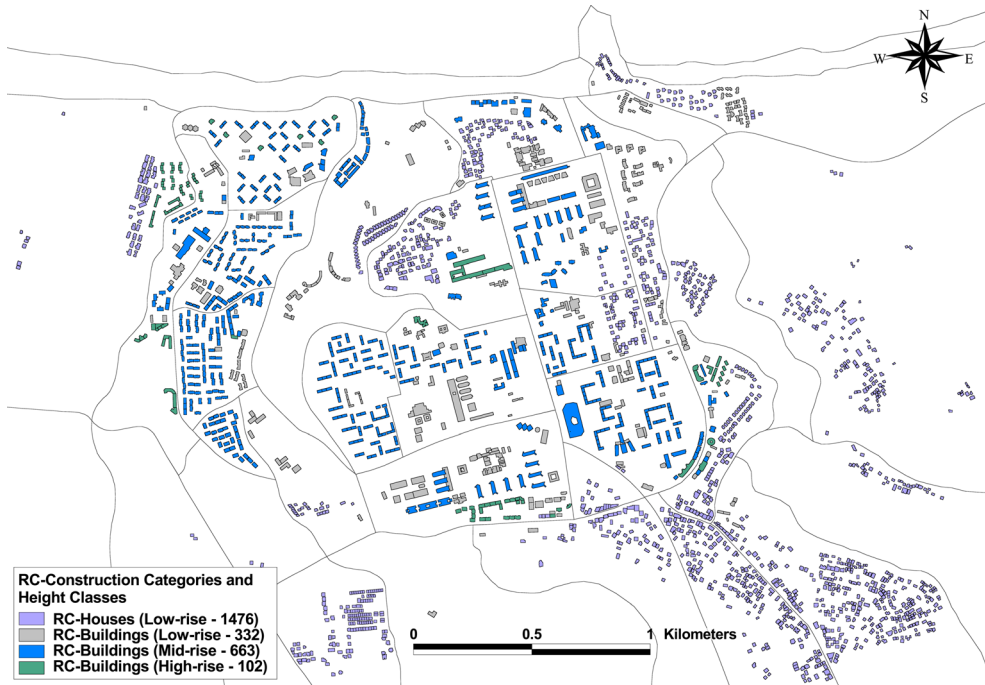
**Figure 5.** RC construction classification by categories and height classes in Boumerdès.

The damage distribution (Figure 6) shows that in the southwestern part of the city (Zones 1A and 1B), where most of the buildings were of mid-rise height (Figure 5), the damage was extensive. There were very few low-rise buildings and almost no high-rise buildings in this area. From Figure 8 it can be clearly seen that there was a higher rate of damage for mid-rise buildings as compared to low-rise and high-rise buildings. Furthermore, not far from Zone 1, in Zone 3, in the southwestern part of the city, where the majority of the buildings were newly built three-story houses, the damage was also extensive. In contrast, in Zone 4, in the southeastern part of the urbanized area, where almost all the existing buildings were single, nonengineered, one- to three-story houses (Figure 5), only some

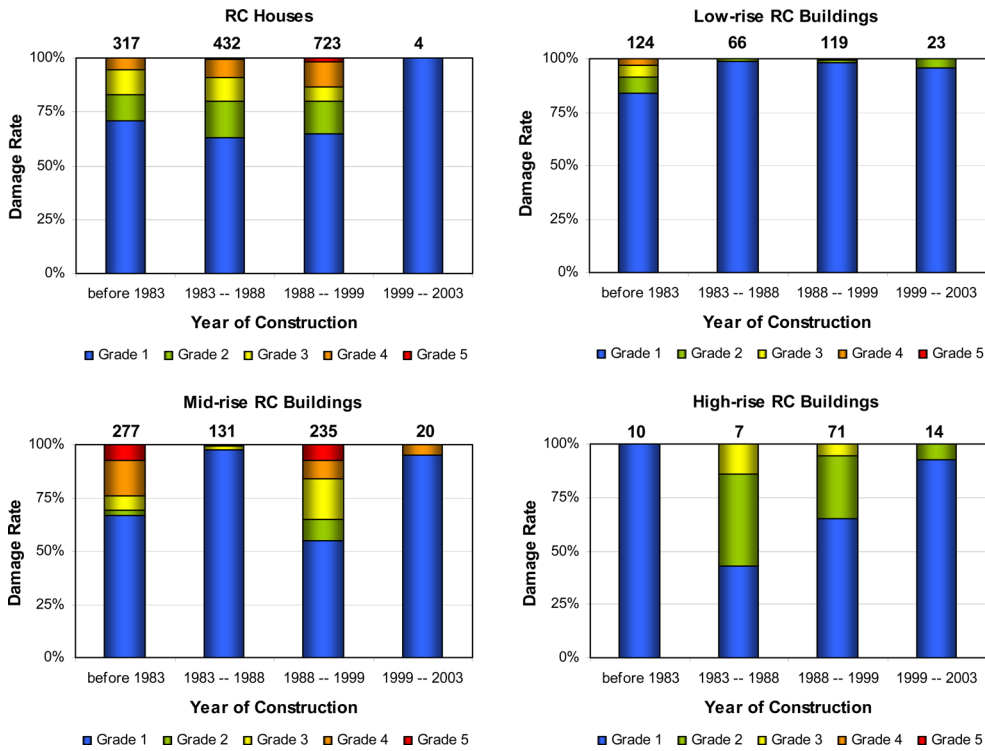
**Figure 8.** Damage rate in relation to year of construction for different types of RC structures at the time of the earthquake.

4 level, while no heavy damage was observed for high-rise RC buildings. Of the total number of RC houses, most of which were three stories high, 10.23% (151 units) suffered Grade 4 or 5 damage. Furthermore, it can be observed from Figure 8 that the correlation between the damage rate and the year of construction (which reflects the version of the seismic code that was applicable at that time) suggests that the damage distribution was not strongly influenced by the version of the seismic code in use at the time of construction. For the type of structure which suffered the most extensive damage, RC buildings of mid-rise height, there is almost no correlation between the damage rate and the year of construction. The same can be said of the RC houses in the study area.

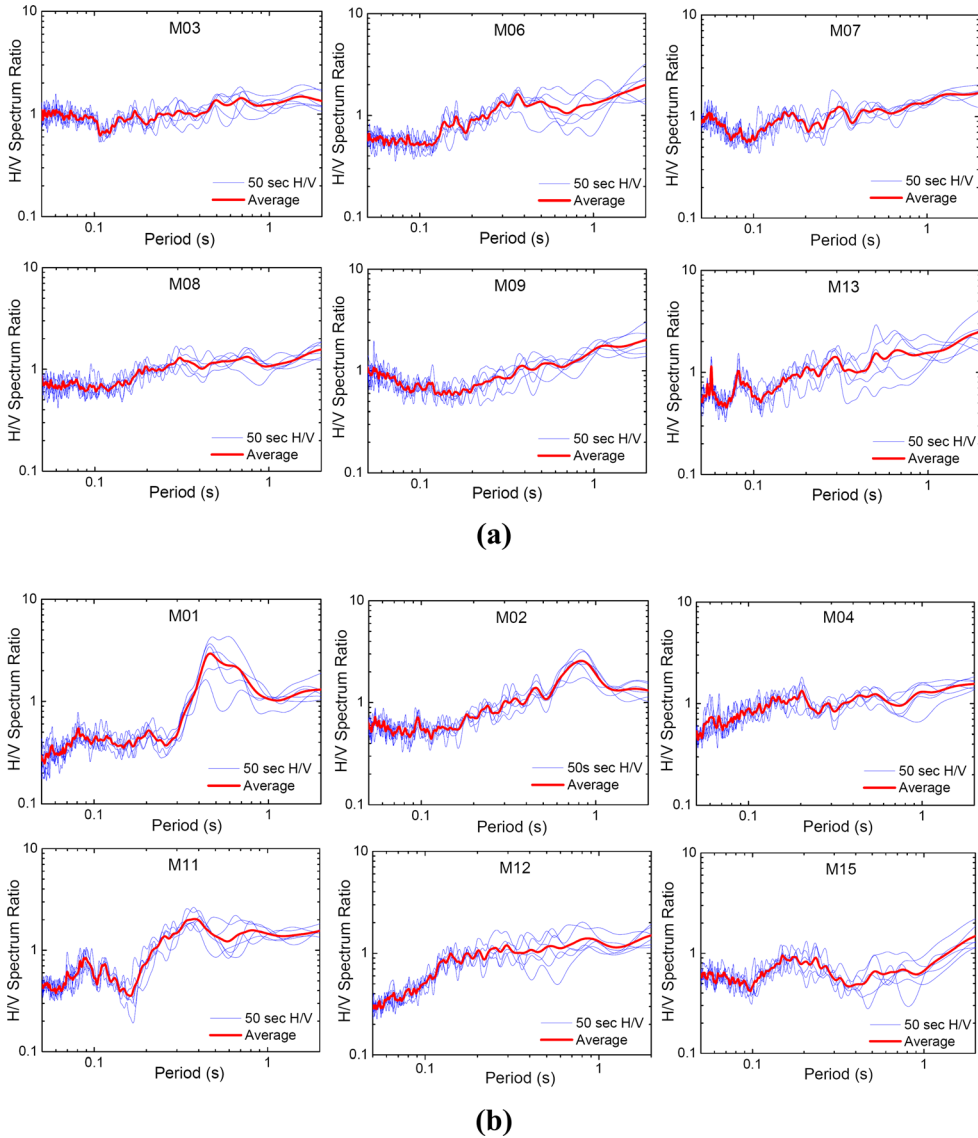
**Figure 10.** Averaged H/V Fourier spectral ratios of microtremors computed from six 50-s segments recorded at each location: (a) H/V spectral characteristics at several sites of heavy damage in Boumerdès, and (b) H/V spectral characteristics at several sites with no damage or only slight damage in Boumerdès.

measurements by the present authors and the building damage distribution for the city of Boumerdès. The microtremor measurements by the present authors match quite well with the detailed H/V ratio-based site mapping provided by Hellel et al. (2010). As shown in Figures 10 and 13, both studies come to the same conclusion: All the H/V ratios measured for sites that sustained heavy damage were characterized by unclear results; however, the H/V ratio curves showed more variation in shape at the sites that sustained no damage or only slight damage.

In fact, for Zone 1A in the southwestern part of the city, the H/V ratios showed no clear results (Figures 10a and 13); however, this zone suffered very extensive damage, with

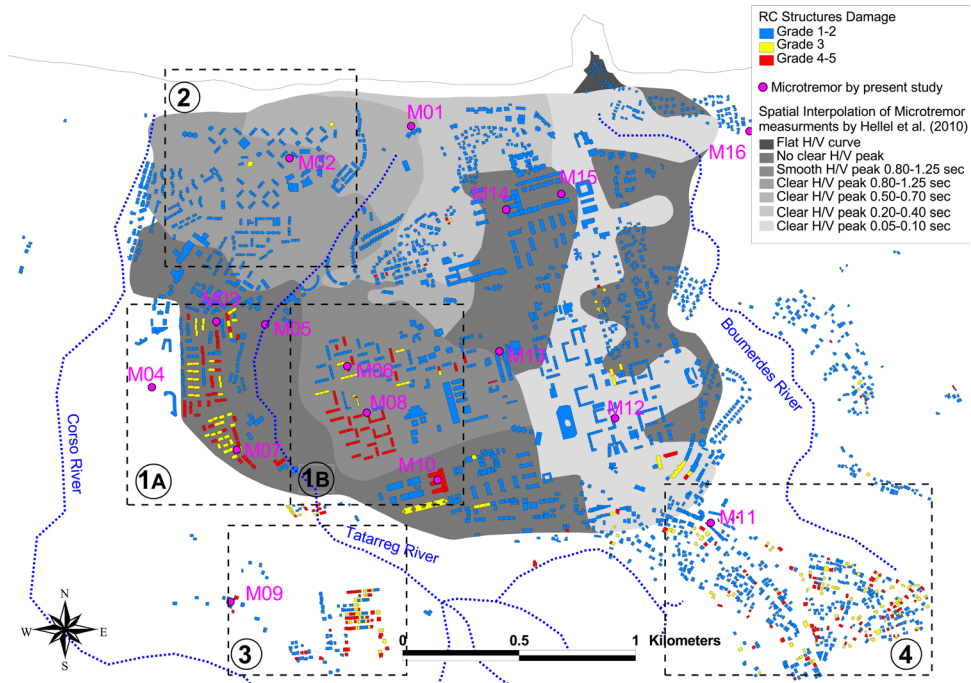
**Figure 13.** Spatial interpolation of 260 H/V peak ratios from microtremor measurements (modified from Hellel et al. 2010), location of 16 microtremor measurements by the authors, and building damage distribution in the city of Boumerdès.

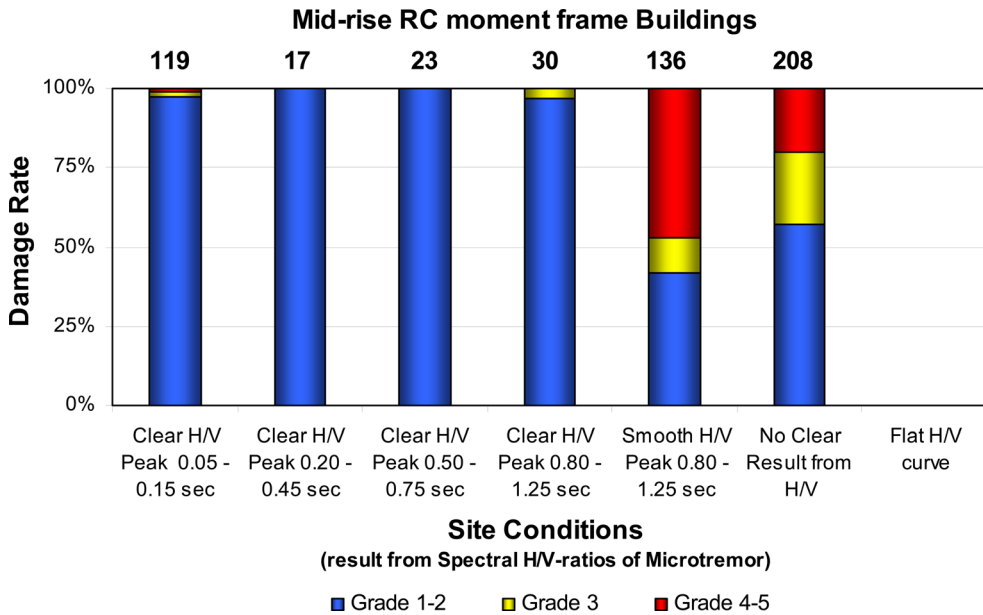
**Figure 14.** Damage rate for mid-rise RC moment-frame buildings with respect to the site conditions in the city. Large numbers of this building type were located at sites that presented smoothed-to-unclear results of spectral H/V ratios of ambient noise. The buildings located at sites with smoothed H/V ratios were five stories and were built in 1970 (Figure 4b), and those located at sites with unclear H/V ratios were four stories and were built in 1996 (Figure 4a).

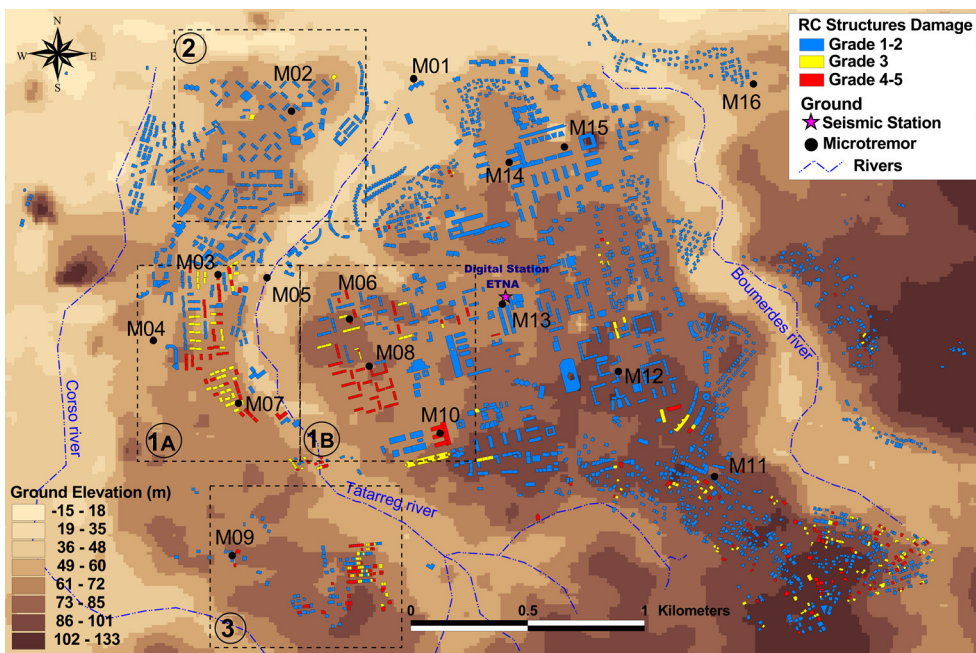
**Figure 15.** Ground elevation model with cells measuring  $15 \text{ m}^2$ , and building damage distribution for the city of Boumerdès. K–K' is the area shown in the cross section in Figure 18 illustrating a topographic relief of the damaged and undamaged zones in the city of Boumerdès.

As mentioned above, according to the damage assessment after the 2003 earthquake, the zones with high damage—Zones 1A, 1B, and 3—were located on hilltops and steep slopes along the Tatarreg River valley (Figure 15). The damage extended 160 to 200 m from the scarp edge of the slope. Figure 16 shows some of the collapsed buildings located on hilltops in Zone 1A along the Tatarreg River valley. Several past earthquakes around the world have caused similar damage concentrations along the tops of steep slopes and on hilltops, for instance, the 1980 Irpinia earthquake ( $M_s = 6.9$ ) (Athanasopoulos 1998), the 1999 Parnitha (Athens) earthquake ( $M_s = 5.9$ ) (Gazetas et al. 2002, Assimaki et al. 2005), the 2003 Bingöl, Turkey, earthquake ( $M_s = 6.4$ ) (Aydan et al. 2003), and the 2003 San Simeon, California, earthquake ( $M_w = 6.5$ ) (McCrink et al. 2010).

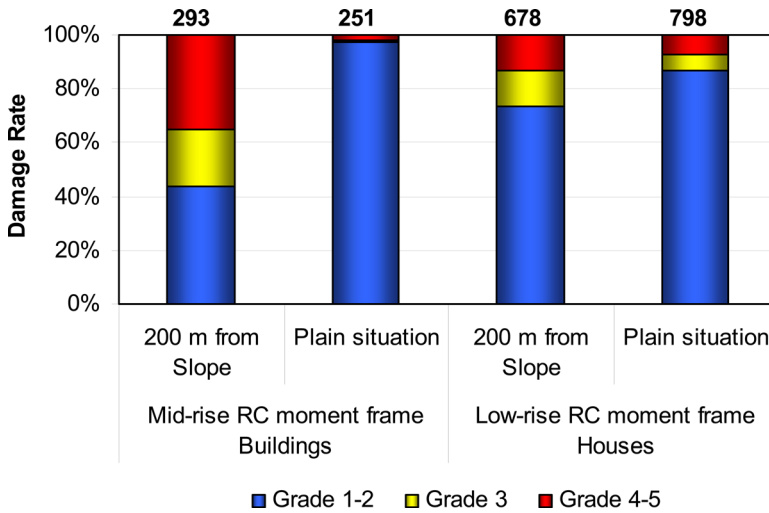
**Figure 17.** Damage rate for RC moment-frame structures with respect to topographic position. The damage rate increases for mid-rise RC moment-frame buildings with four and five stories located up to 200 m from slopes and becomes insignificant for buildings located on flat ground. The damaged RC moment-frame houses mostly had three stories, which suggests that they had fundamental period values close to those of the damaged four- and five-story buildings.

in Boumerdès. In the western part of the city, almost all the buildings that suffered heavy damage were mid-rise RC moment-frame structures, mostly four- to five-story buildings in Zones 1A and 1B and three-story houses in Zone 3, which suggests that these building types had fundamental period values close to each other, and also close to the period of amplification created under the effects of hilltops and steep slopes along the Tatarreg River valley. Figure 4a shows a typical four-story RC moment-frame building in Zone 1A that was built in 1996. Figure 4b shows a typical five-story RC moment-frame building in Zone 1B, which was built by the same contractor in the 1970s.

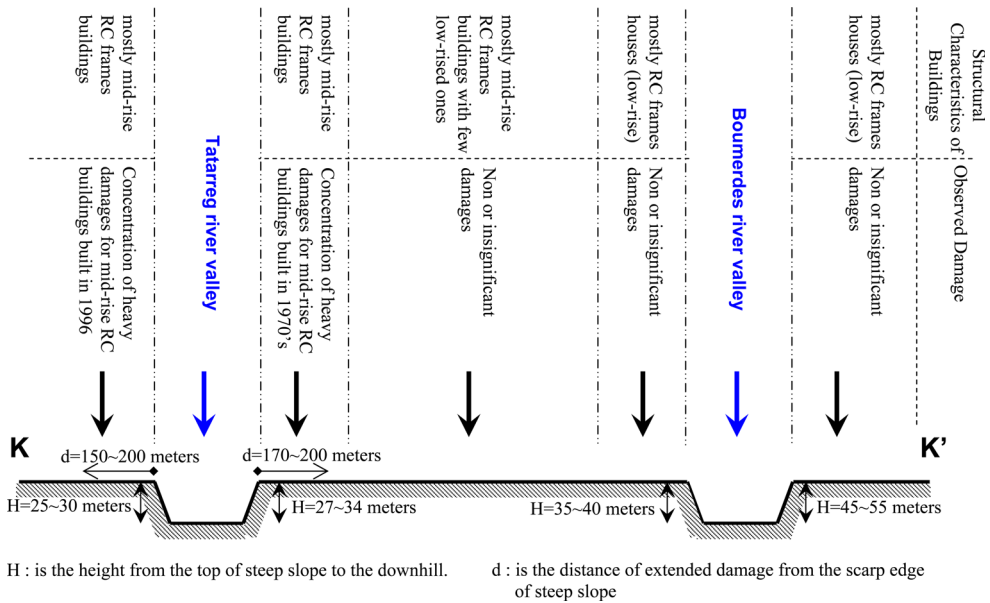
**Figure 18.** Topographic relief of the cross section K–K' (as shown in Figure 15) in relation to the damage distribution and existing structural characteristics of buildings (see Figures 5 and 6) in the city of Boumerdès.

very serious concentration of damage was observed in zones with strong topographic relief. On the other hand, one can clearly see from the free-field microtremor recordings presented in this study that at the most locations where spectral H/V-ratios displayed no clear results are corresponding to these topographic features, such as hill-top and steep slope situations. As pointed out by Lang (2004), the applicability of the spectral H/V-method or stability of results could depend on topographical site conditions, which may unfavorably alter the spectral H/V ratios. Indeed, the same observations noted here were also noted by Lang (2004) when conducting free-field microtremor recordings in the city of Bingöl, Turkey. The H/V ratios observed on the steep slopes displayed no clear results. In addition, the results of investigations conducted by Lermo and Chávez-García (1993) showed that an unusual generation of distinct peaks and troughs can occur with respect to the shape of spectral H/V ratios of microtremors recorded on hilltops or steep slopes.

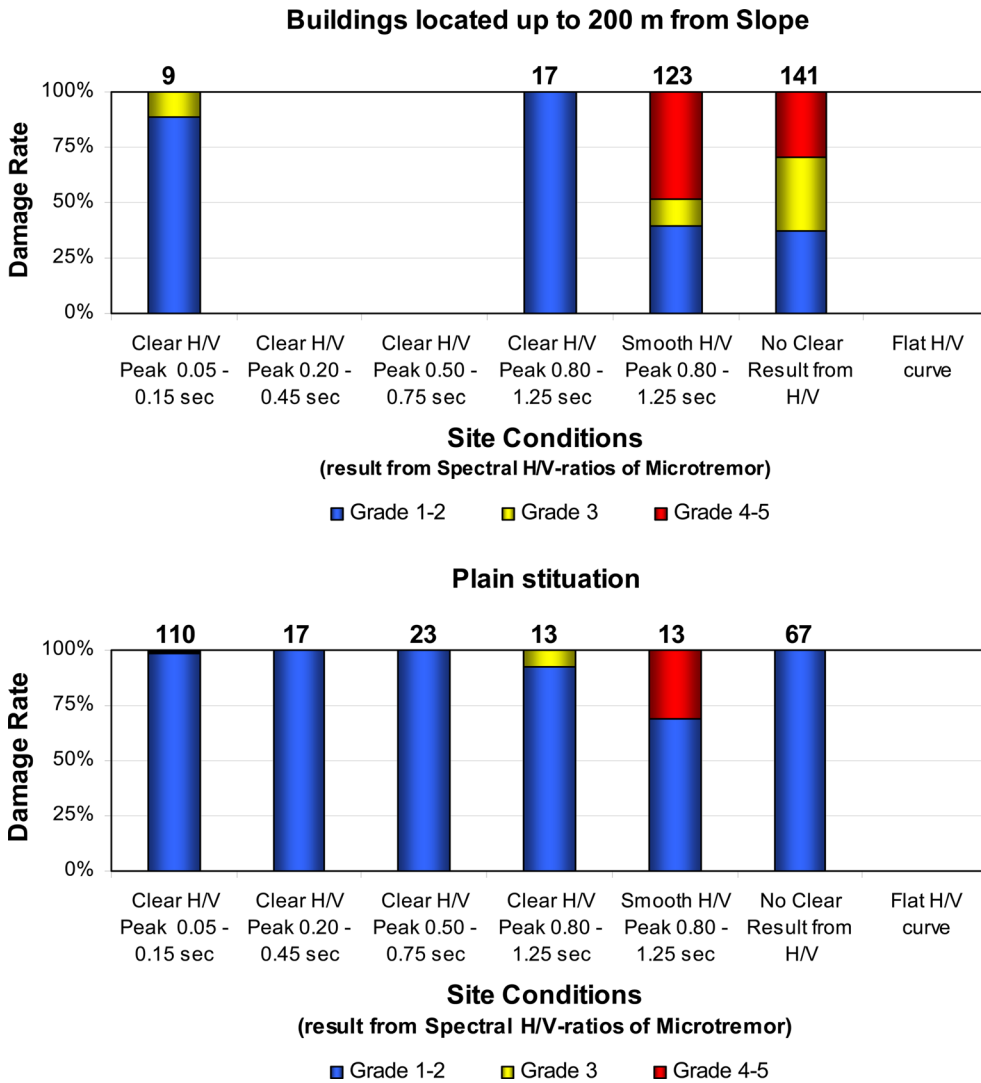
**Figure 19.** Damage rate for mid-rise RC moment-frame buildings considering both topographic positions and site conditions from microtremor measurements. For buildings located up to 200 m from slopes, the damage rate increases and almost all the microtremor measurements show unclear results or smoothed H/V ratios of ambient noise. The clear peaks observed at some locations are due to the fact that the angle of the slope is small, which suggests that the topographic effects were insignificant. For flat locations, almost all of the microtremor measurements show H/V ratios with clear peaks, and there were insignificant damage rates at these locations.

systems. In addition, this study shows that topographic features may also significantly affect the free-field H/V ratios of microtremors. As shown in Figure 19, it is expected that when there are no clear results from H/V ratios, it indicates the presence of topographic effects due to hilltops and steep slopes.

The damage rate increased for mid-rise RC moment-frame buildings located up to 200 m from slopes. In fact, in Zones 1A and 1B along the Tatarreg River valley, the buildings located very close to the scarp edge of the slope totally collapsed, while those located some distance away from the scarp edge either partially collapsed or suffered extensive damage to their structural elements, columns, and beams, as shown in Figure 16. As mentioned by Géli et al. (1988), topographic effects generally result in larger amplitudes of ground motion toward ridge crests, which can increase damage to the buildings in these locations. In addition, the microtremor measurements in Zone 1A showed no clear results for H/V ratios, suggesting that the ambient noise records were strongly influenced by the topography, which concurs with the possibility that the amplitude of the ground motion was strongly affected, leading to extensive damage (Figure 19). For Zone 1B, microtremor measurements showed H/V ratios with smoothed peaks, suggesting that the ambient noise records in this zone were not as strongly influenced by topographic effects as in Zone 1A. However, it can clearly be seen that there was a higher rate of damage in Zone 1B than in Zone 1A, as shown in Figure 19. Even though the local subsoil conditions (thickness of layers) in Zone 1B are probably different to those of Zone 1A, the fact that the damaged buildings in Zone 1B were five-story structures built in 1970 (before the publication of seismic design codes in Algeria) may explain the difference in the damage rate between these two zones. In Zone 1A, most of the damaged buildings were four-story structures built in 1996 using the seismic code published in 1988.
