BUILDING DAMAGE AND TSUNAMI INUNDATION GIS DATASETS AFTER THE 2010 CHILE EARTHQUAKE

Abstract: This paper presents the results of a field survey conducted by the authors after the 2010 Chile earthquake. The authors visited the affected area about a month after the earthquake. The GIS datasets for the damage levels of buildings in Talca and the tsunami-inundated areas in Talcahuano, Dichato, and Constitución are constructed in this study, and a series of fundamental analyses are performed using a digital elevation model (DEM). Further, the usefulness of satellite images captured after the earthquake to detect damaged buildings in Talca is discussed using the GIS datasets constructed in this study.

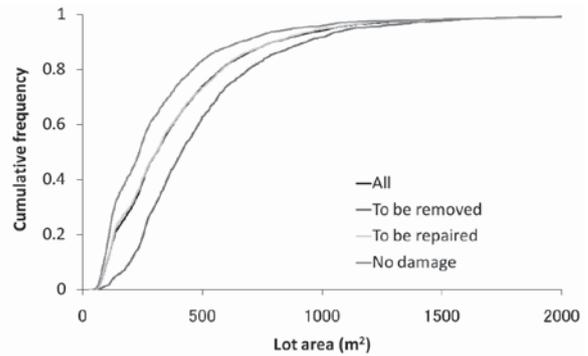
Figure 6 Cumulative frequencies of the areas of building lots with respect to the damage level

Figure 6 shows the cumulative frequencies of the areas of building lots with respect to the damage level. The mean of all the georeferenced areas was approximately 430 m² and was almost equal to that of the areas associated with the buildings to be repaired. The mean of the lot areas of the buildings to be non-damaged was approximately 340 m², which was considerably smaller than that of the buildings to be removed. On the basis of the results, it has been speculated that the newer buildings are constructed in relatively small lots; however, the construction periods are not available at this moment.

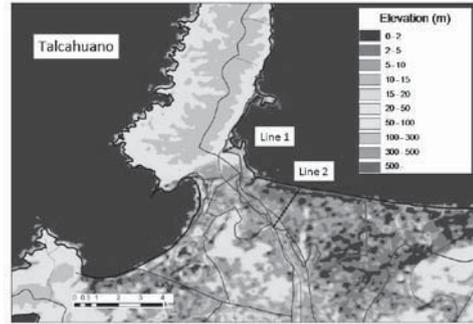
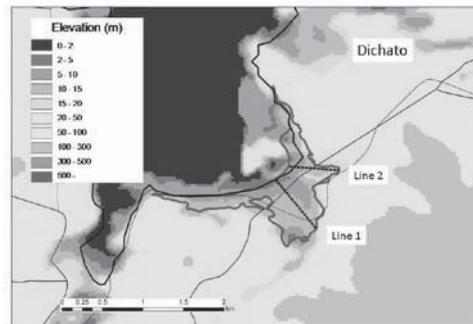
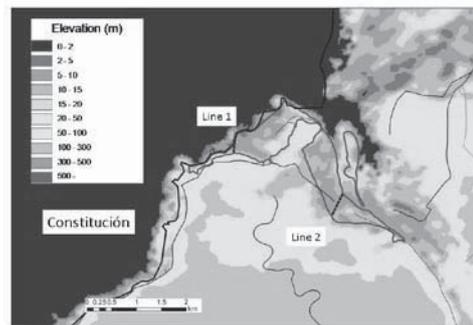
Figure 8 Tsunami-inundated areas in Talcahuano, Dichato, and Constitución

Figure 8 shows the tsunami-inundated areas in Talcahuano, Dichato, and Constitución and the distributions of the elevation derived from the ASTER GDEM. The elevations in the inundated areas are lower than 20 m on the

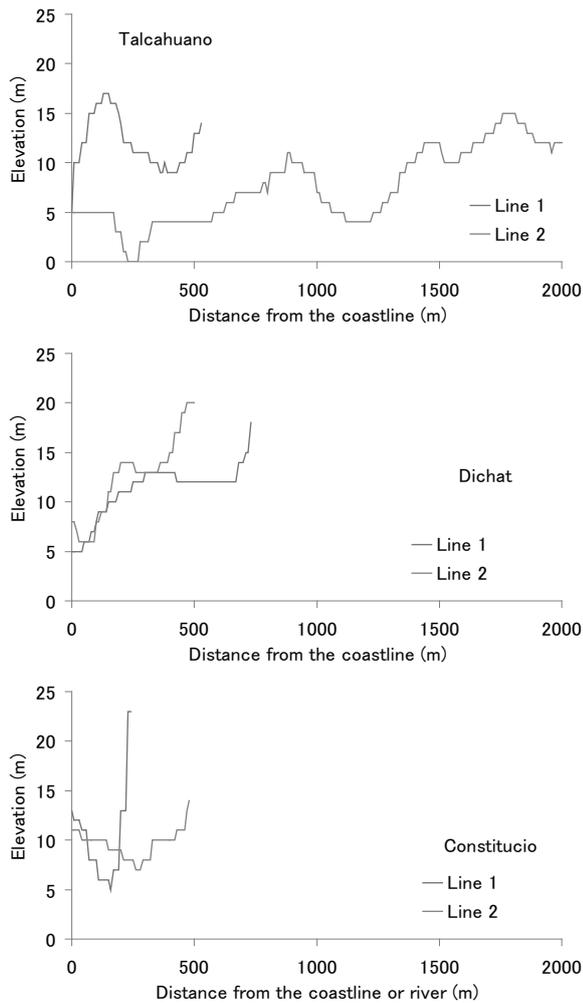
Figure 9 Elevations along the transverse lines set in Fig. 8

whole except for a certain area in Constitución. As shown in the figure, we set the two traverse lines in each inundated area. The elevations were extracted along the two lines. The extracted elevations are illustrated in terms of the distance from the coastline in Fig. 9. As for Line 2 in Constitución, the elevations are presented with respect to the distance from the Maule River. The relatively low elevations and slow grades result in long travel distances of the tsunami wave. According to Line 2 in Talcahuano, the tsunami wave could travel approximately 2000 m from the coastline. Line 1 in Constitución was assigned to identify the surveyed site by Imamura *et al.* (2010). According to their report, the tsunami runup height was 28.3 m at the site. Since the DEM used in this study is a global dataset that consists of 30-m grid cells, the elevation at the site is estimated to be approximately 23 m. The slope is estimated to be approximately 67% and is almost equivalent to that reported by Imamura *et al.* (2010), which is 63.5%.

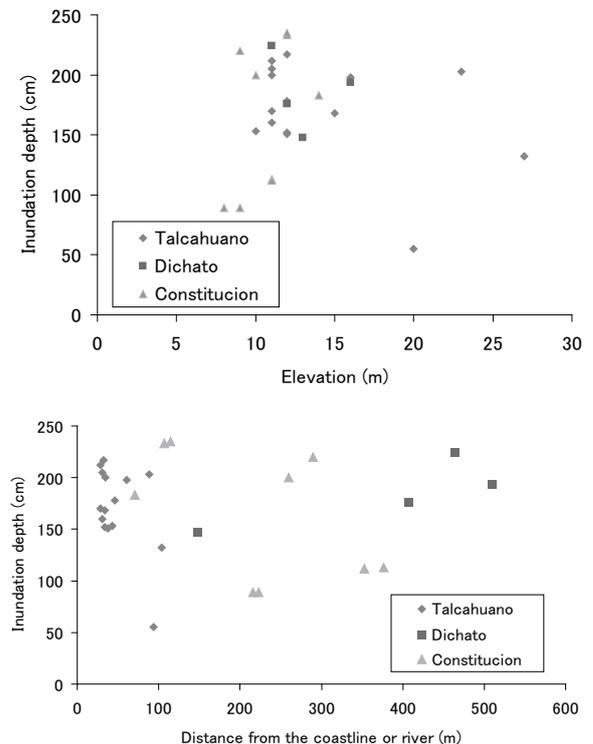
Figure 11 Summary of the measurement of tsunami inundation depth

As shown in Fig. 10, the inundation depth was measured at several sites in the three cities. The inundation depth along the beachfront street in Talcahuano was larger than 150 cm, but a depth of 55 cm was observed in its bystreet (site 4). Figure 11 summarizes the measurements in the three cities. The inundation depth is presented with

respect to the elevation and the distance from the coastline. As for the results in Constitución, the records are shown with respect to the distance from the Maule River. A clear tendency is not seen in the relationship between the tsunami inundation depth and the elevation. The recorded depth in
