# DAMAGE DETECTION OF THE MAY 6, 2012 TORNADO IN TSUKUBA, JAPAN USING AERIAL THERMAL INFRARED IMAGES

Daiki HANADA<sup>\*1</sup>, Kentaro SUZUKI<sup>1</sup> and Fumio YAMAZAKI<sup>2</sup>

**KEY WORDS:** Tornado, Aerial Thermal Infrared Image, Temperature Distribution, Damage Detection, GIS

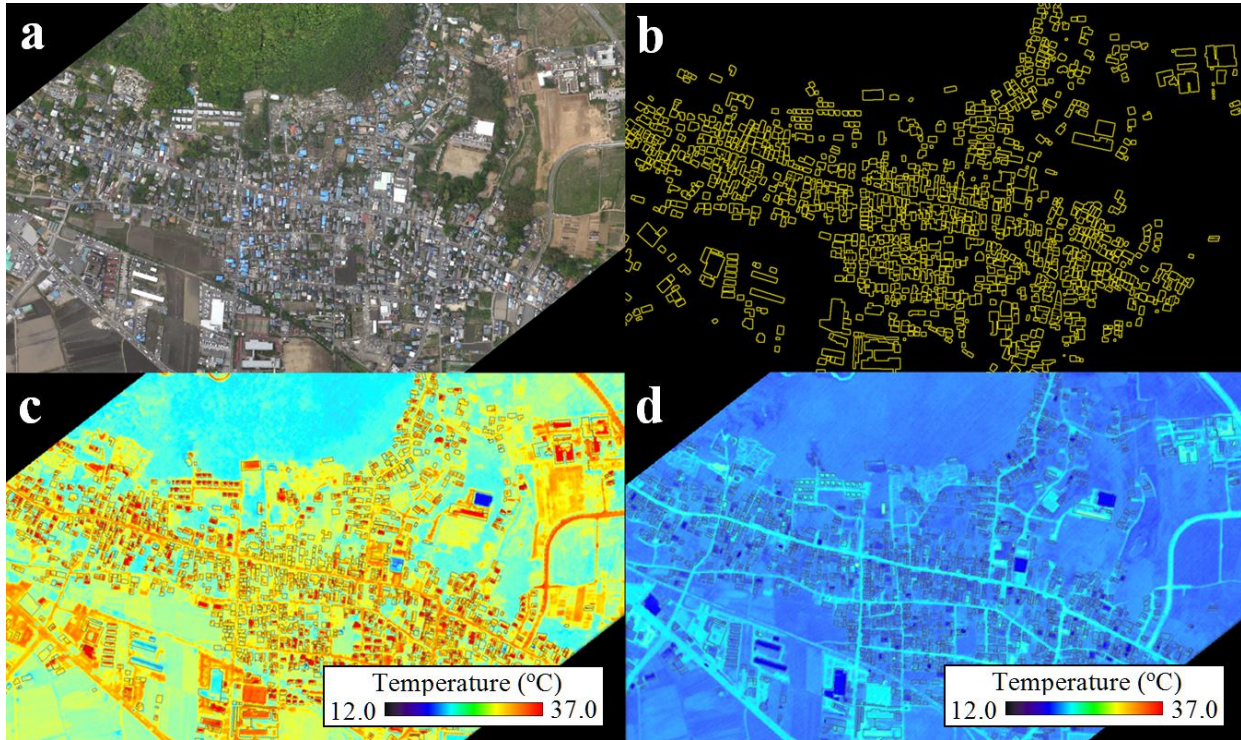
Figure 2 Visible image of Hojo district in Tsukuba City at daytime (a), building footprints created from Figure 2a (b), TIR image at daytime (c), and TIR image at nighttime on May 8, 2012 taken from helicopter.

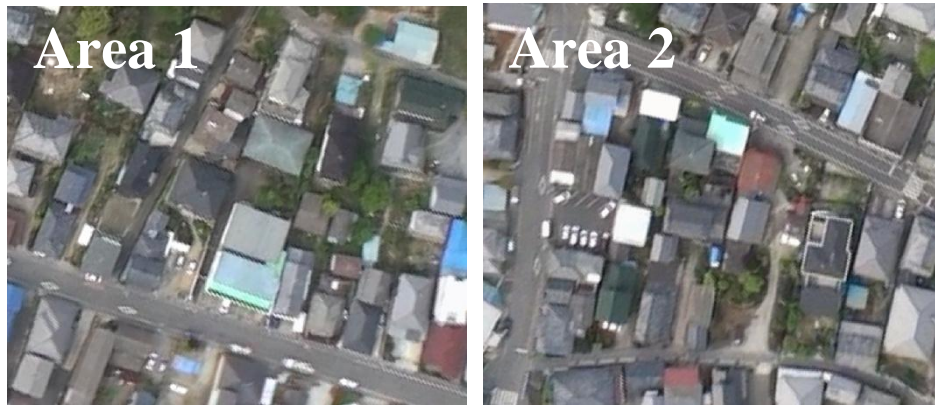
The characteristics of the TIR images at non-damaged areas were discussed first. Figure 5 show the locations of two target non-damaged areas in Figure 4. Figure 6 shows the surface temperature within the building footprints from the daytime and nighttime TIR images, superimposed on the visible image. From the daytime roof temperature distributions in Figures 6a and 6c, the roofs mostly show high temperature although some low temperature roofs exist. From the nighttime roof temperature distributions in Figure 6b and 6d, the buildings showing high temperature at daytime are still in relatively higher temperature at nighttime. It is observed that the roof temperature within a footprint of a non-damaged is mostly uniformly distributed but the effects of surrounding vegetation, shadow and footprint's accuracy can be observed around the outline.

Figure 5 Target areas of non-damage in Figure 4.

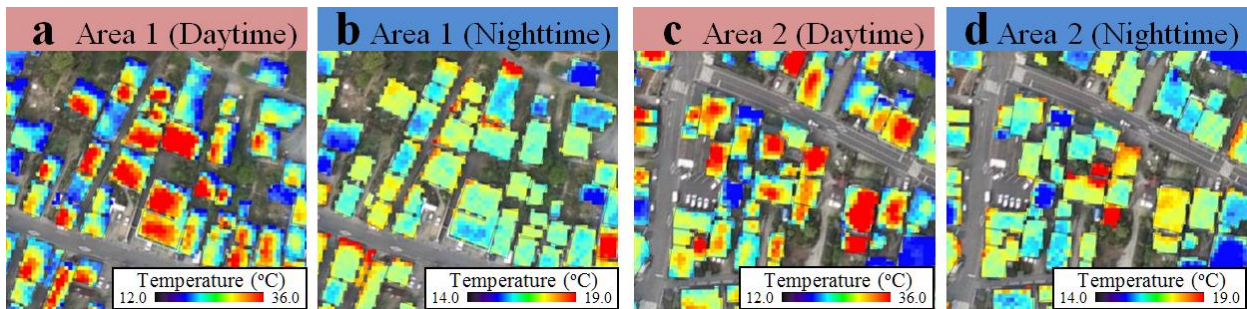
Figure 6 Temperature within building footprints for non-damage areas, **a, c**: Daytime, **b, d**: Nighttime.

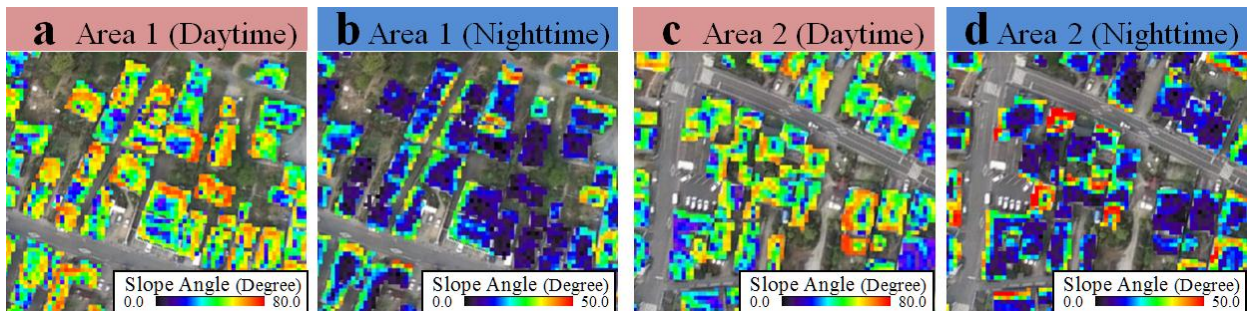
Figure 7 shows the slope angle of the surface temperature within the footprints. In calculation of the slope angle, the temperature of the adjacent pixels affected the result although the angle is shown only within the footprints. In the daytime slope angles in Figures 7a and 7c, high temperature roofs show generally larger slope angles because the temperature difference with their surroundings is large due to the difference of surface materials. In the nighttime slope angles in Figure 7b and 6d, the slope angles within some building outlines are displayed red color affected by surrounding road or vegetation. However most building roofs are in low temperature with uniform distribution, and thus their temperature change within its outline is small.

Figure 7 Slope angle of the temperature within building footprints in Figure 6, **a, c**: Daytime, **b, d**: Nighttime.

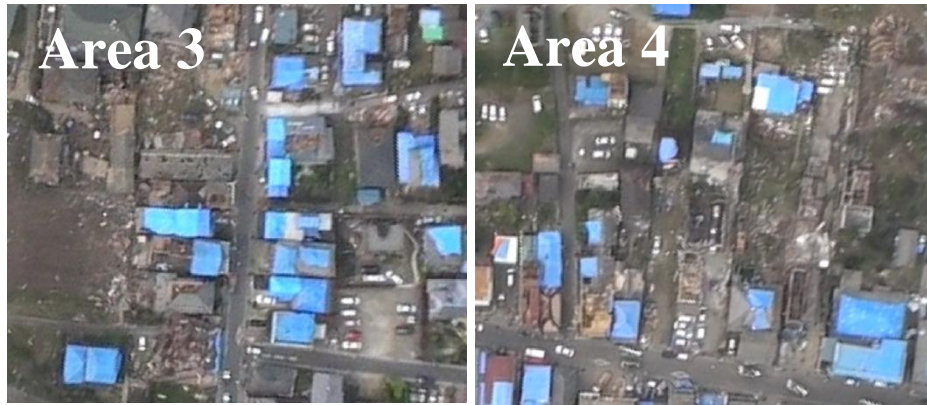
Next the characteristics of the TIR images at heavily-damaged areas were discussed. Figure 8 show the locations of two target heavily-damaged areas in Figure 4. Figure 9 shows the surface temperature within the building footprints from the daytime and nighttime TIR images, superimposed on the visible image. From the daytime roof temperature distributions in Figures 9a and 9c, damaged roofs mostly show low temperature because they were covered by blue sheet or reduced to debris. The nighttime roof temperature distributions in Figure 9b and 9d also exhibit low values. The temperature distributions for heavily-damaged buildings are seen to be somewhat different from those of non-damaged ones both at daytime and nighttime, but this observation is highly affected by the material, color and orientation of the roof, shadow and surrounding conditions.

Figure 8 Target areas of heavy-damage in Figure 4.
