USE OF AIRBORNE OPTICAL AND THERMAL IMAGERY FOR THE DETECTION OF BUILDING DAMAGE DUE TO THE 2012 TSUKUBA TORNADO

Fumio Yamazaki¹⁾, Daiki Hanada²⁾ and Kentaro Suzuki²⁾

1) Professor, Department of Urban Environment System, Chiba University, Japan

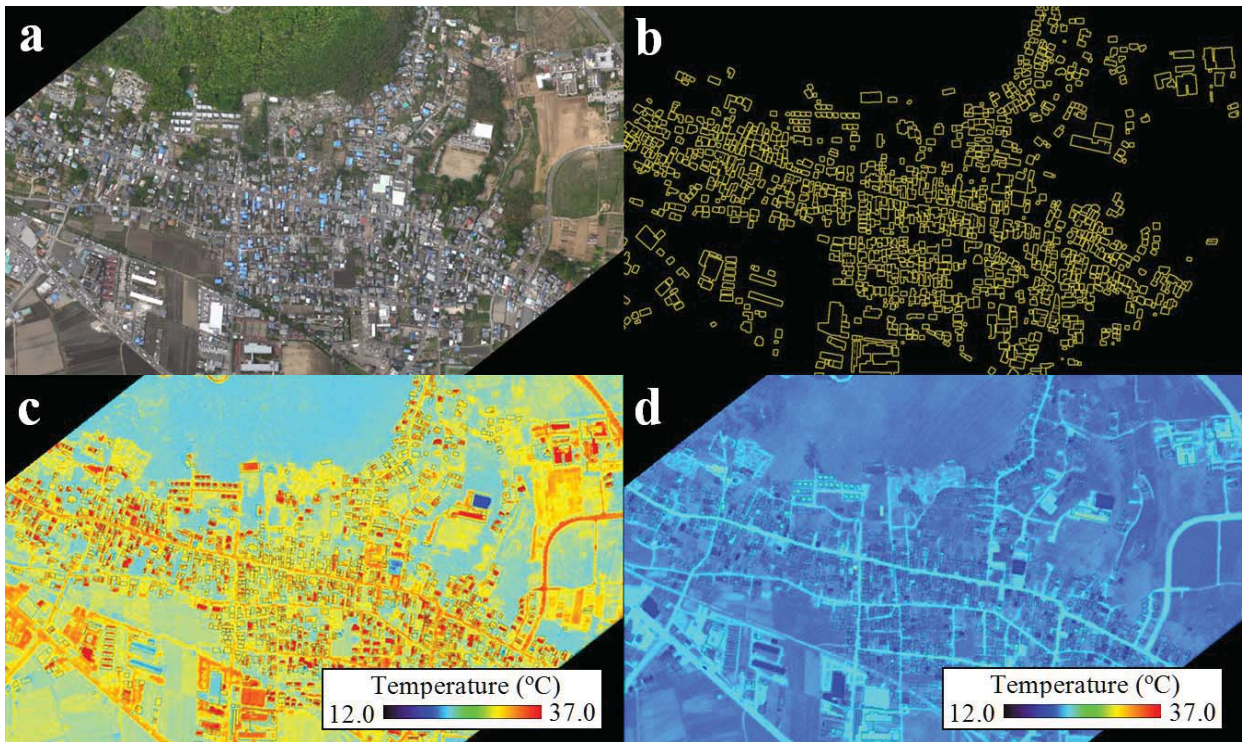
taken from a helicopter of SKYMAP co. by our request after the tornado. **Figure 3** (a, c) show a part of the post-event visible and TIR images taken at daytime (about 14:00) on May 8, 2012 while (d) shows a part of the TIR image taken at nighttime (about 19:30) on the day.

The damage assessment was carried out in the following steps; Firstly building footprints were manually created from the daytime aerial visible image and an existing Zenrin digital map on ArcGIS software (**Figure 3b**). Then, damage status of each building was detected visually from the daytime aerial visible image based on the building damage classification shown in **Figure 4**. This classification was applied here, modified from the floor damage criteria by the Cabinet Office of Japan (2009), which is recommended to use when evaluating the monetary loss of residential structures for local governments. In the classification, the damage level of each wooden house is judged by 5 grades: such as no to slight (G0-G1), minor (G2), moderate (G3), major damage (G4) and collapse (G5). We employed the method based on the damaged percentage of a roof (R) since it is suitable to apply to vertical aerial images.

Figure 3 (a) Visible image of Hojo district in Tsukuba City at daytime, (b) building footprints created from (a), (c) TIR image at daytime, and (d) TIR image at nighttime on May 8, 2012 taken from helicopter.

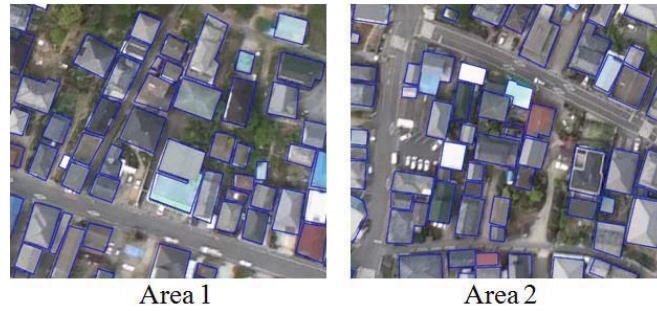
The characteristics of the TIR images at non-damaged areas were discussed first. **Figure 6** shows the locations of two target non-damaged areas in **Figure 4**. **Figure 7** shows the surface temperature within the building footprints from the daytime and nighttime TIR images, superimposed on the visible image. From the daytime roof temperature distributions in **Figure 7 (a, c)**, the roofs mostly show high temperature although some low temperature roofs exist. From the nighttime roof temperature distributions in **Figure 7 (b, d)**, the buildings showing high temperature at daytime are still in relatively higher temperature at nighttime. It is observed that the roof temperature within a footprint of a non-damaged building is mostly uniformly distributed but the effects of surrounding vegetation, shadow and footprint's inaccuracy can be observed around the outline.

Figure 6 Target areas of non-damage in Figure 4

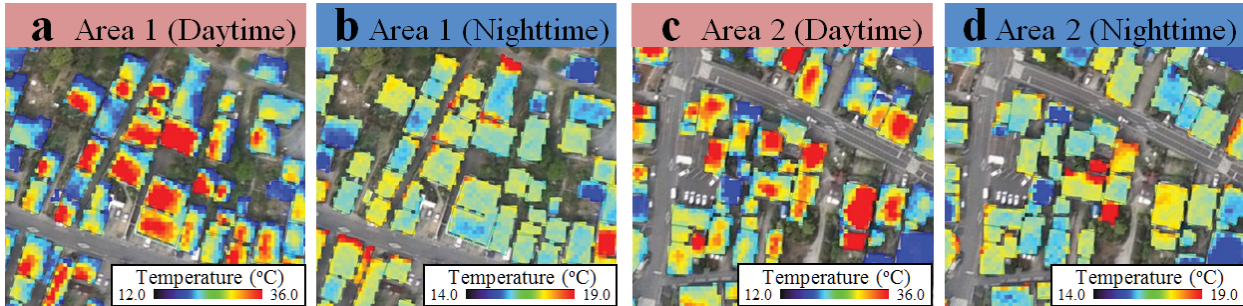
Figure 7 Temperature within building footprints for non-damage areas, a, c: Daytime, b, d: Nighttime

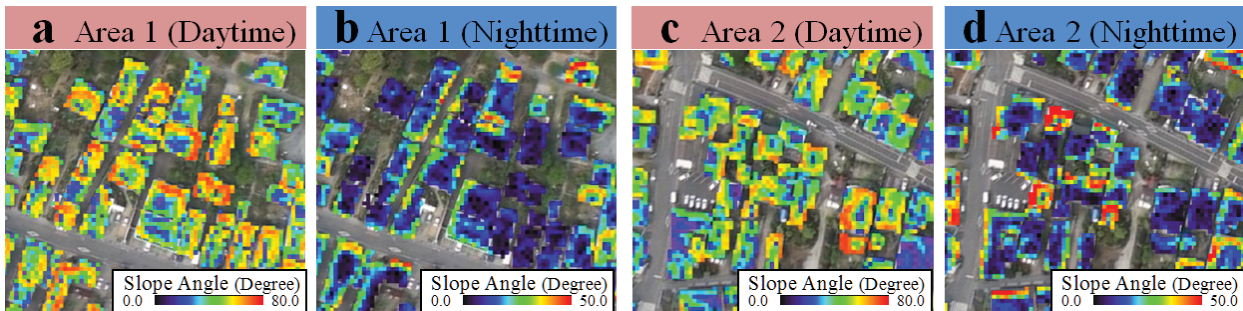
Figure 8 Slope angle of the temperature within building footprints in Figure 7, a, c: Daytime, b, d: Nighttime

temperature within the footprints. In calculation of the slope angle, the temperature of the adjacent pixels affected the result although the angle is shown only within the footprints. In the daytime slope angles in Figures 8 (a, c), high temperature roofs show generally larger slope angles because the temperature difference with their surroundings is large due to the difference of surface materials. In the nighttime slope angles in Figure 8 (b, d), the slope angles within some building outlines are displayed red color affected by surrounding road or vegetation. However most building roofs are in low temperature with uniform distribution, and thus their temperature changes within their outlines are small.
