# Development of Building Damage and Tsunami Inundation GIS Dataset following the 2010 Chile Earthquake

## Summary

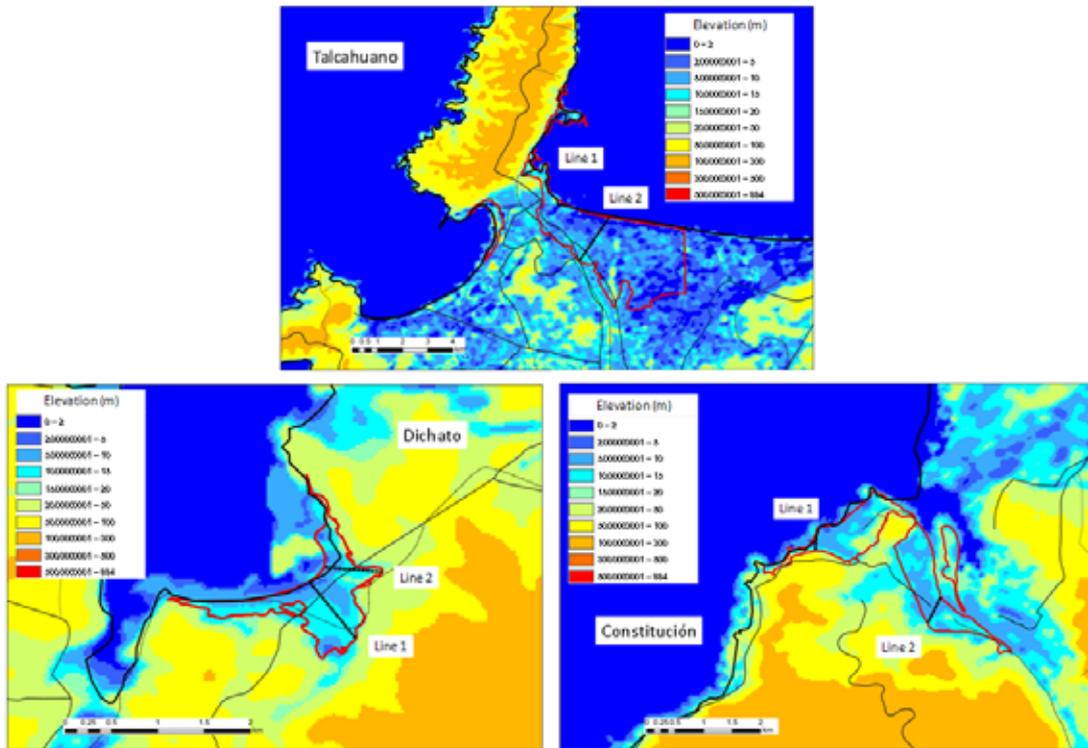
Fig. 8: Tsunami-inundated areas in Talcahuano, Dichato, and Constitución

Figure 8 shows the tsunami-inundated areas in Talcahuano, Dichato, and Constitución and the distributions of the elevation derived from the ASTER GDEM. The elevations in the inundated areas are lower than 20 m on the whole except for a certain area in Constitución. As shown in the figure, we set the two traverse lines in each inundated area. The elevations were extracted along the two lines. The extracted elevations are illustrated in terms of the distance from the coastline in Fig. 9. As for Line 2 in Constitución, the elevations are presented with respect to the distance from the Maule River. The relatively low elevations and slow grades result in long travel distances of the tsunami wave. According to Line 2 in Talcahuano, the tsunami wave could travel approximately 2000 m from the coastline. Line 1 in Constitución was assigned to identify the surveyed site by Imamura *et al.* [13]. According to their report, the tsunami runup height was 28.3 m at the site. Since the DEM used in this study is a global dataset that consists of 30-m grid cells, the elevation at the site is estimated to be approximately 23 m. The slope is estimated to be approximately 67% and is almost equivalent to that reported by Imamura *et al.*, which is 63.5% [13].

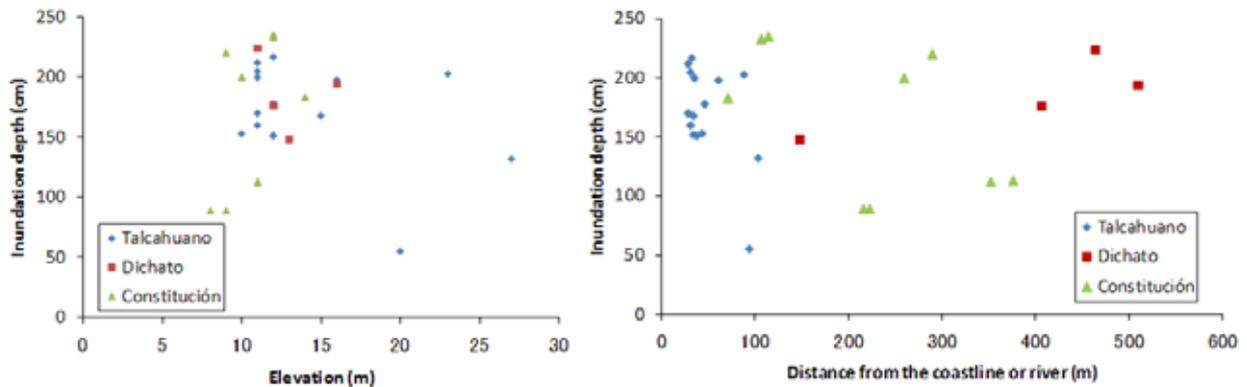
Fig. 11: Summary of the measurement of tsunami inundation depth

As shown in Fig. 10, the inundation depth was measured at several sites in the three cities. The inundation depth along the beachfront street in Talcahuano was larger than 150 cm, but a depth of 55 cm was observed in its bystreet (site 4). Figure 11 summarizes the measurements in the three cities. The inundation depth is presented with respect to the elevation and the distance from the coastline. As for the results in Constitución, the records are shown with respect to the distance from the Maule River. A clear tendency is not seen in the relationship between the tsunami inundation depth and the elevation. The recorded depth in Talcahuano and Constitución decreased with an
