# Damage Assessment of Buried Pipes due to Recent Earthquakes in Japan

F. Yamazaki, K. Kimishima & Y. Maruyama

*Department of Urban Environment Systems, Chiba University, Chiba, Japan*

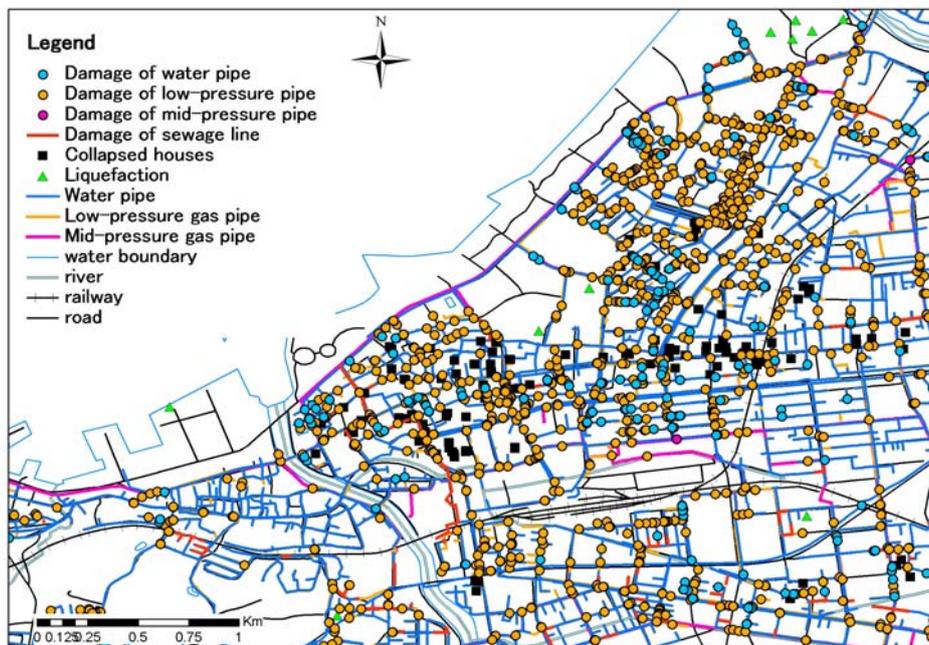
Damage datasets used in this study are shown in Table 1. The datasets include the locations of breaks/leaks of water, gas, and sewage lines, and those of collapsed houses. Liquefaction occurrences were also detected by visual inspection using aerial images from Pasco Co., Ltd. The Digital Map 2500 (Spatial Data Framework), developed by the Geographical Survey Institute of Japan (2002), was used as a base map. Inventory data of water and gas systems were also gathered and all the data were integrated on GIS as shown in Fig. 1.

Figure 1. Inventory data and damage data of lifeline systems in Kashiwazaki City due to the 2007 Niigata Chuetsu-Oki earthquake

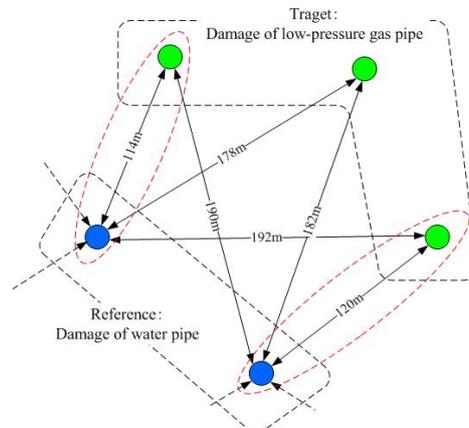
To evaluate the probability that earthquake damages are caused simultaneously, the shortest distances among the locations of the various damages were analyzed. The distances to neighboring damages were obtained for all the damage incidents (Fig. 6), and then the shortest distances were found for all the damage locations of water, low-pressure gas, and mid-pressure gas pipes, sewage lines, houses, and liquefaction occurrence. Because of the data structure in GIS, the polylines, which indicate the damage locations of sewage lines, were divided into the points with 1 m interval, and then the shortest distances were calculated. Table 2 shows the ratio of the damage incidents with the shortest distance less than 250 m.

Figure 6. Definition of the shortest distances between the damage incidents
