Building Damage Mapping of the 2006 Central Java, Indonesia Earthquake Using High-Resolution Satellite Images

Hiroyuki MIURA¹, Fumio YAMAZAKI² and Masashi MATSUOKA³

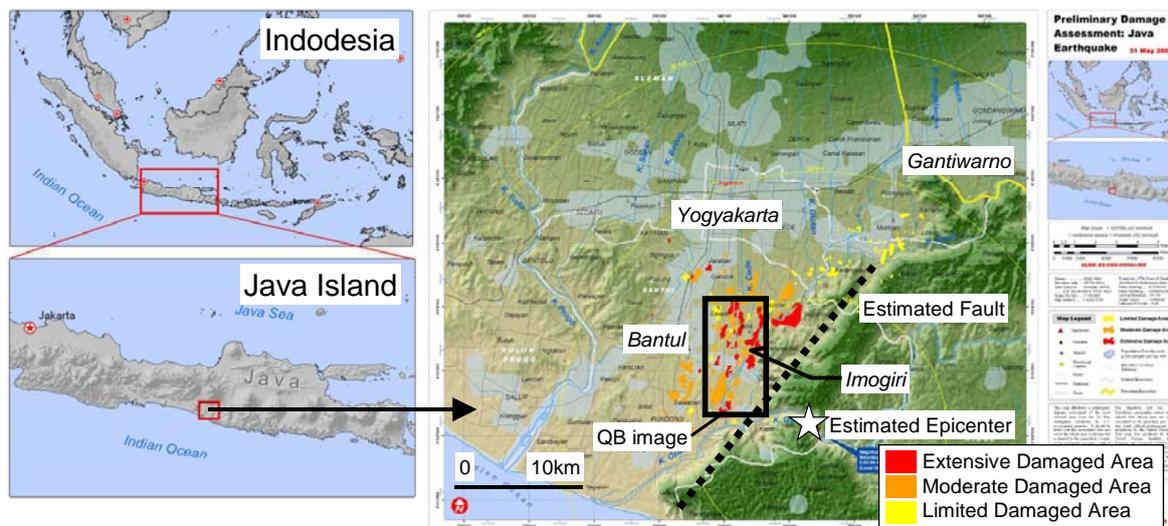
Fig. 1 Location of Central Java, Indonesia and damage distribution estimated by UNOSAT(2006)

Figure 1 shows the location of the Central Java, Indonesia and the damage distribution estimated in UNOSAT (2006). The damage was interpreted from QB images observed after the earthquake in the UNOSAT map. The map shows that heavily damaged areas are concentrated in the northwest of the fault. The authors
