Visual Damage Interpretation of Buildings Using QuickBird Images Following the 2007 Peru Earthquake

Summary

Keywords: QuickBird; visual damage detection; the 2007 Pisco earthquake; building damage

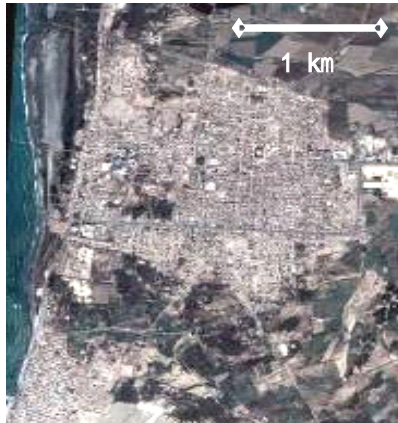
Fig. 1: QB satellite image of Pisco acquired 12 days after the earthquake.

QuickBird satellite captured a clear image of Pisco city on 27 August 2007, 12 days after the quake, as shown in Figure 1. QuickBird also observed Pisco city on 3 June 2007, 3 months before the earthquake. Figure 2 shows partial enlargements of the pre- and post- event QB images. In the post-event image, the building damages could be identified by debris from the variation of texture and the disappearance or decrease of shadow of collapse buildings. As a characteristic of this region in remote sensing imagery, the shadows of buildings are relatively small due to the low-latitude with little vegetation. The building materials in the city are of similar color with that of bare ground.

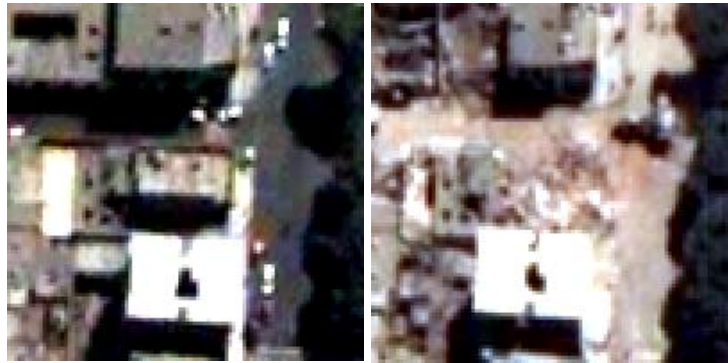
Fig. 2: Enlargement of a part of the images: the pre-event (left) and post-event (right) ones.

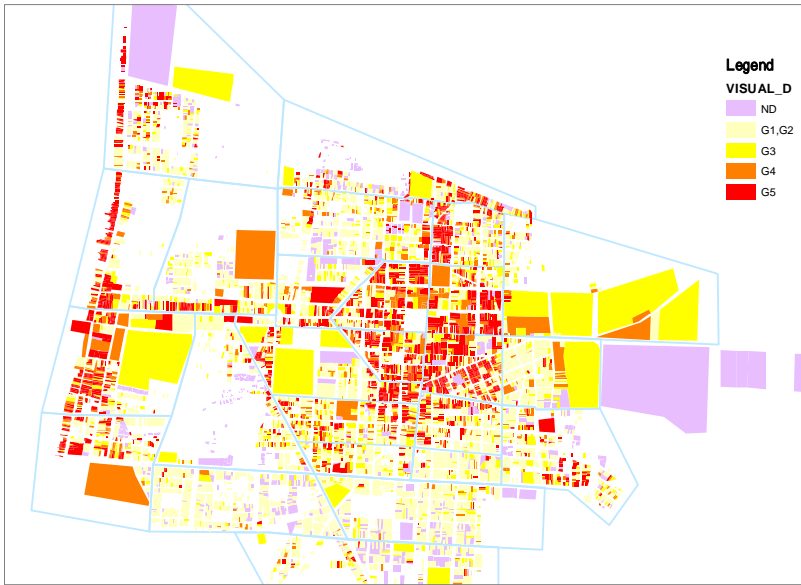
Fig. 3: Result of visual damage interpretation plotted on GIS using QB satellite images.

Figure 3 shows the result of interpretation displayed on GIS. In the image interpretation, it was too difficult to distinguish Grades 1 and 2 because these are defined by a slight damage to lateral faces of a building. Therefore, these two damage levels were unified as Grade 1/2 in this study. Severe

damaged buildings of Grade 5, which represent completely collapsed buildings, were observed in the area along the coast and in the old urban area located in the eastern part of the city. A building with certain damages in roof was classified as Grade 4. Large lots in the outskirts of the city are the properties of schools, hospitals and factories. Approximately, 1,100 lots were categorized as no data, and those are denoted as ND in Figure 3.

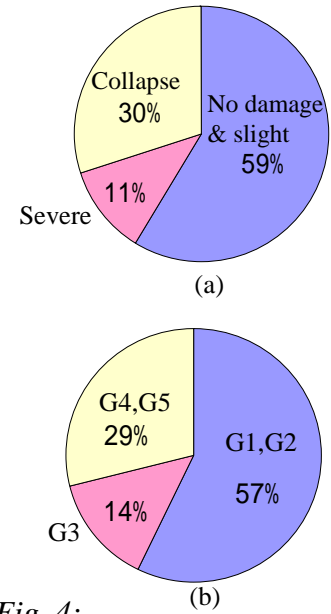
Fig. 4: Ratio of each damage rank by (a) QB visual detection and (b) field survey.

The ratios of damage grade by images interpretation and field survey are illustrated in Figure 4. Each corresponding damage rank is almost the same ratio. Most of the damaged buildings were classified as Grade 4 and Grade 5, and only a few of them were categorized into Grade 3 (moderate damage). The trend of damage observed in this earthquake may depend on the characteristic of masonry structures, specifically lack of rigidity, and thus they collapsed quickly.

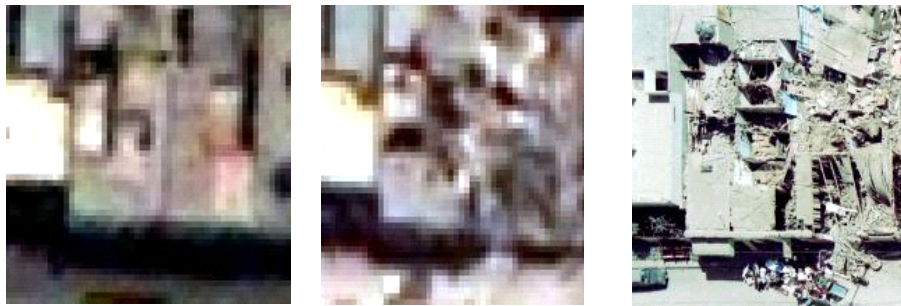
(a) the pre-event QB (b) the post-event QB (c) the post-event aerial photo
 Fig. 5: Comparison of the satellite images and an aerial photograph

A part of each image is shown in Figure 5. The resolution of the aerial photograph is considered to be about 0.2 m, remarkably high, and thus even the detail of building damage is recognized. It can be clearly confirmed that the roof had been broken down and only the walls remained at the building located in the center of the photo.

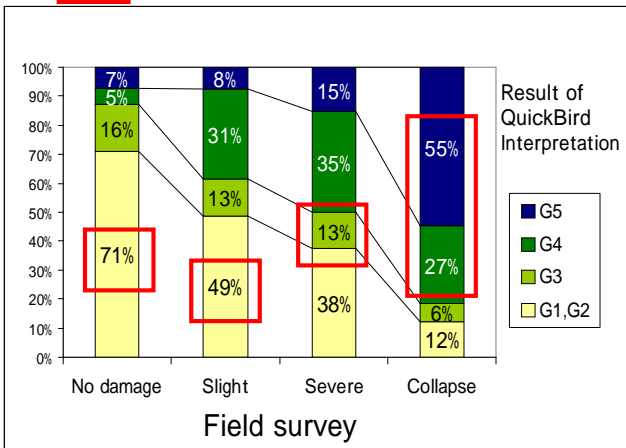
Fig. 6: Producer's accuracy of QB image interpretation in central Pisco.

Figures 6 to 9 summarize the accuracy of building damage classification by visual interpretation against field survey. The accuracy of G5 has significantly improved using the high resolution aerial image. When the levels G4 and G5 are added together, the accuracy of 80% or more is achieved in any case, thereby demonstrating the usefulness of QB high-resolution satellite images in damage detection.

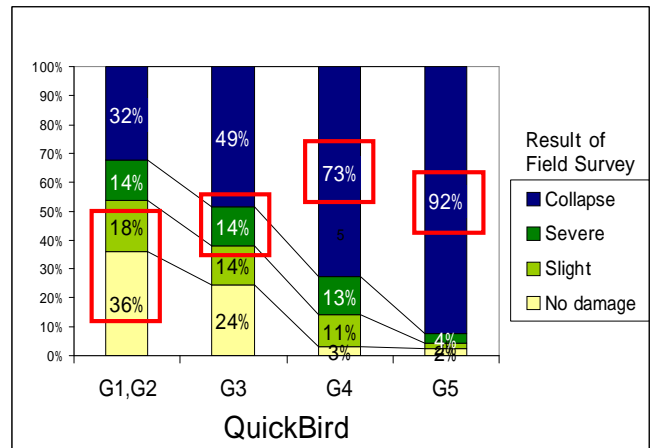
Fig. 7: User's accuracy of QB image interpretation in central Pisco.

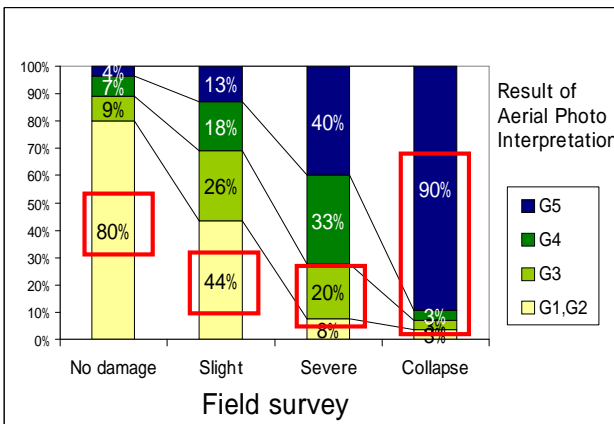
Fig.8: Producer's accuracy of aerial photo interpretation in central Pisco.

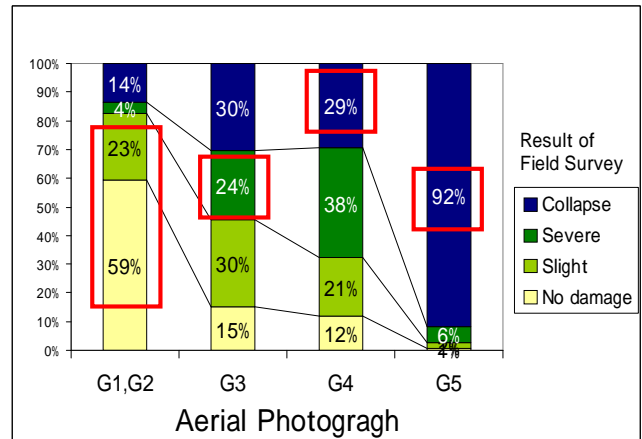
Fig.9: User's accuracy of aerial photo interpretation in central Pisco.
